Tree Survey Report

Yiewsley Library & Car Park 192 High Street, Yiewsley, UB7 7BE

Prepared for London Borough of Hillingdon

Date: 1st April 2019

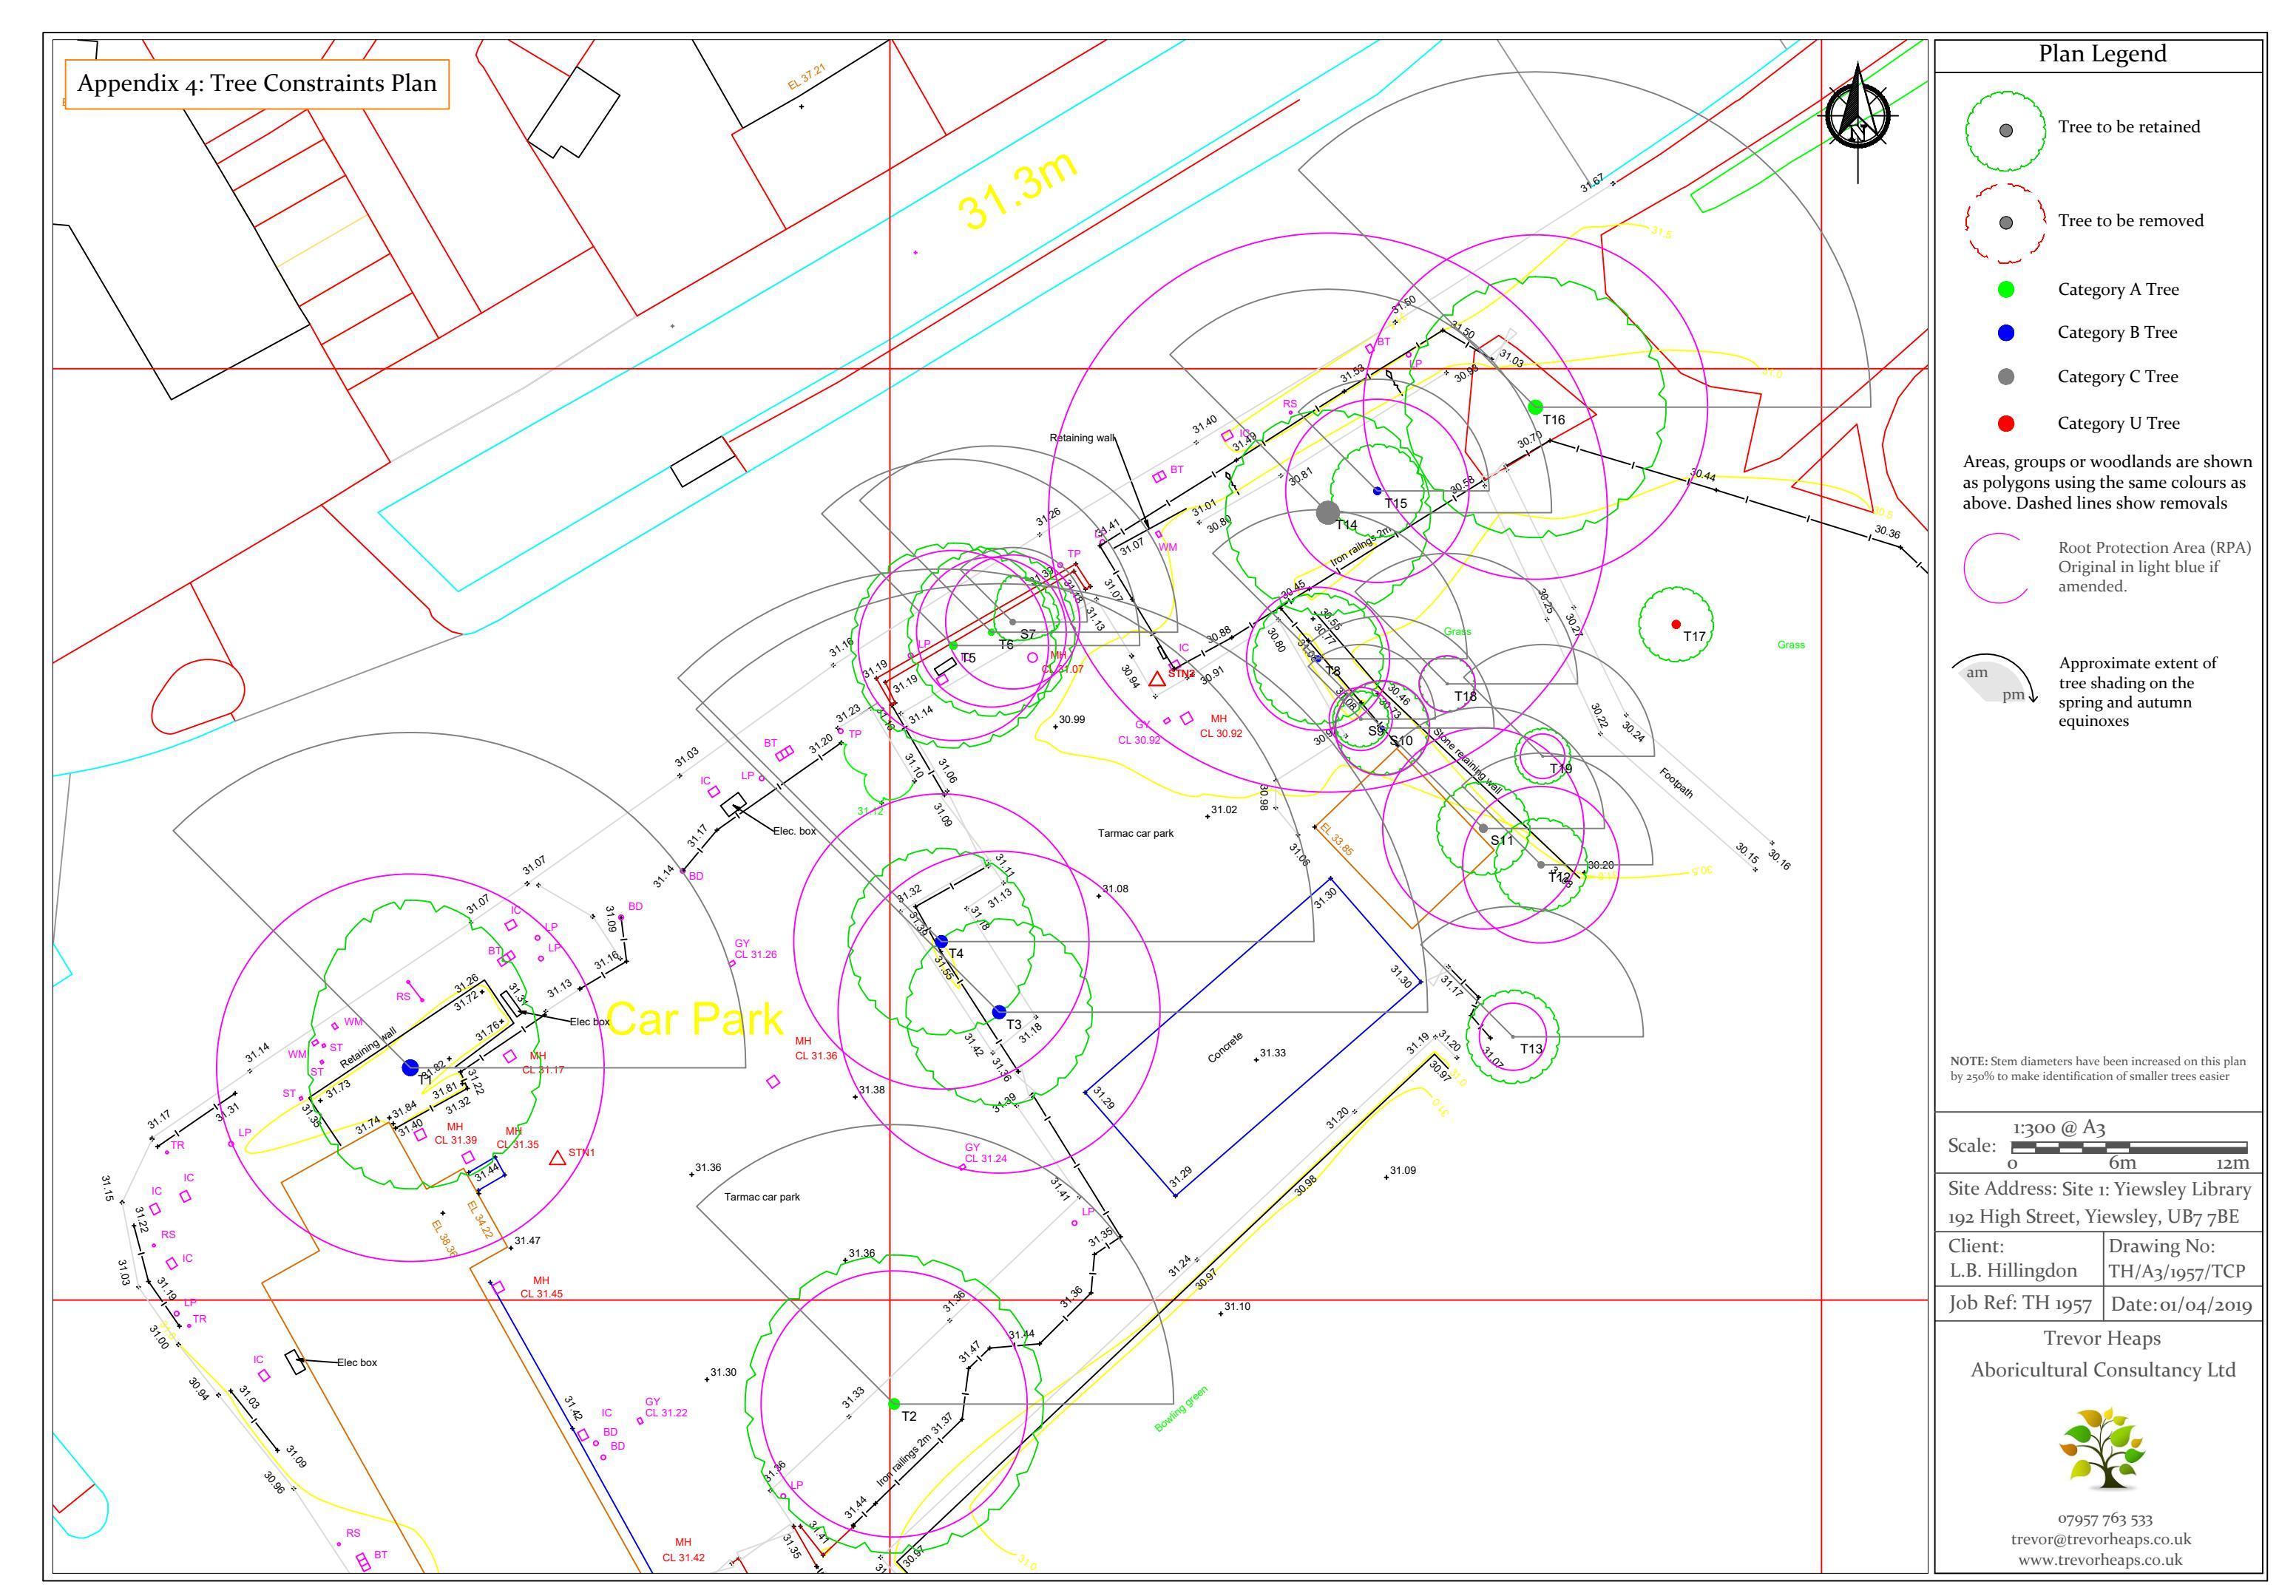
9.7 The tree constraints plan also shows the position of the Root Protection Areas (RPAs) as a magenta circle. BS5837 (Section 3.7) defines the RPA as a '*layout design tool indicating the minimum area around a tree deemed to contain sufficient roots and rooting volume to maintain the tree's viability, and where the protection of the roots and soil structure is treated as a priority'.* In other words, the RPA represents the <u>minimum</u> area around each tree in which the ground should remain largely undisturbed.

9.1.1 Their locations are shown on the Tree constraints plan in Appendix 4.

10.1 If future proposals are designed around the arboricultural constraints shown on the tree constraints plan in Appendix 4, there are no practical (arboricultural) reasons why this site could not be re-developed.
