## **Re: Verification Report for New Sports Hall Construction at St John's School, Potter Street Hill, Northwood**

### **Introduction and background**

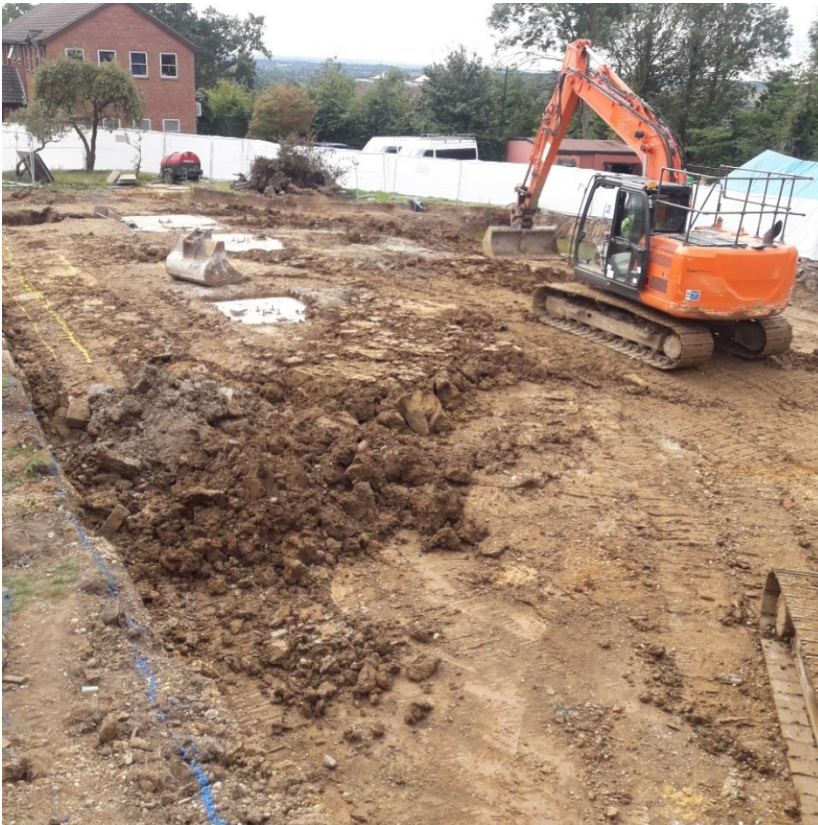
**Photograph 1.1:** Looking south west from south west corner of proposed building showing the strip and reduced level excavations carried out. With arisings removed from site.

With reference to the Photograph 1.1, the reduced level strip appears to show only the natural clay across most of the area indicating further that the arising encountered in TP1 were localised to backfill around the original foundations.

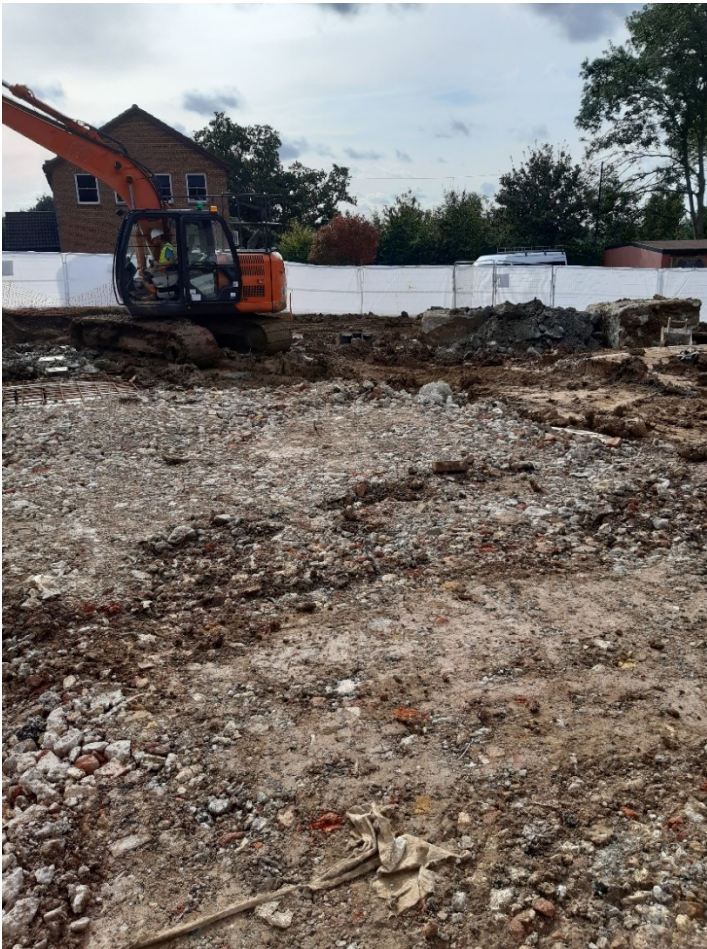
**Photograph 1.2:** Looking south west from south west corner of proposed building showing reduced level and imported working platform placed.

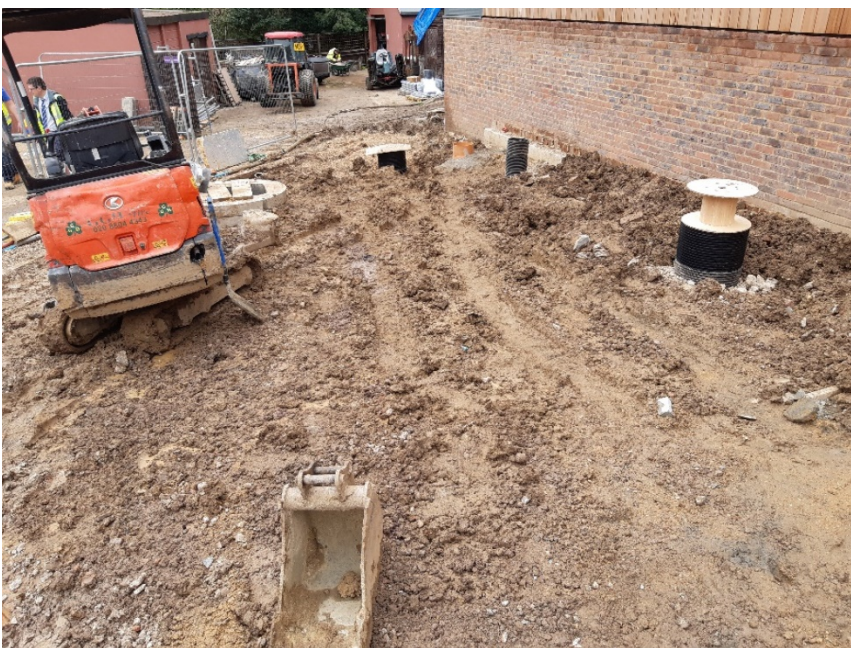
**Photograph 1.3:** Southern area of the site taken week commencing 12<sup>th</sup> October 2020 showing the reinstatement of soils up to level in readiness for topsoil covering (100-150mm). Looking north west from the southern end of the site showing the south west corner of the new building (over the position of TP1).

We have been provided with a report for the imported topsoil placed across the landscaped areas which we are advised has been placed to provide a minimum covering of between 100-150mm. This analysis report is appended and confirms that the soils are suitable for use at the site based on concentrations of chemical contaminants.

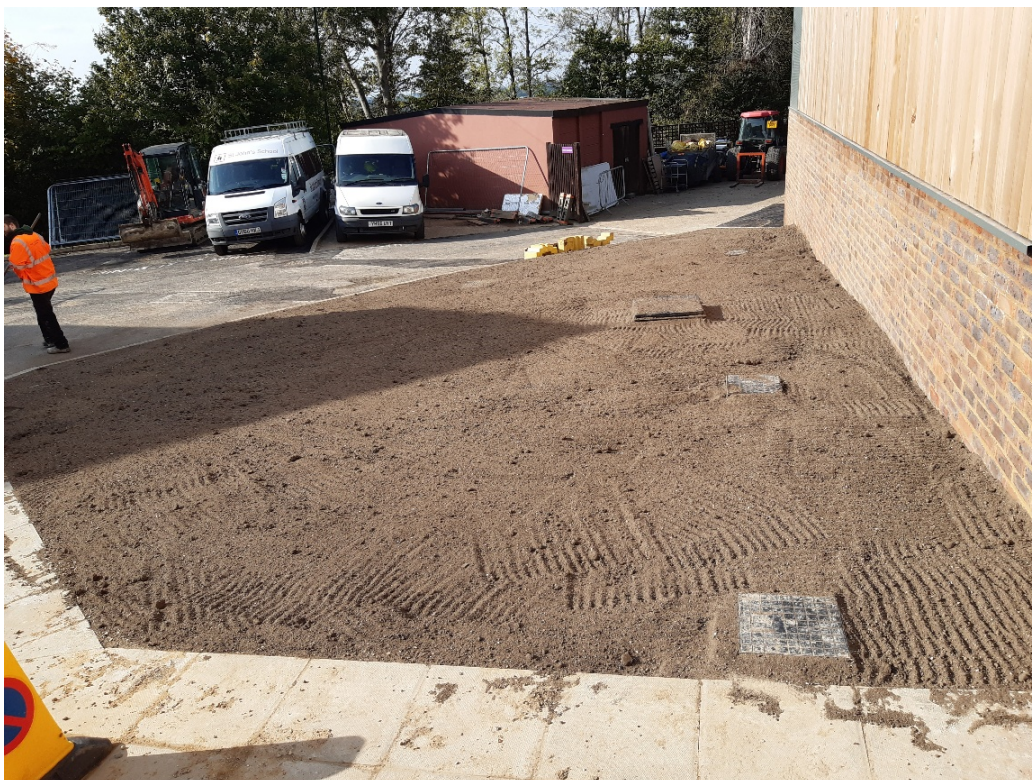
The topsoil was placed on 19<sup>th</sup> October 2020 as confirmed by the following photograph provided by Borrás and a copy of the waste transfer note for the imported topsoil load also enclosed.

**Photograph 1.4:** Taken 19<sup>th</sup> October 2020 showing placed imported topsoil in subject area

Based on the information provided and reviewed in the preceding, it is considered that the soils potentially containing asbestos fibres no longer remain within the landscaped areas and therefore do not present a risk to identified receptors as end users of the site.
