Arboricultural Impact Assessment

Method Statement & Tree Protection Plan

Old Barn House, High Road, Eastcote
Middlesex, HA5 2EW

Ref: TH 5162

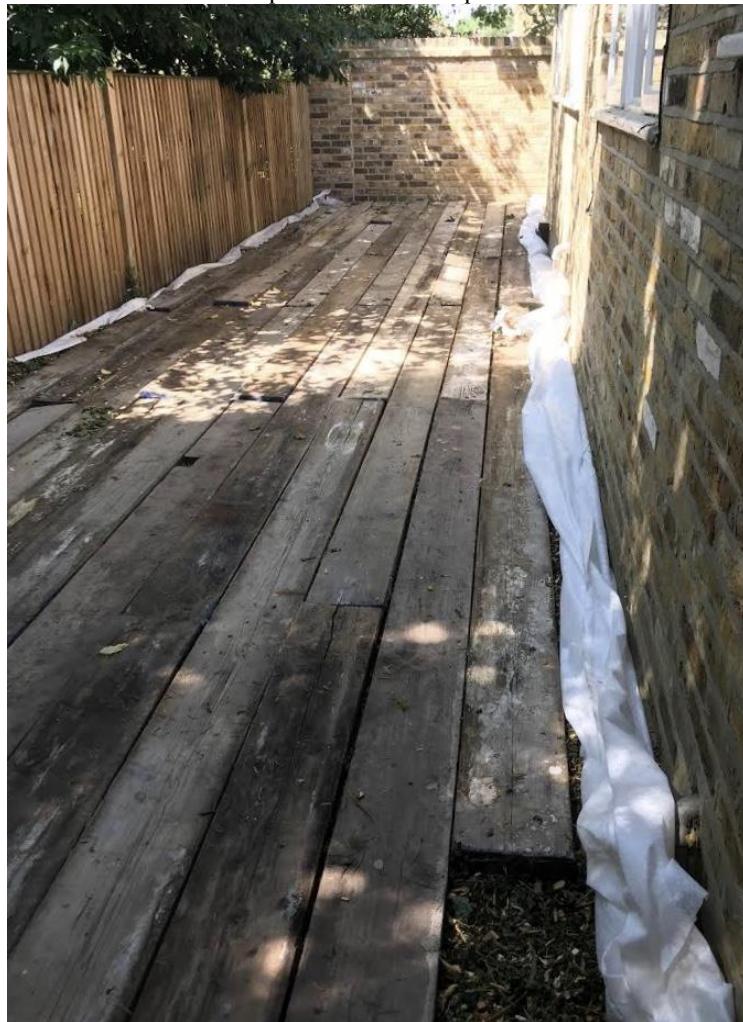
Photo 1. Scaffold boards placed on woodchip

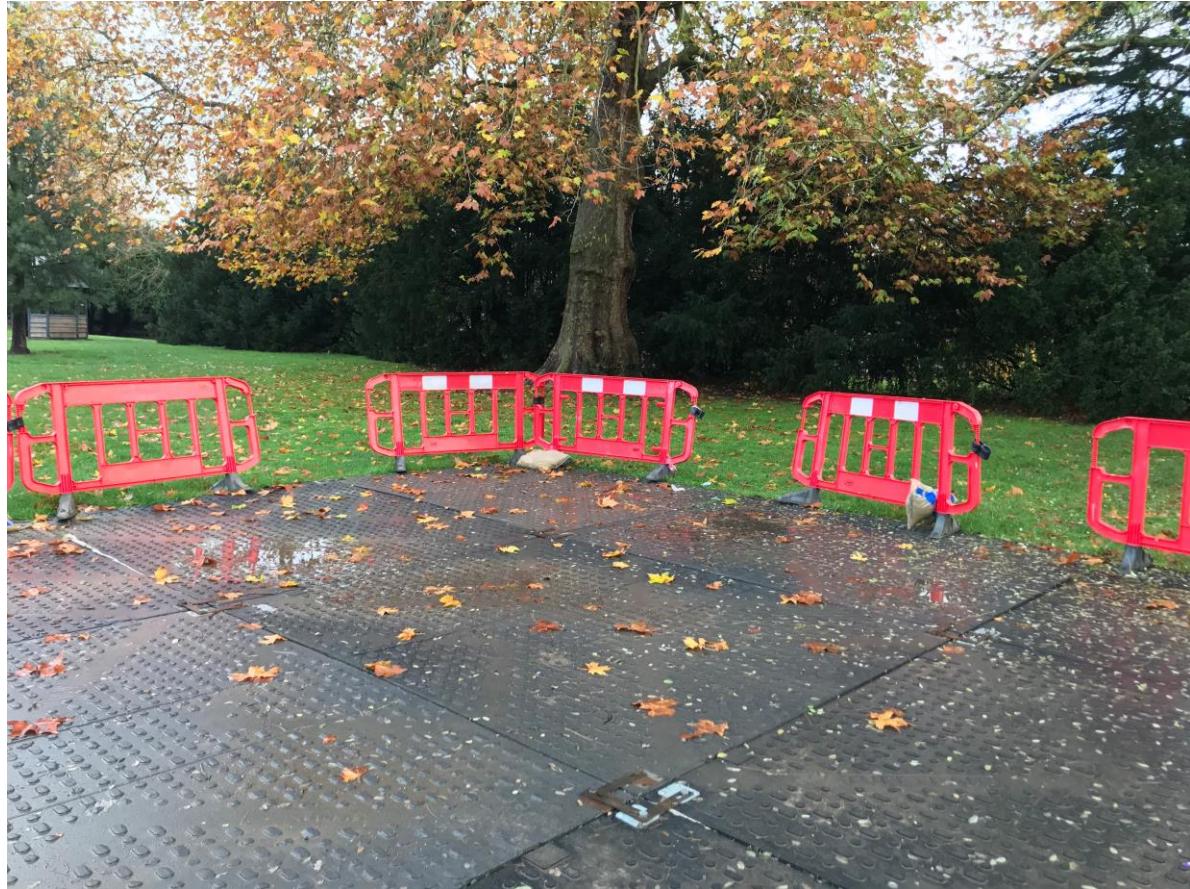
Photo 2. An example of heavy-duty ground protection.

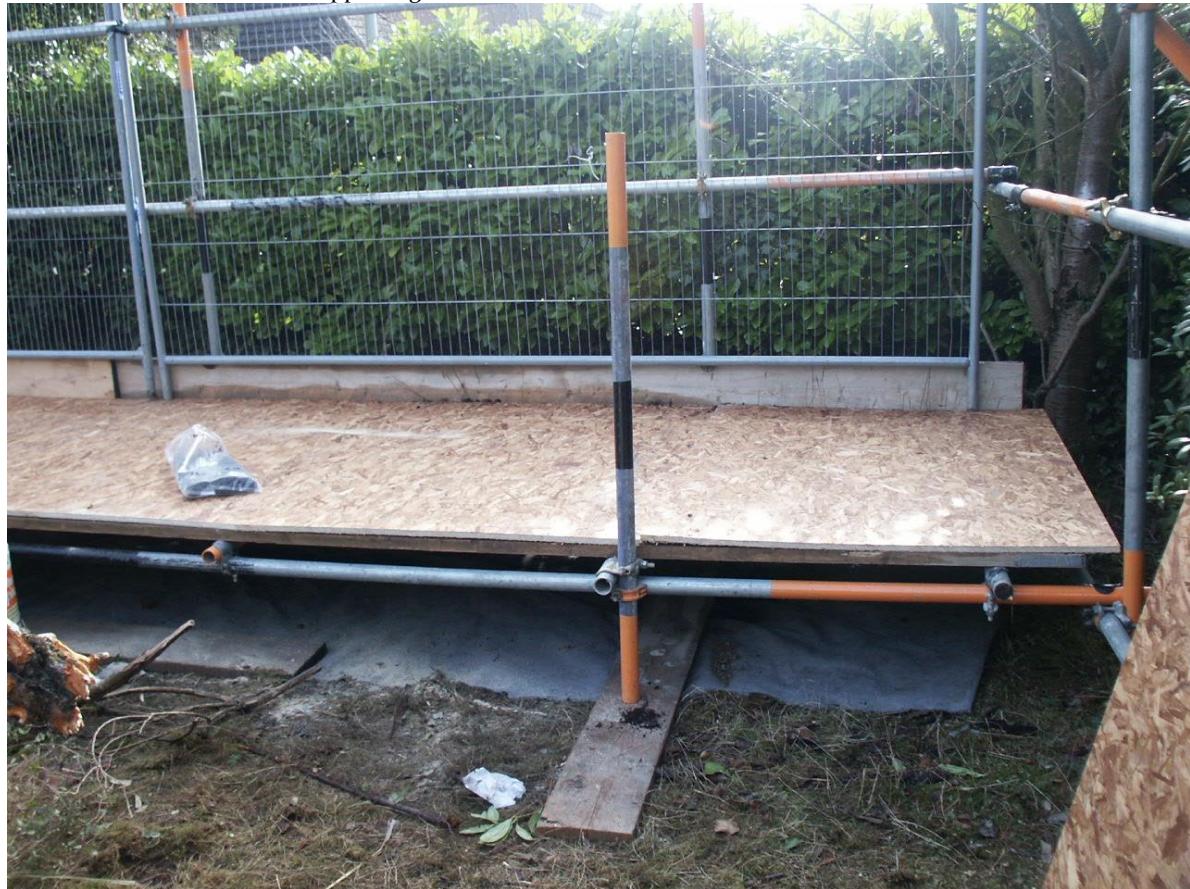
Photo 2 Scaffold framework supporting wooden boards

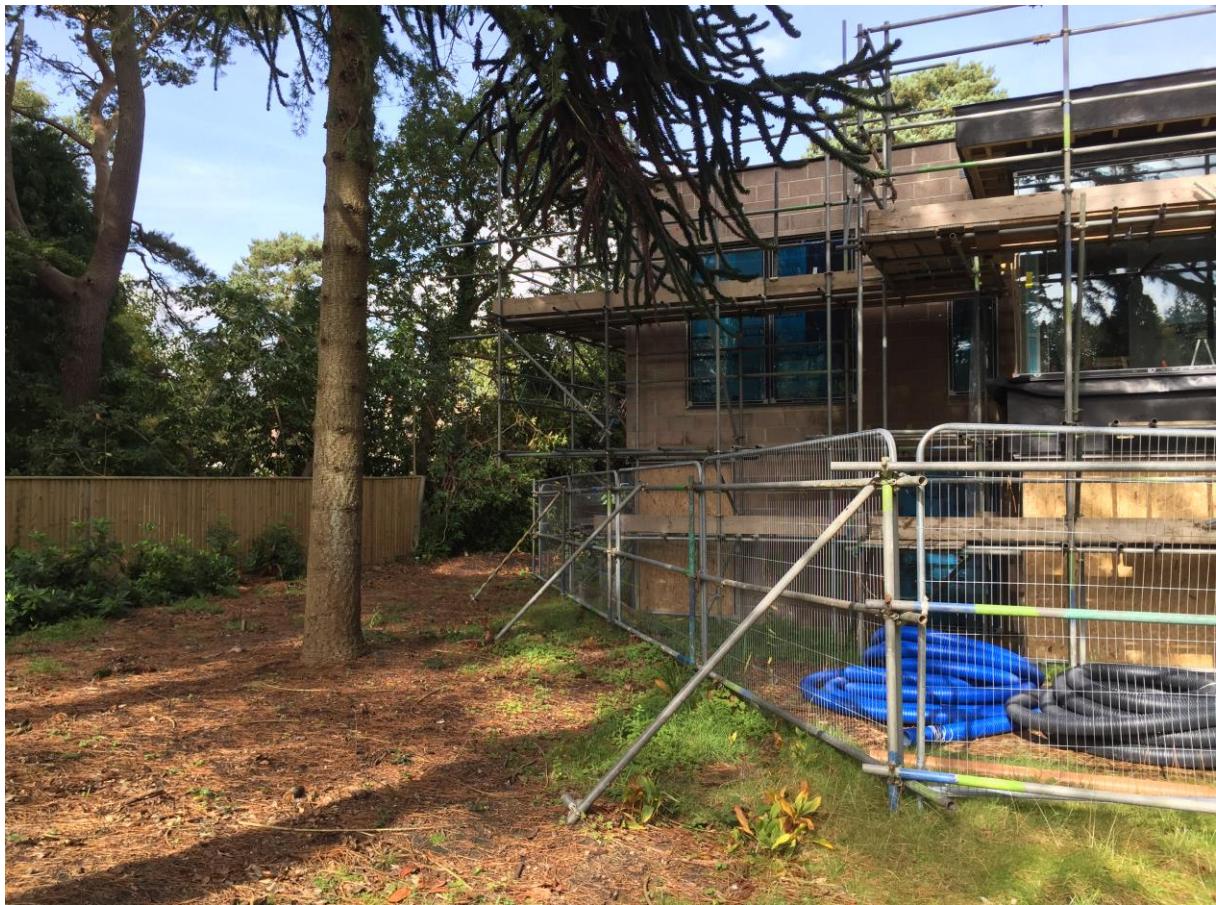
Photo 1: A worked example of the default specification for protective barrier (BS 837:2012)

The framework support (shown in Figure 2 and photo 1) is the usual method of support for 'Heras' fencing. Some variations are possible if site conditions are appropriate; i.e. support by wooden posts (75mm x 75mm x 2.75m) dug or concreted into the ground (dry mix concrete contained within a plastic bag), or if there is no pressure for access, a lighter form of netting on stakes.

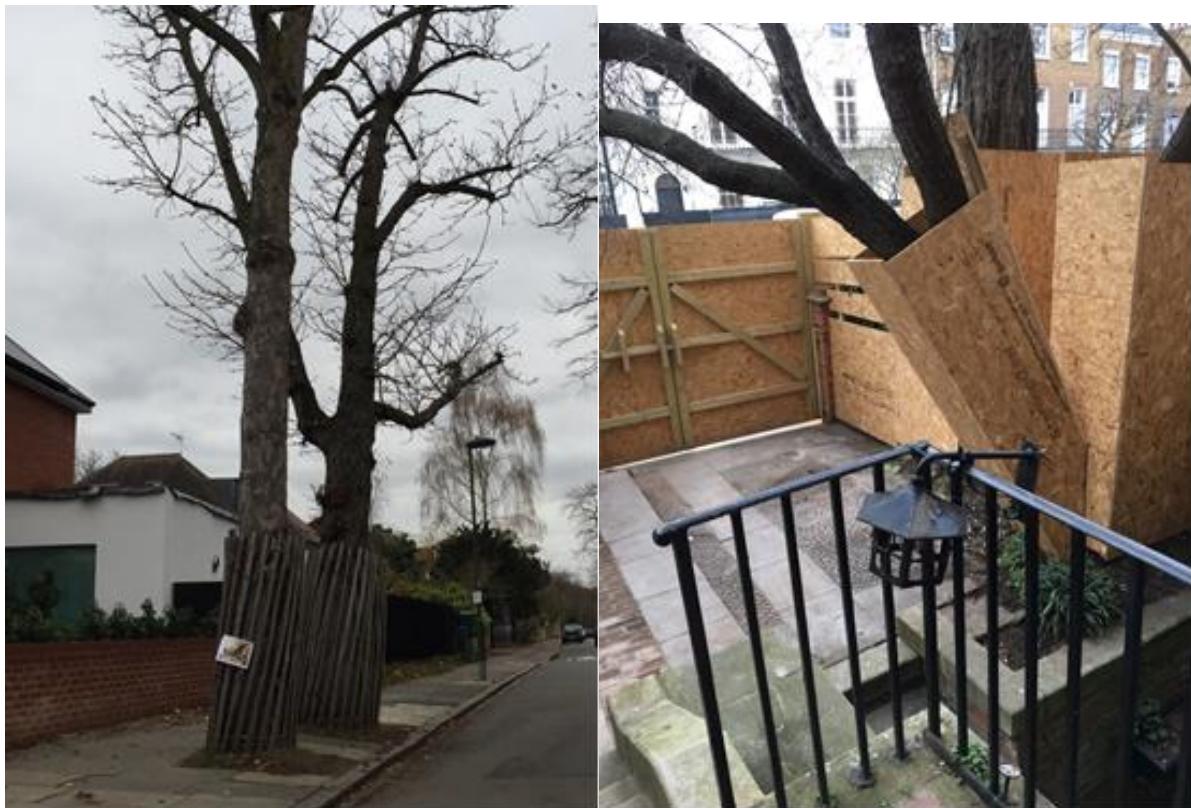
Photo 2: Trees protected by hessian & chestnut pale fencing / limbs protected by wooden boxing

Where specified in the AMS, the tree(s) stem/s shall be boxed off with wooden ply boards or wrapped in hessian and chestnut pale fencing / trunk protection (see example below). This will help avoid any direct damage to tree stems from passing machinery (see photo 2).

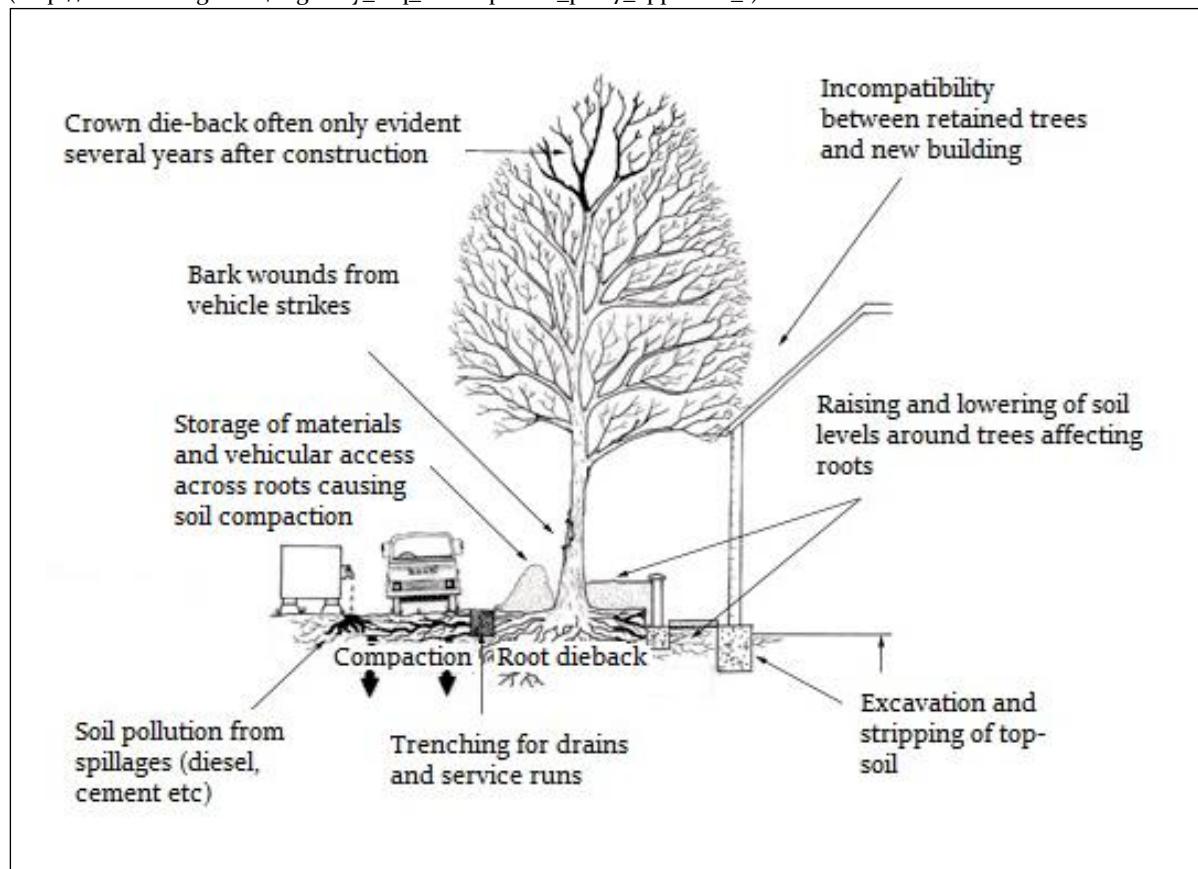
Figure 4: Common problems for trees on development sites
(http://www.leics.gov.uk/highway_req_development_part7_appendix_f)

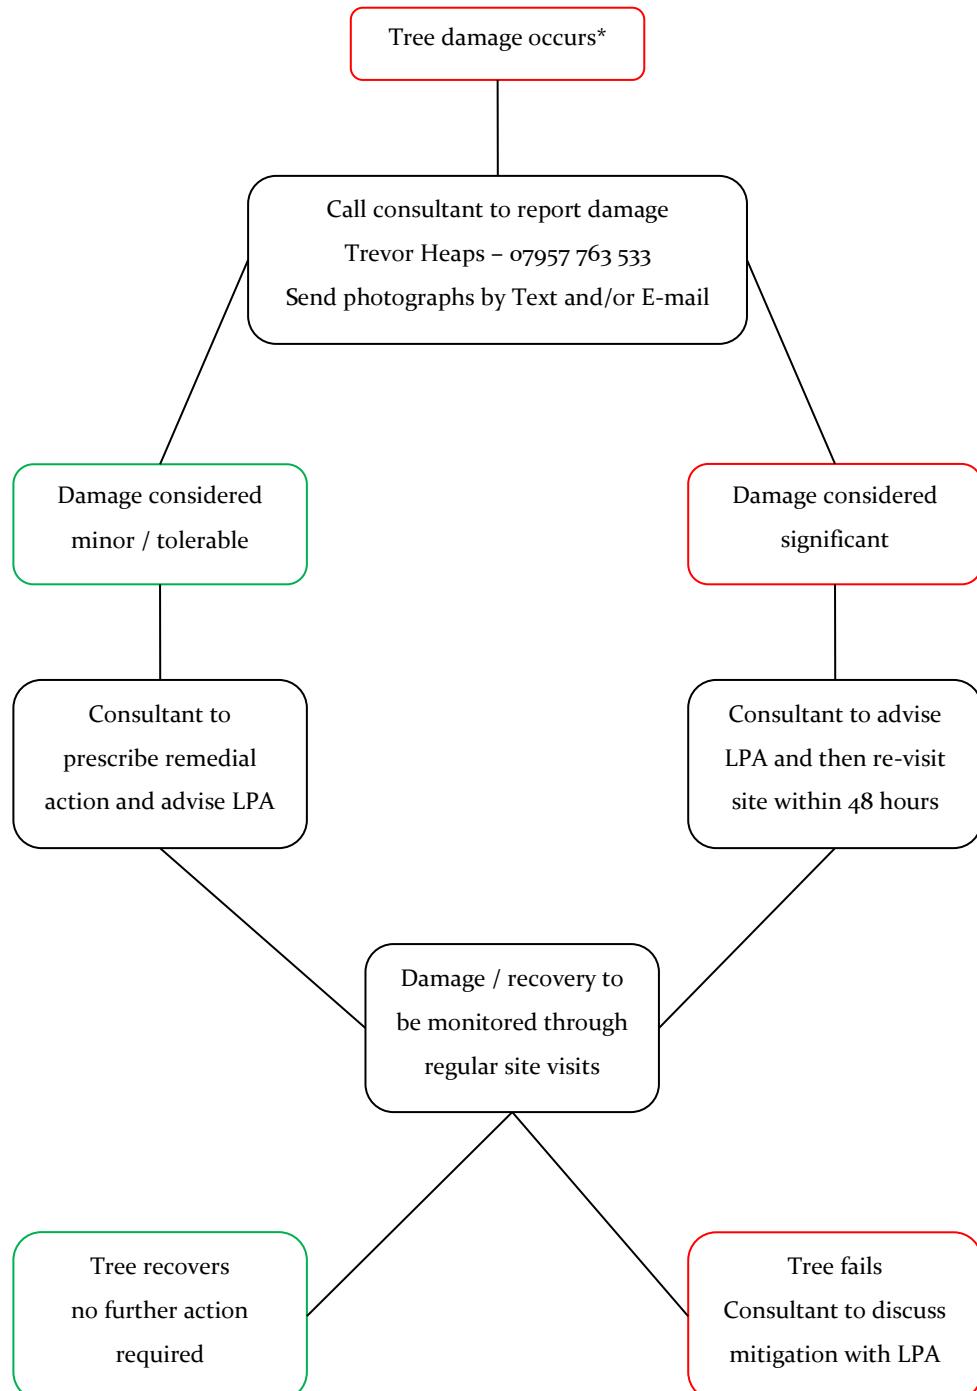
Appendix 6 - Procedure to follow in case of damage to retained trees

*Tree damage could include: unauthorised branch / root pruning; accidental damage to roots, stem, branches or crown; bark damage to vehicle / machinery strikes; and spillage of toxic materials within root protection areas (RPAs)
