## Tree Survey, Arboriculture Impact Assessment and Method Statement

**Site Address: 102 Green Lane, Northwood, Middlesex, HA6 1AJ**

**Date of Report: 27.04.26**

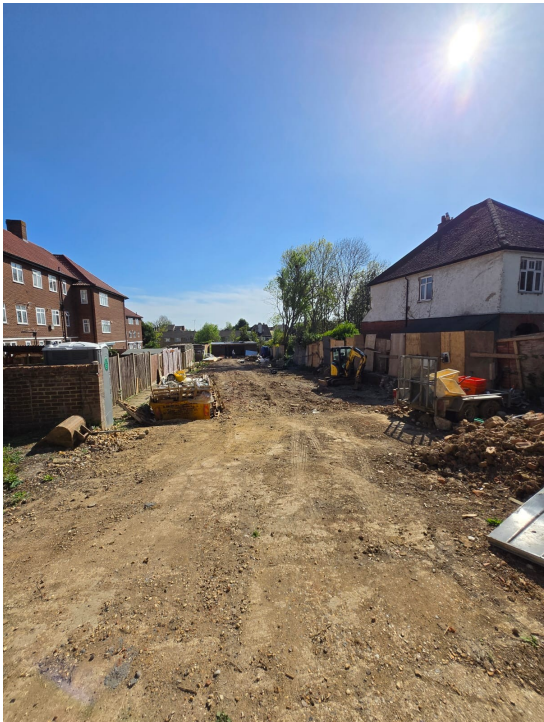
Site photo 1 facing south

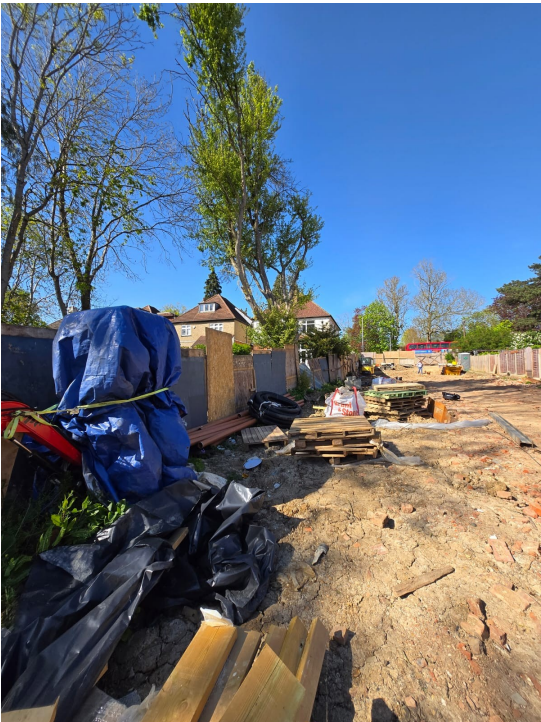
Site photo 2 facing north (T1 centre)

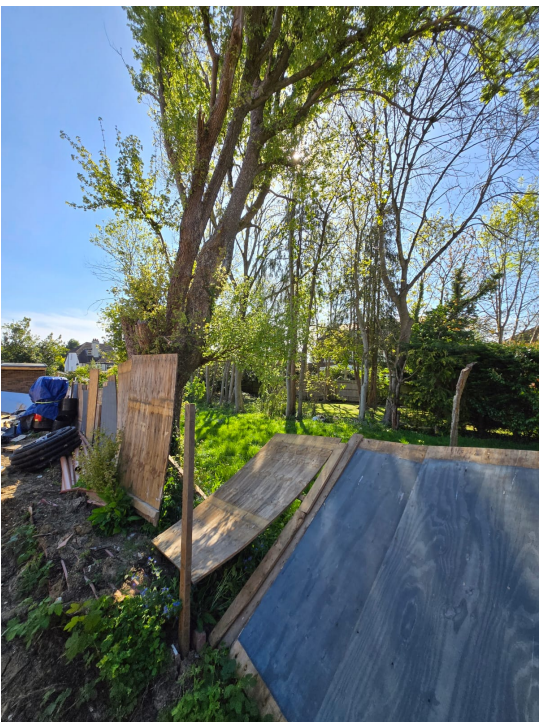
Site photo 3 of T1 (facing south)

| Unidentifier | Species | Scientific name | Height (m) | Stem Diameter @1.5m (DBH) (mm) | Root Protection Area (m) | Crown Spread (4 cardinal points N, S, E, W) | | | | Height of Lowest Branch | Age Class | Condition | Category | Details |
|---|---|---|---|---|---|---|---|---|---|---|---|---|---|---|
| T1 | Field Maple | Acer campestre | 17 | 500 | 6 | 3.8 | 3.8 | 2.5 | 5.5 | 3 | M | Fair | C3 | Tree is located on neighbours side of boundary. It has been heavily pruned on the eastern side where one of three co-dominant stems would have extended over the boundary. The removal of this stem has resulted in an uneven appearance. Further, more sympathetic, pruning may restore the appearance. |

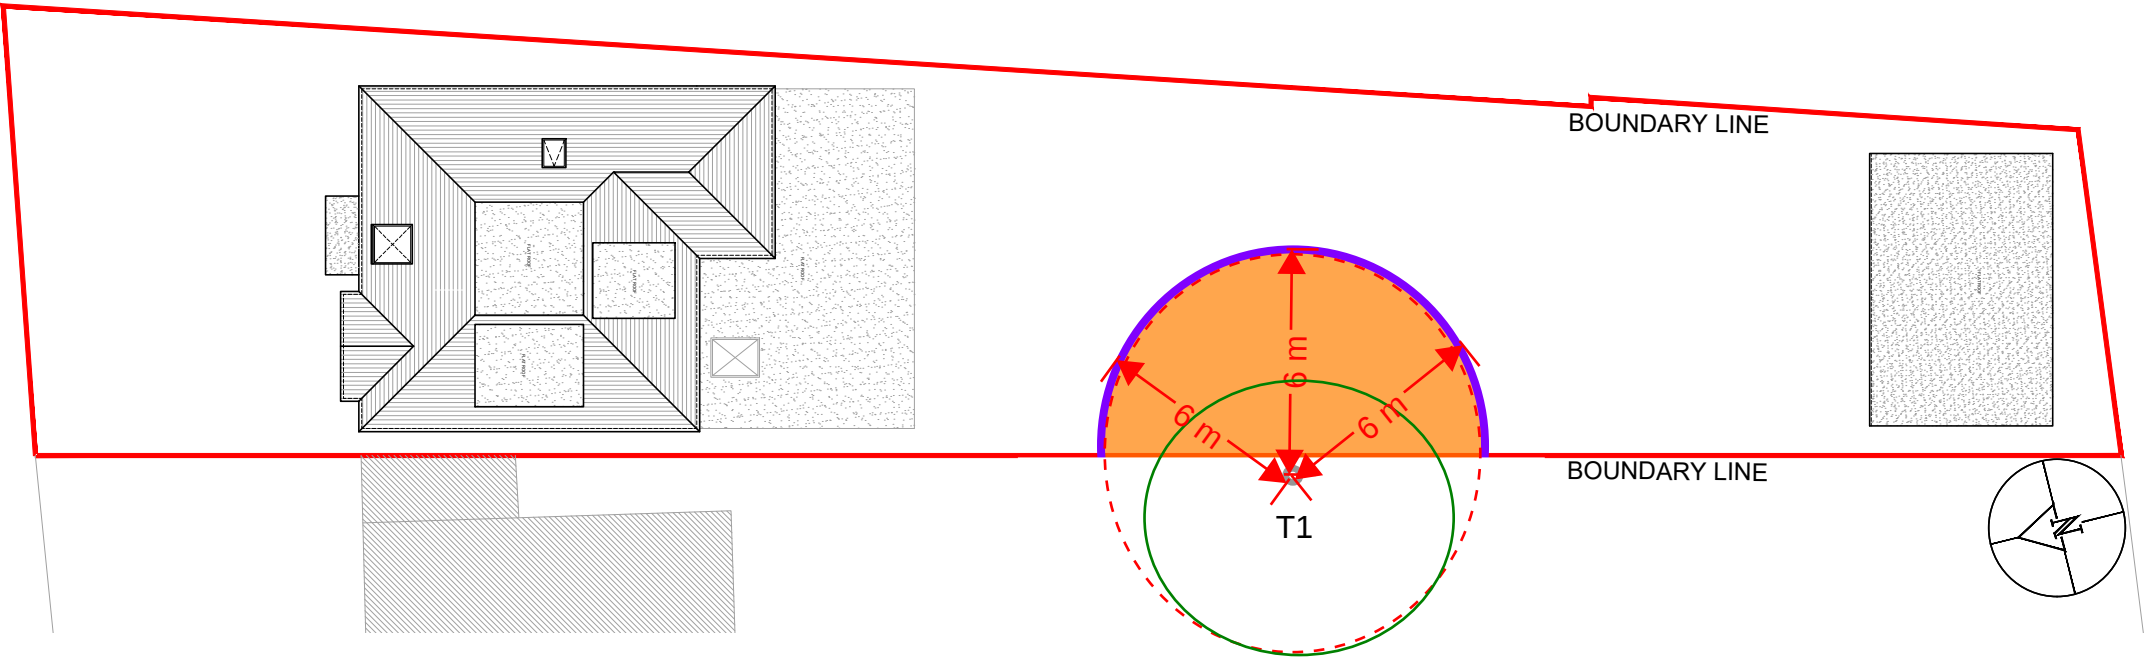
APPENDIX C

All trees to be retained on, and adjacent to site, shall be protected with fencing erected around the RPA in accordance with *BS 5837; 2012; 'Trees in Relation to Design, Demolition and Construction - Recommendations'* and to the layout in the Tree Protection Plan in Appendix C. The fencing shall be installed under the supervision of a qualified arboriculturalist. The fencing shall be retained and maintained during the main works by the Contractor. Following completion of all works, the arboriculturalist shall supervise the contractor removing the fencing, to ensure retention of the RPAs.
