### **Arboricultural Impact Assessment Method Statement & Tree Protection Plan (to BS:5837 2012)**

**45 Dene Road, Northwood  
HA6 2DD**

Ref: TH 6158

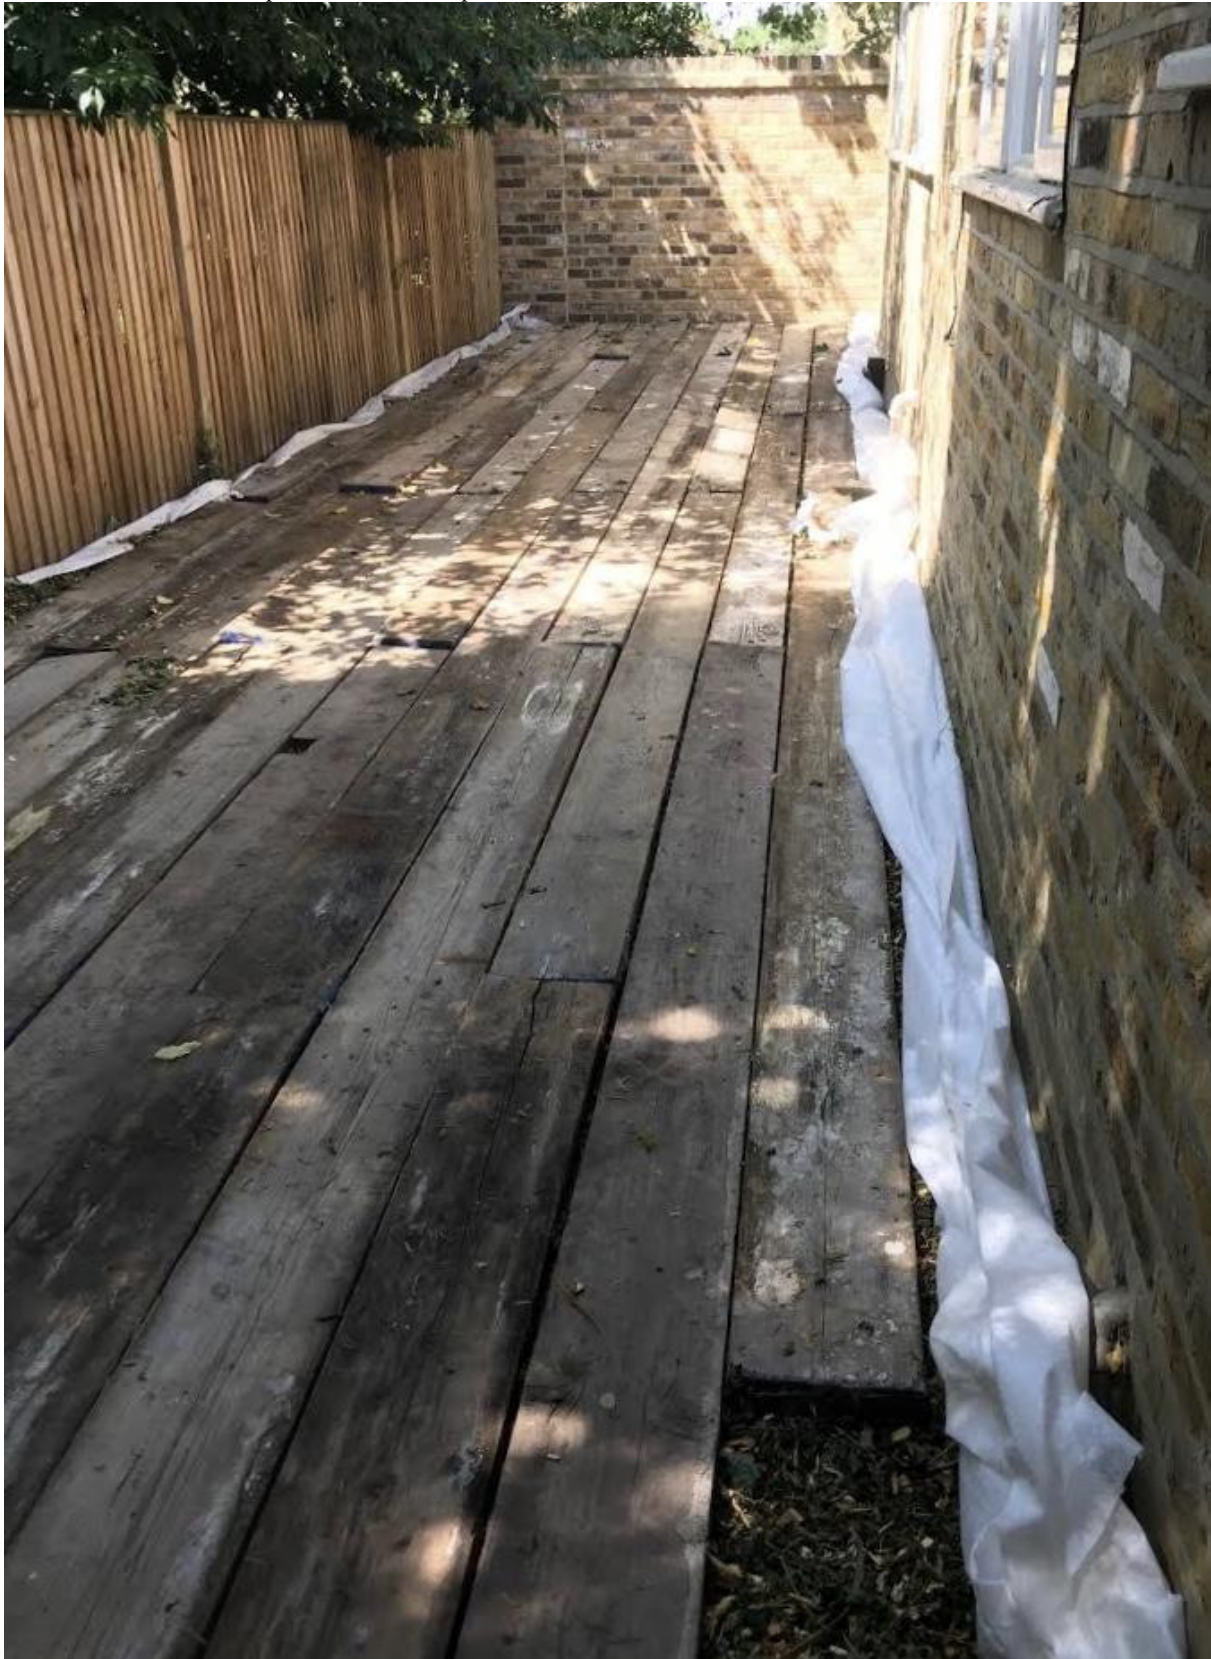
**Photo 1.** Scaffold boards placed on woodchip

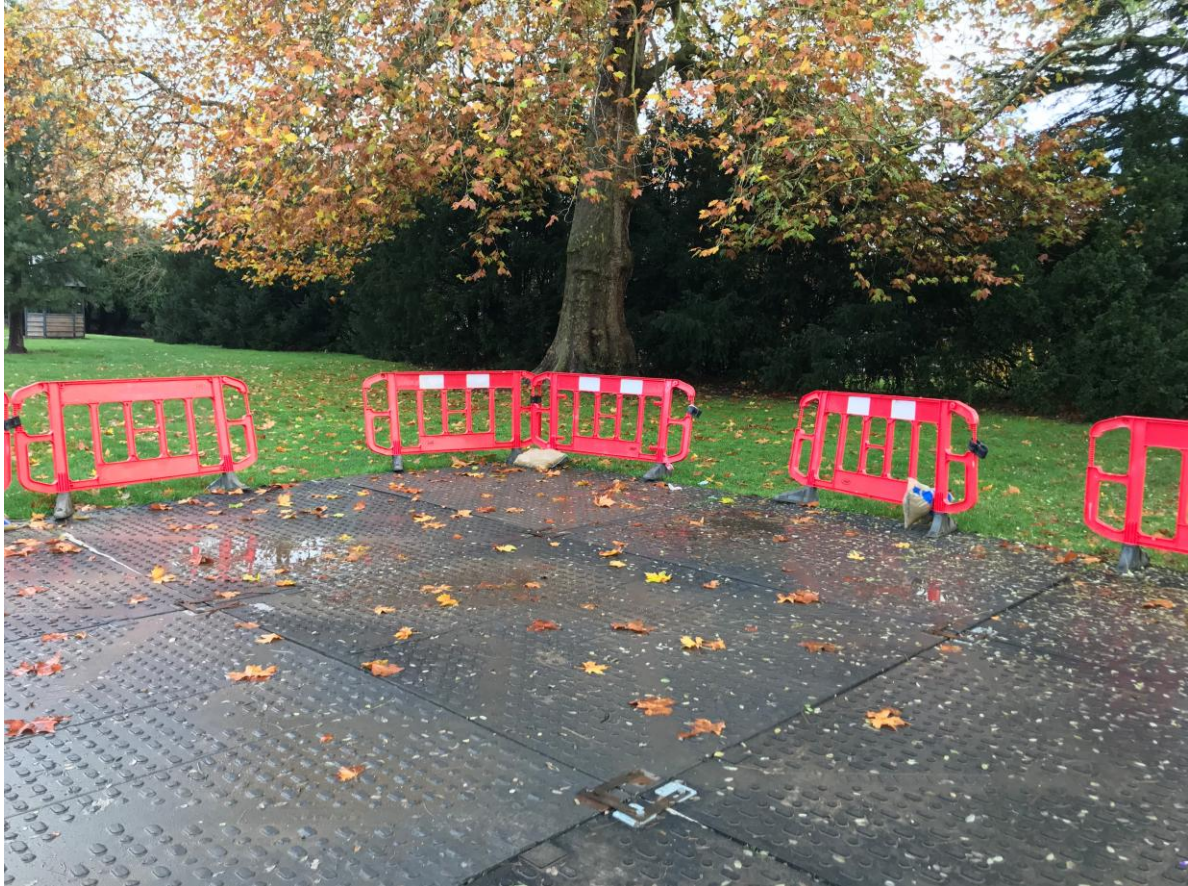
**Photo 2.** An example of heavy-duty ground protection.

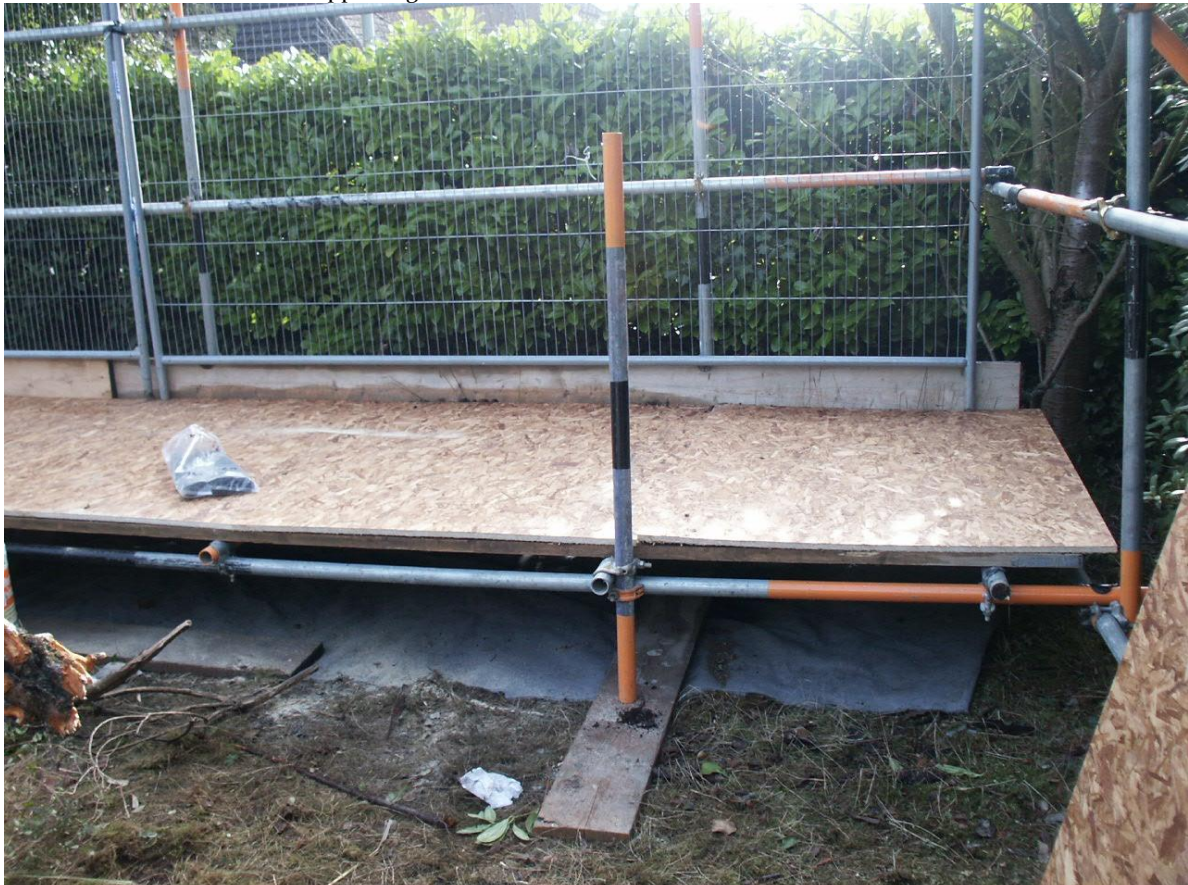
**Photo 2** Scaffold framework supporting wooden boards

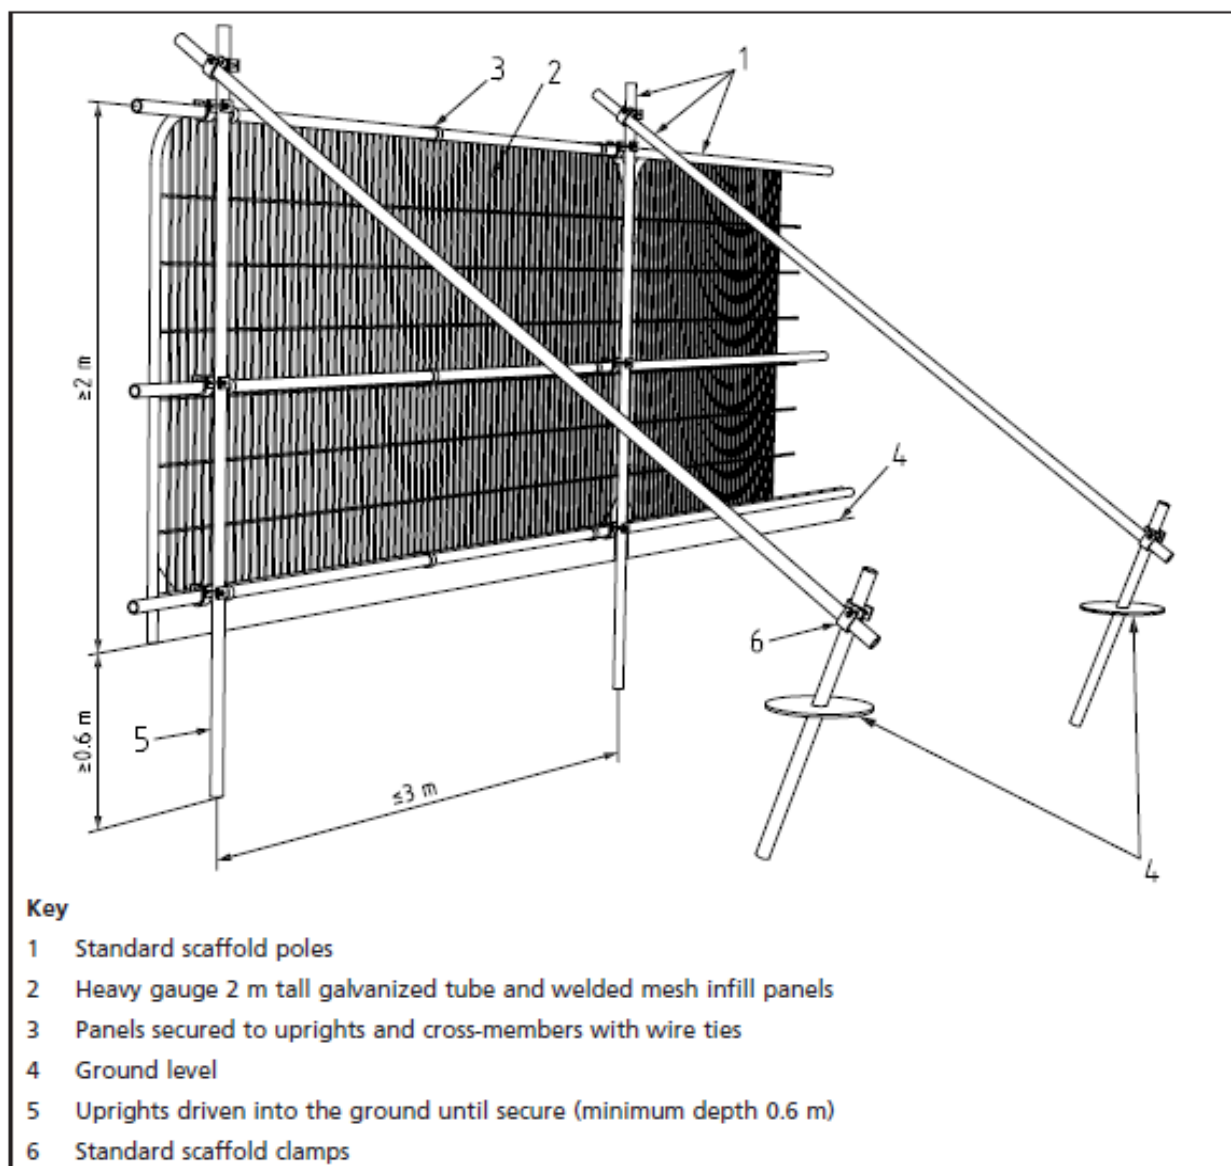
The framework support (shown in Figure 2 and photo 1) is the usual method of support for 'Heras' fencing. Some variations are possible if site conditions are appropriate; i.e. support by wooden posts (75mm x 75mm x 2.75m) dug or concreted into the ground (dry mix concrete contained within a plastic bag), or if there is no pressure for access, a lighter form of netting on stakes.

**Figure 2:** Default specification for protective barrier (BS 5837:2012)

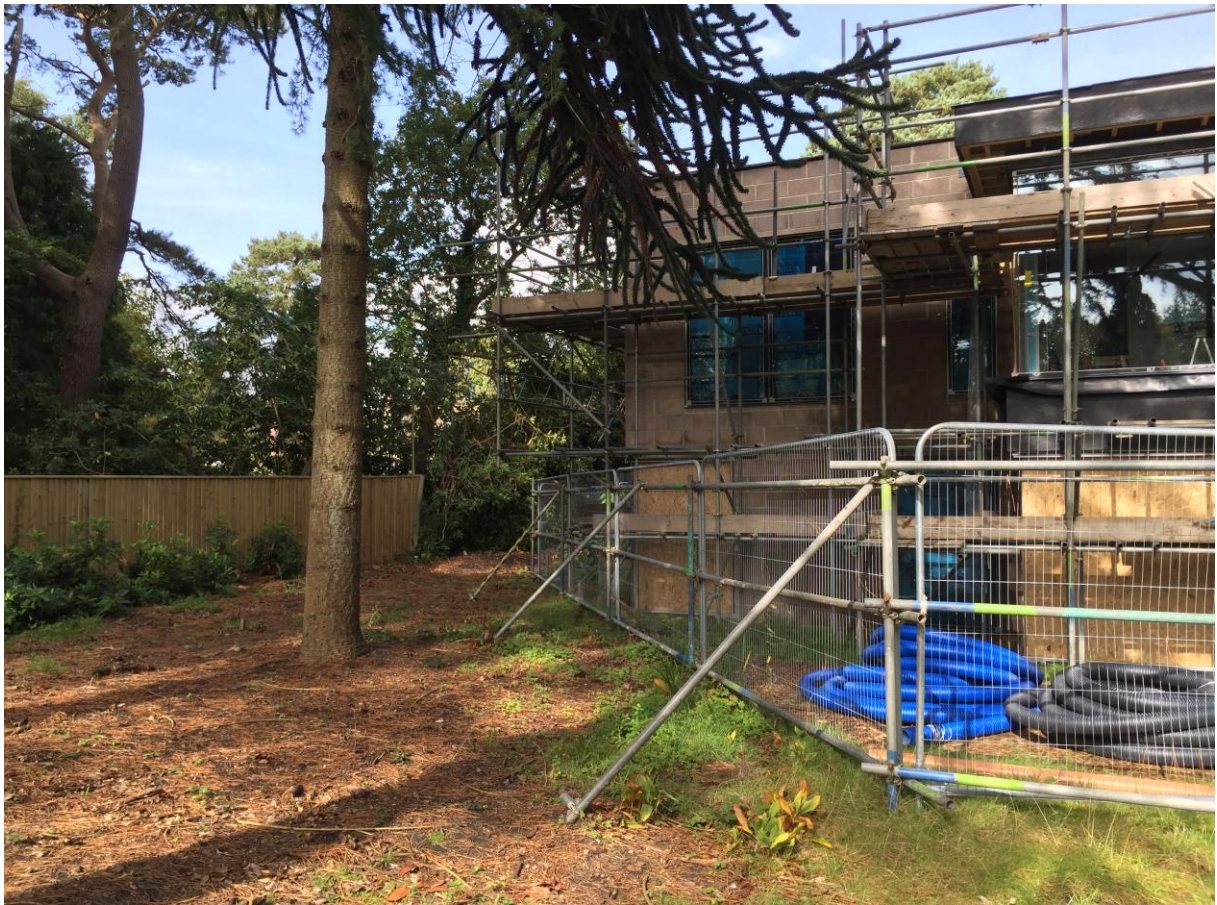
**Photo 1:** A worked example of the default specification for protective barrier (BS 837:2012)

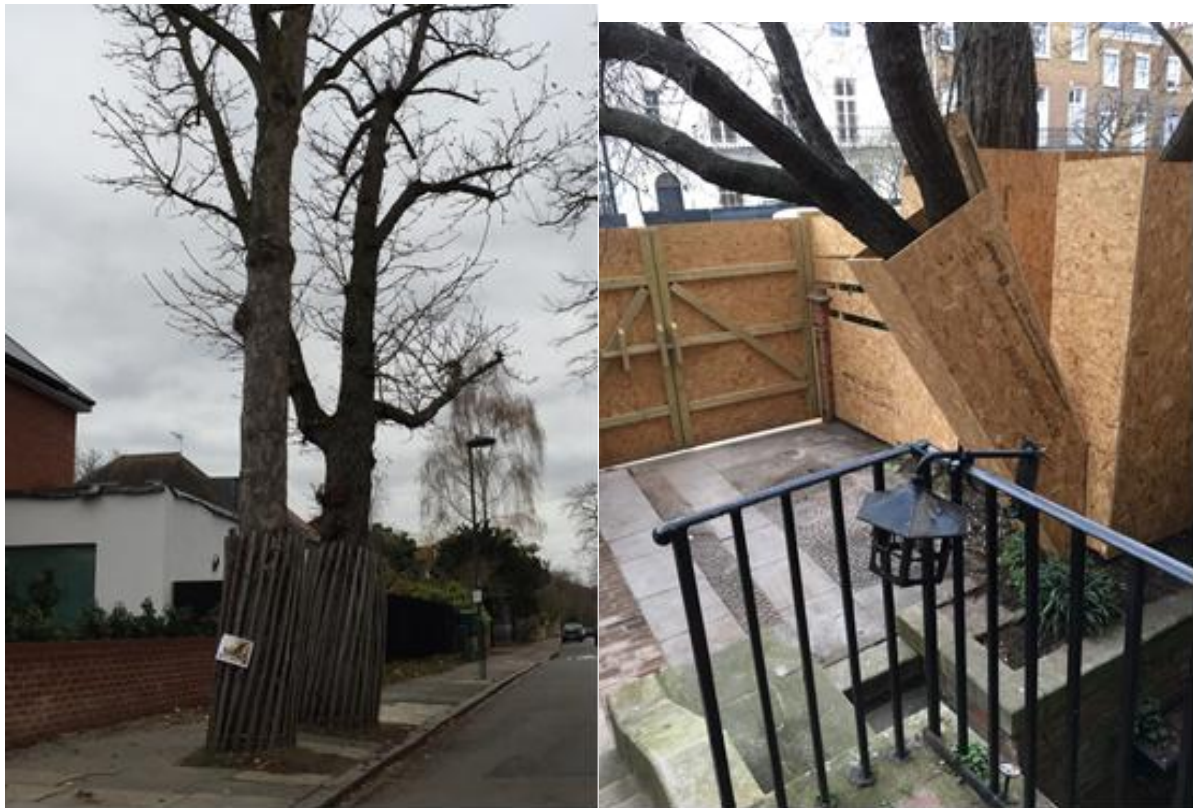
Where specified in the AMS, the tree(s) stem/s shall be boxed off with wooden ply boards or wrapped in hessian and chestnut pale fencing / trunk protection (see example below). This will help avoid any direct damage to tree stems from passing machinery (see photo 2).

**Photo 2:** Trees protected by hessian & chestnut pale fencing / limbs protected by wooden boxing
