### **Arboricultural Impact Assessment Method Statement & Tree Protection Plan (to BS:5837 2012)**

**191 Long Lane, Hillingdon, Uxbridge  
UB10 9JW**

Date: 1<sup>st</sup> November 2020

Ref: TH 2556

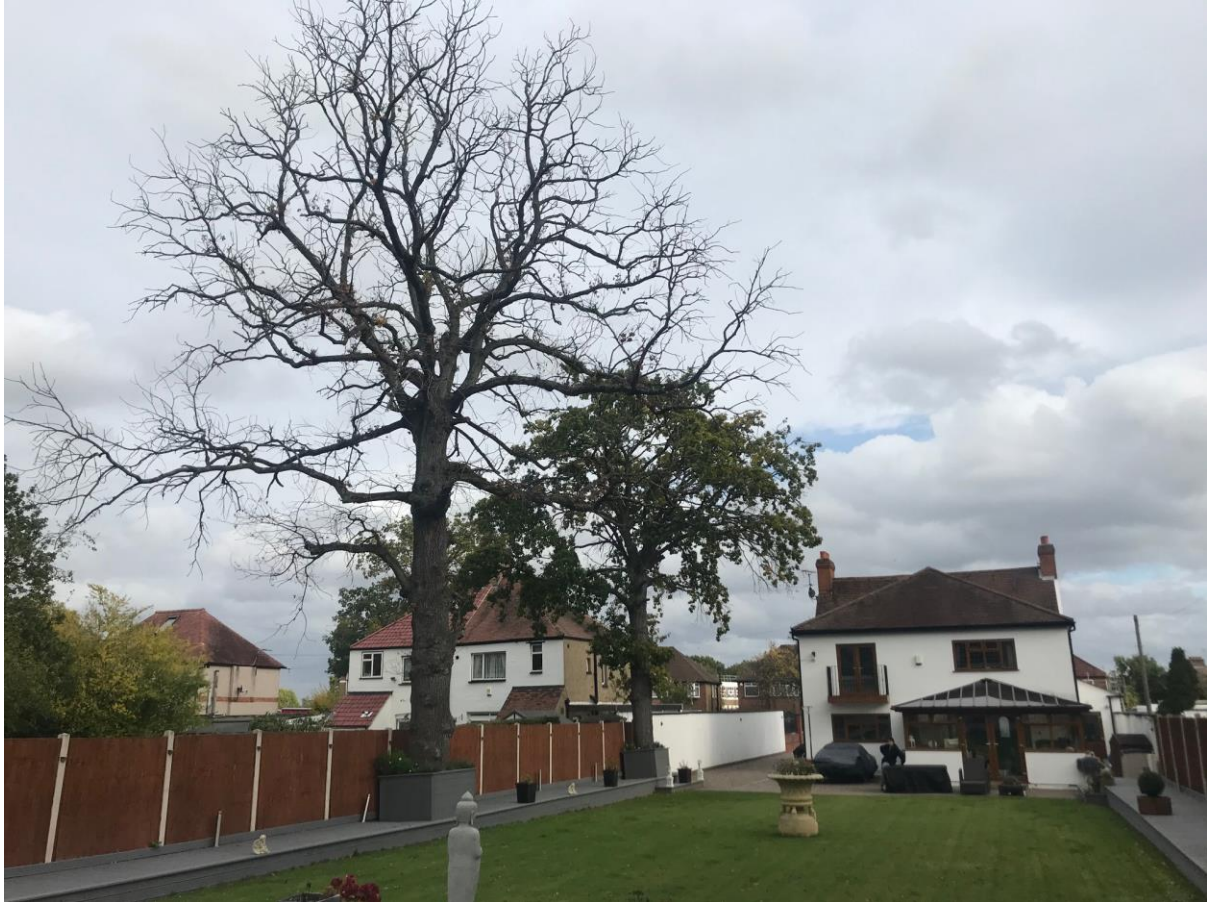
**Note:** Oak T2 is shown to be removed in Appendix T2 because it is dead. It does not need to be removed to facilitate development.

**Photo 1. Dead Oak T2 in the foreground**

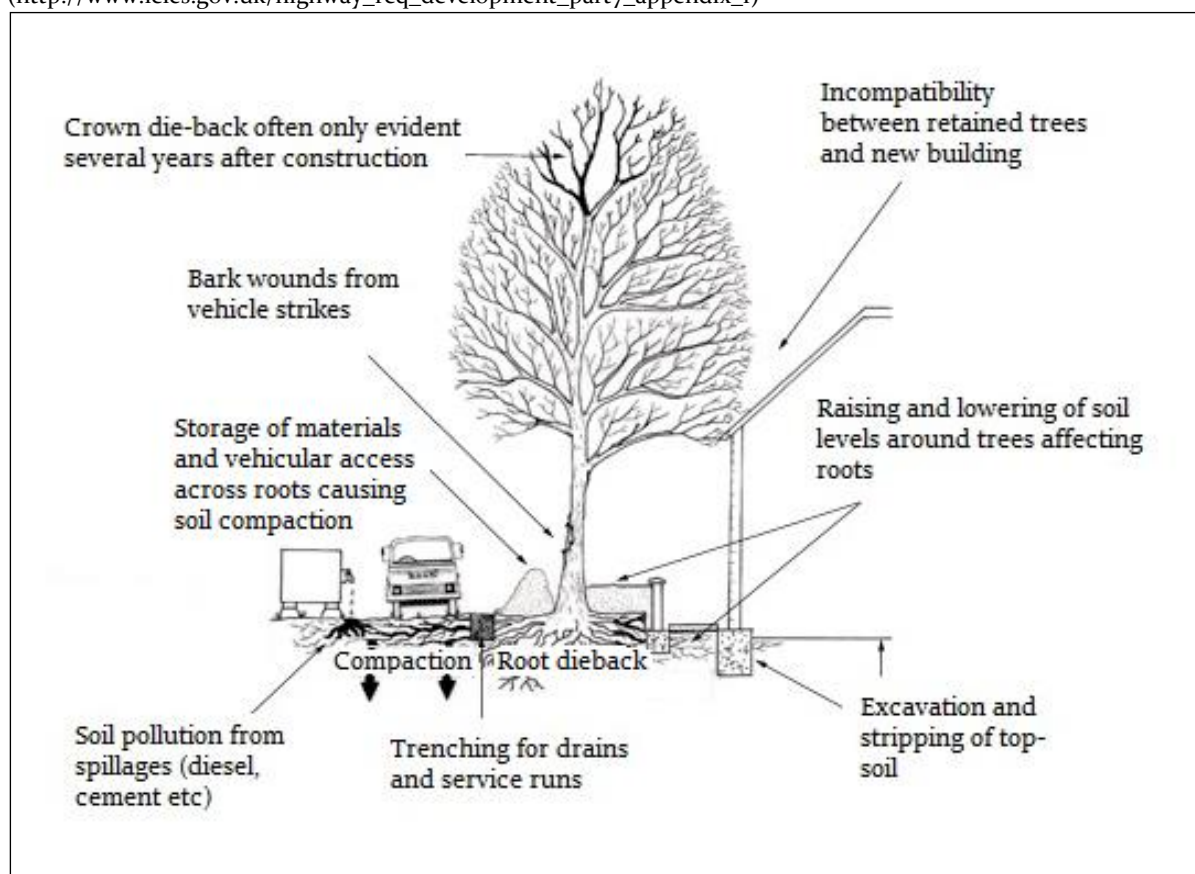
**Figure 4:** Common problems for trees on development sites  
([http://www.leics.gov.uk/highway\\_req\\_development\\_part7\\_appendix\\_f](http://www.leics.gov.uk/highway_req_development_part7_appendix_f))
