### **Arboricultural Impact Assessment Method Statement & Tree Protection Plan (to BS:5837 2012)**

**Meadow Special School, Royal Lane, Hillingdon  
UB8 3QU**

Ref: TH 3639 C

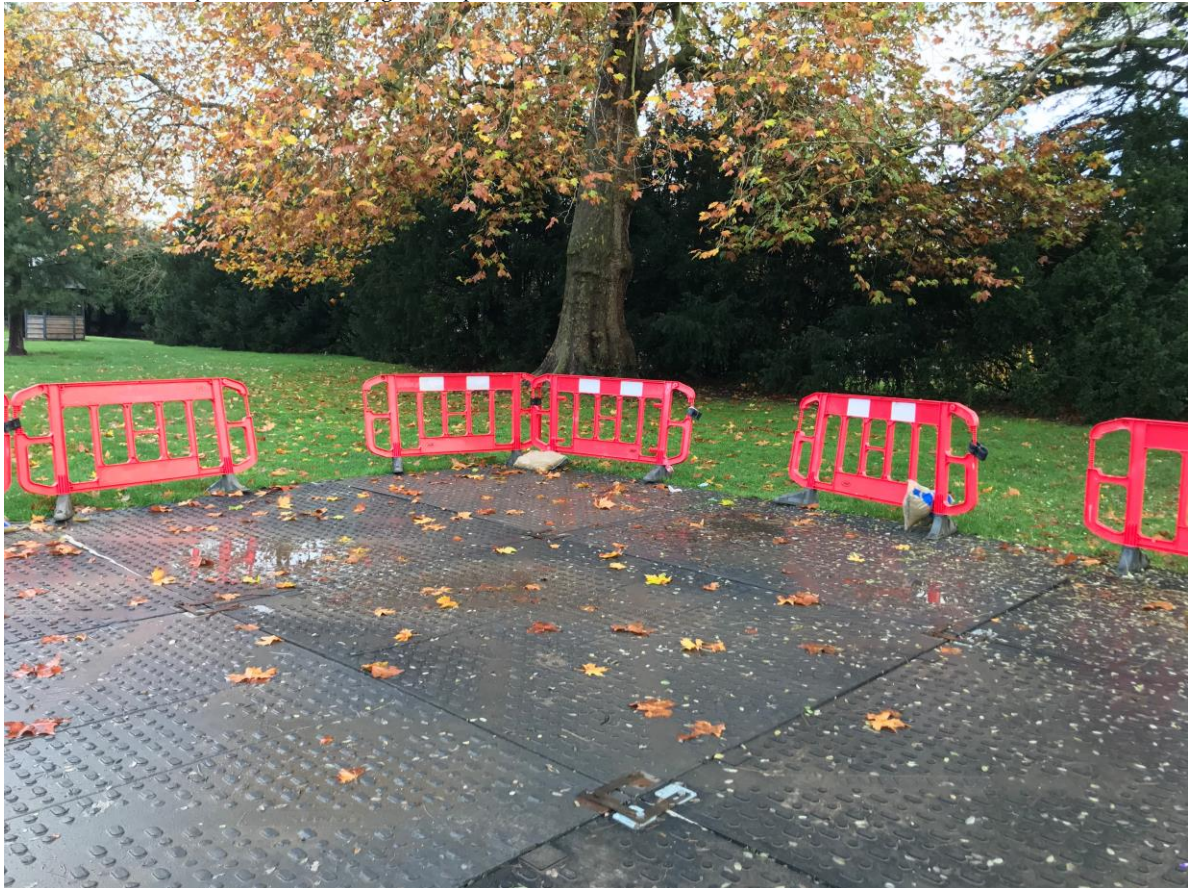
**Photo 2.** An example of heavy-duty ground protection.

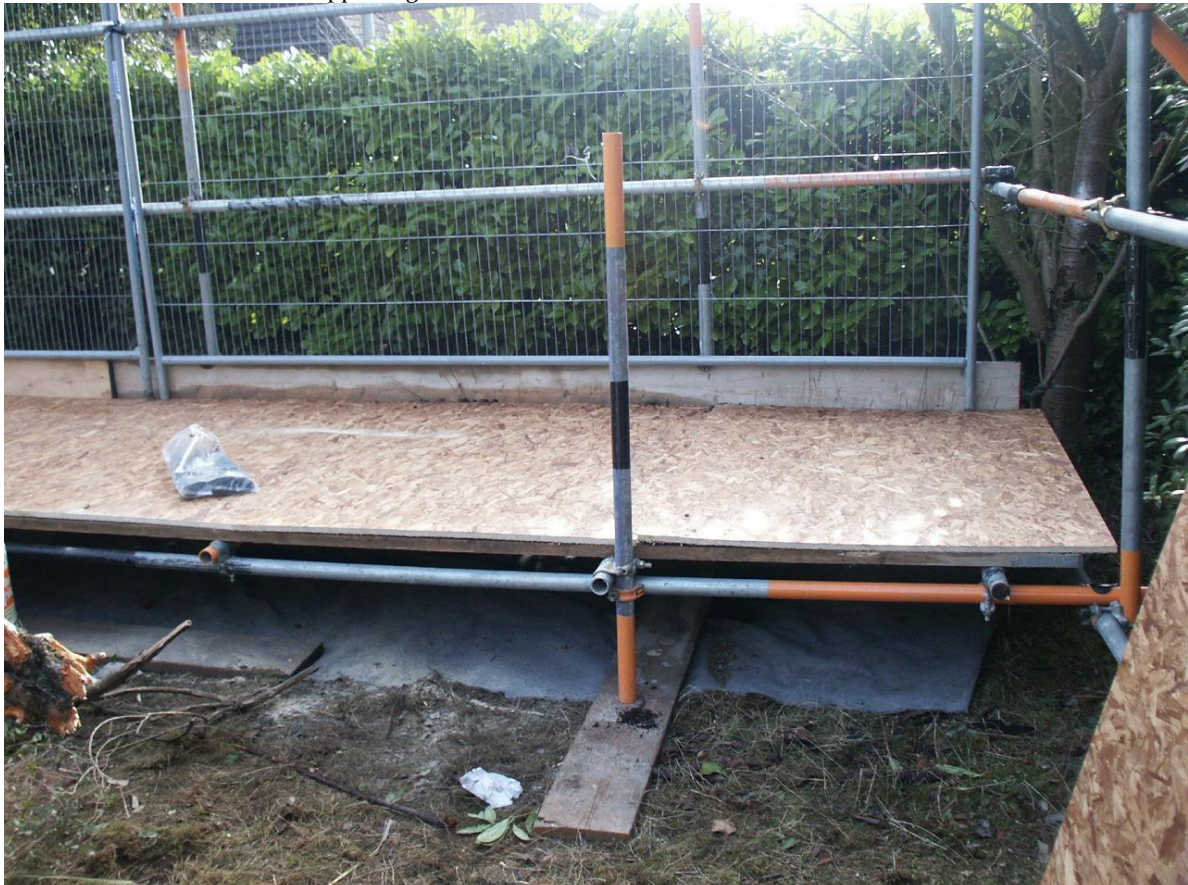
**Photo 2** Scaffold framework supporting wooden boards

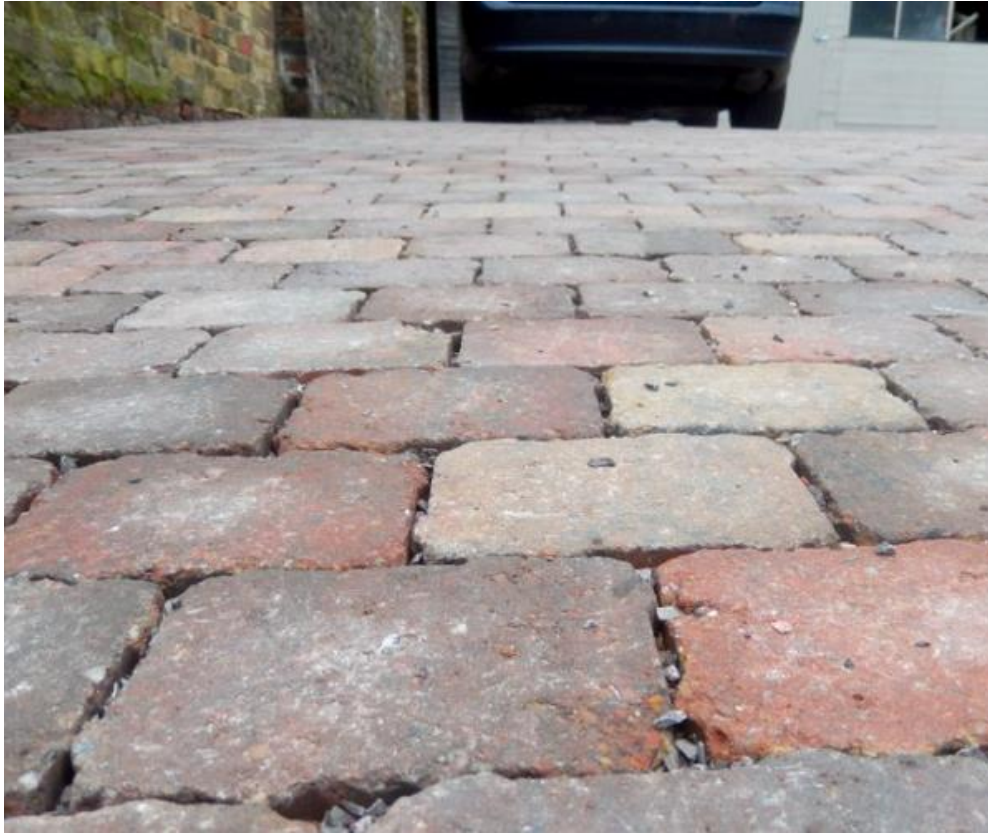
**Photo:** An example of a finished permeable block paved driveway

Conventional kerb edges (set in concrete-filled trenches) are likely to result in damage to roots and should be avoided. Edge retention in RPAs must be designed to avoid any significant excavation into existing soil levels (BS 5837, 7.4.3) and there are several approaches that are fit for this purpose: Railway sleepers pinned in place or wooden boards are two options, depending on the expected loading of the surfacing. A permeable soil fill can then be used to batter the grade back down to the existing soil level.

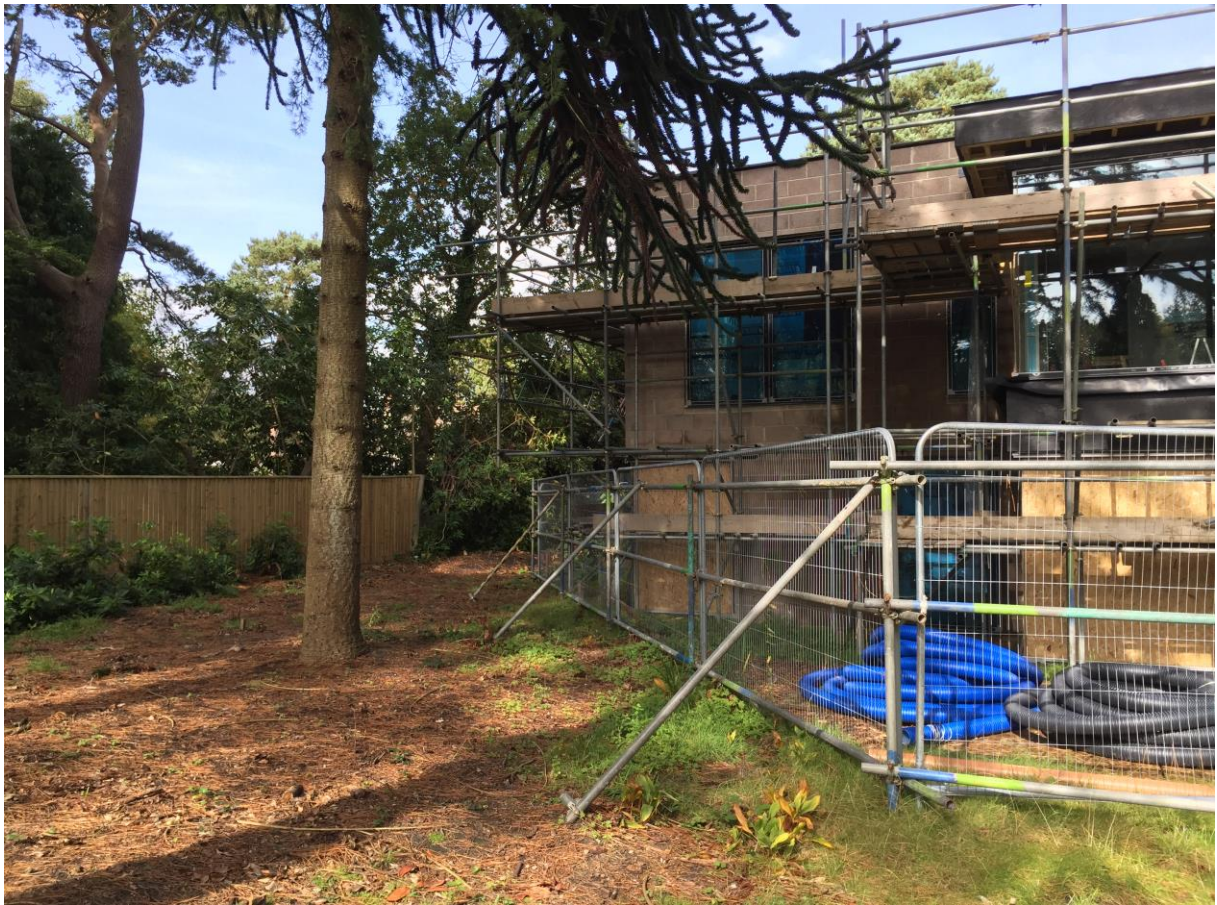
**Photo 1:** A worked example of the default specification for protective barrier (BS 837:2012)

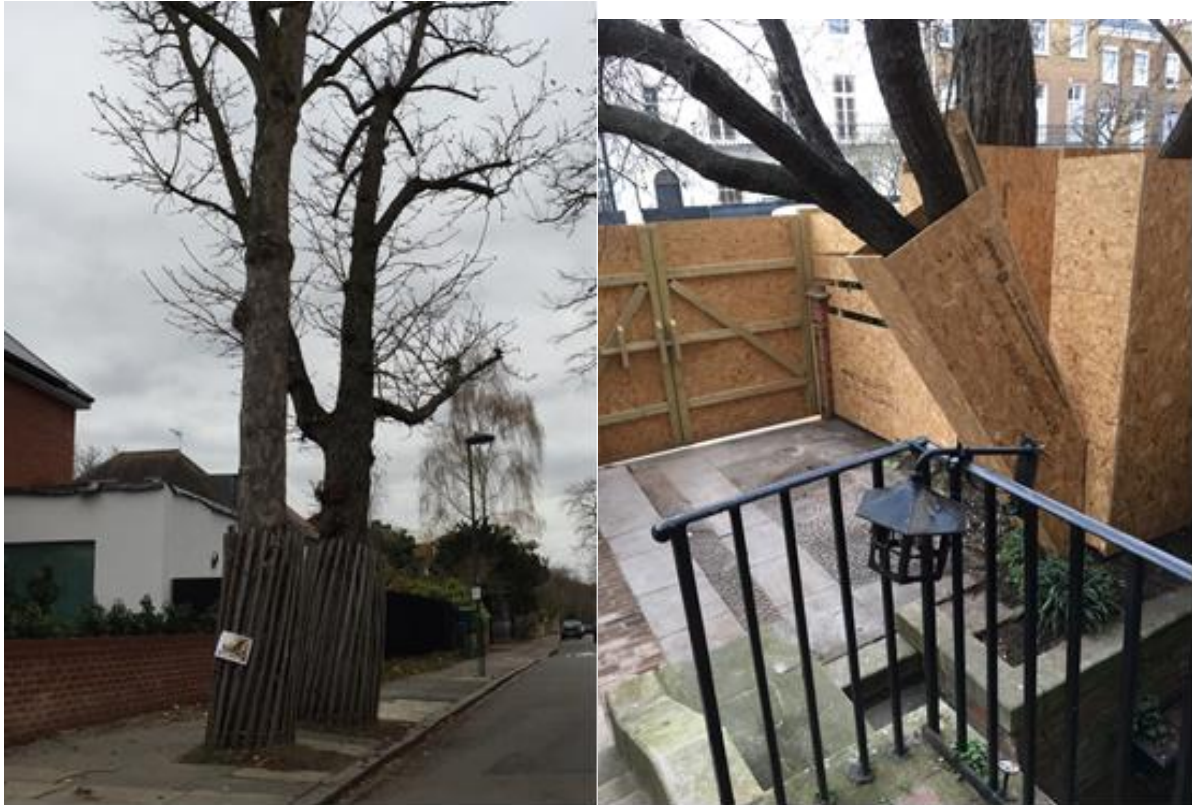
**Photo 2:** Trees protected by hessian & chestnut pale fencing / limbs protected by wooden boxing

Where specified in the AMS, the tree(s) stem/s shall be boxed off with wooden ply boards or wrapped in hessian and chestnut pale fencing / trunk protection (see example below). This will help avoid any direct damage to tree stems from passing machinery (see photo 2).

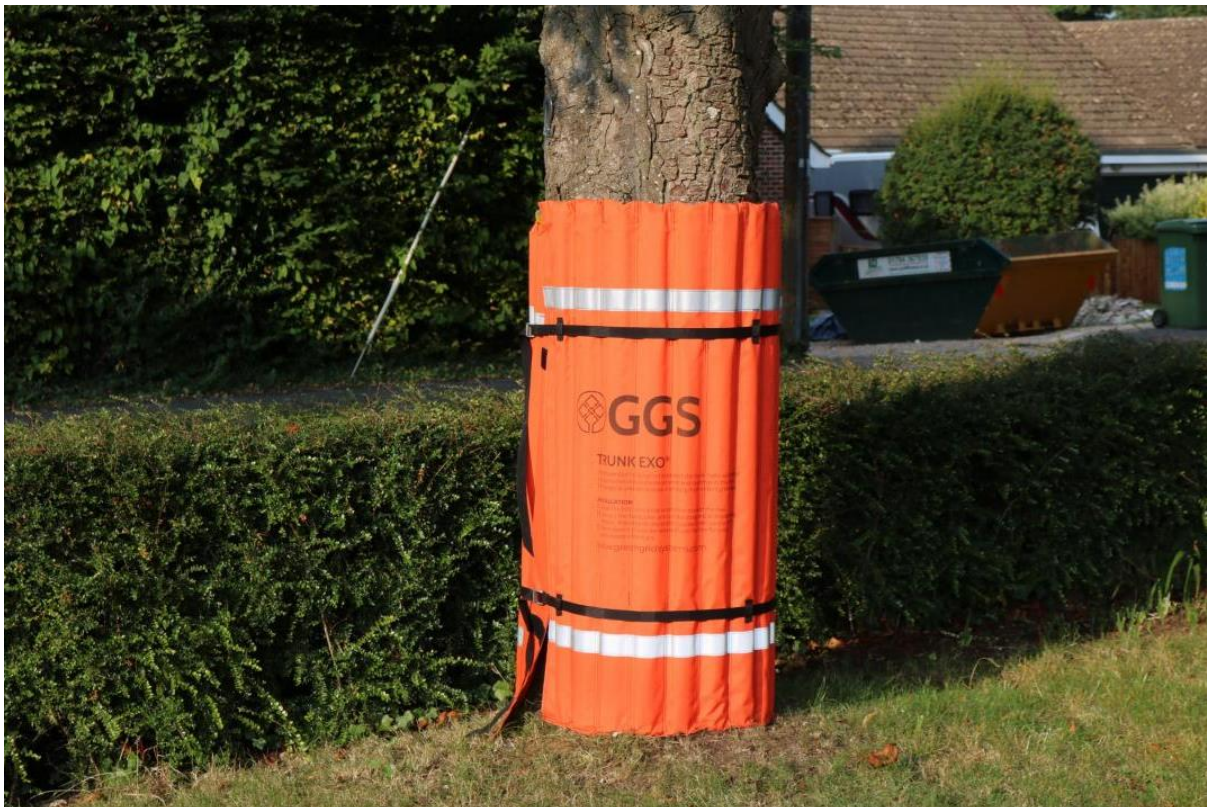
# TREE PROTECTION FENCING

## **KEEP OUT**

Please report any damage to trees  
and/or fencing to the site manager  
or the project arboriculturist
