Arboricultural Impact Assessment

Method Statement & Tree Protection Plan (to BS:5837 2012)

**Meadow Special School, Royal Lane, Hillingdon
UB8 3QU**

Ref: TH 3639 C2

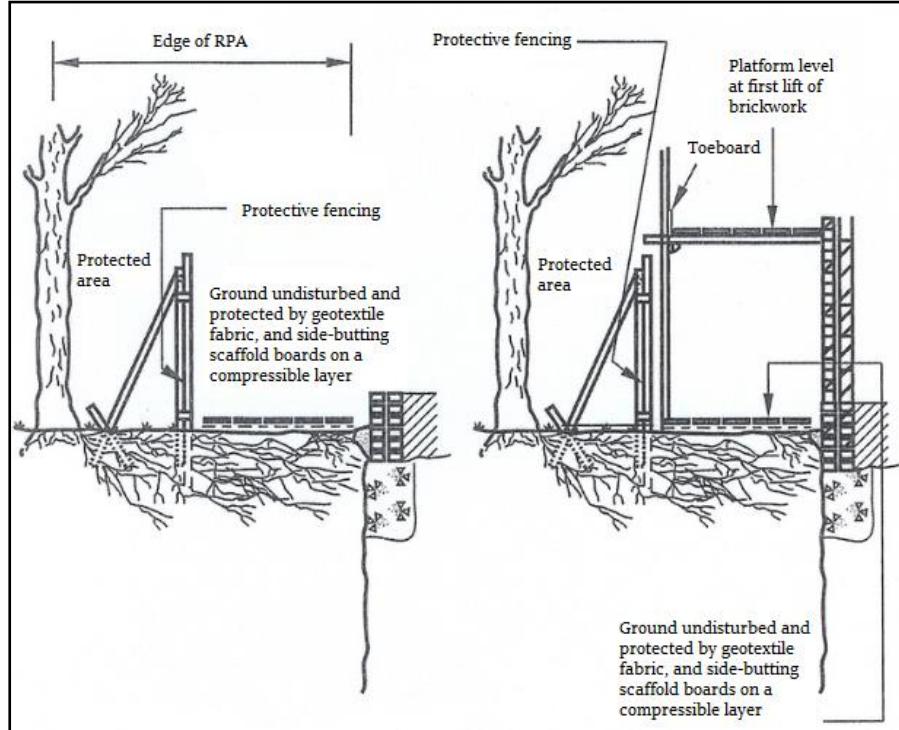
Figure 1: An example of ground protection on work areas within a RPA (BS 5837:2005).

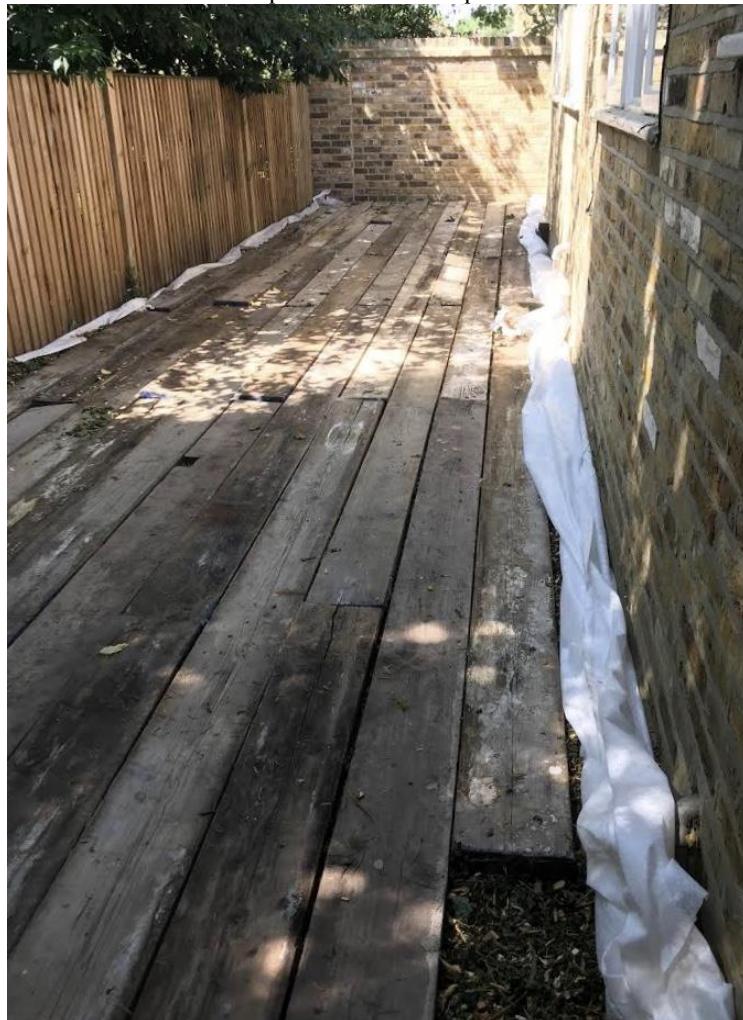
Photo 1. Scaffold boards placed on woodchip

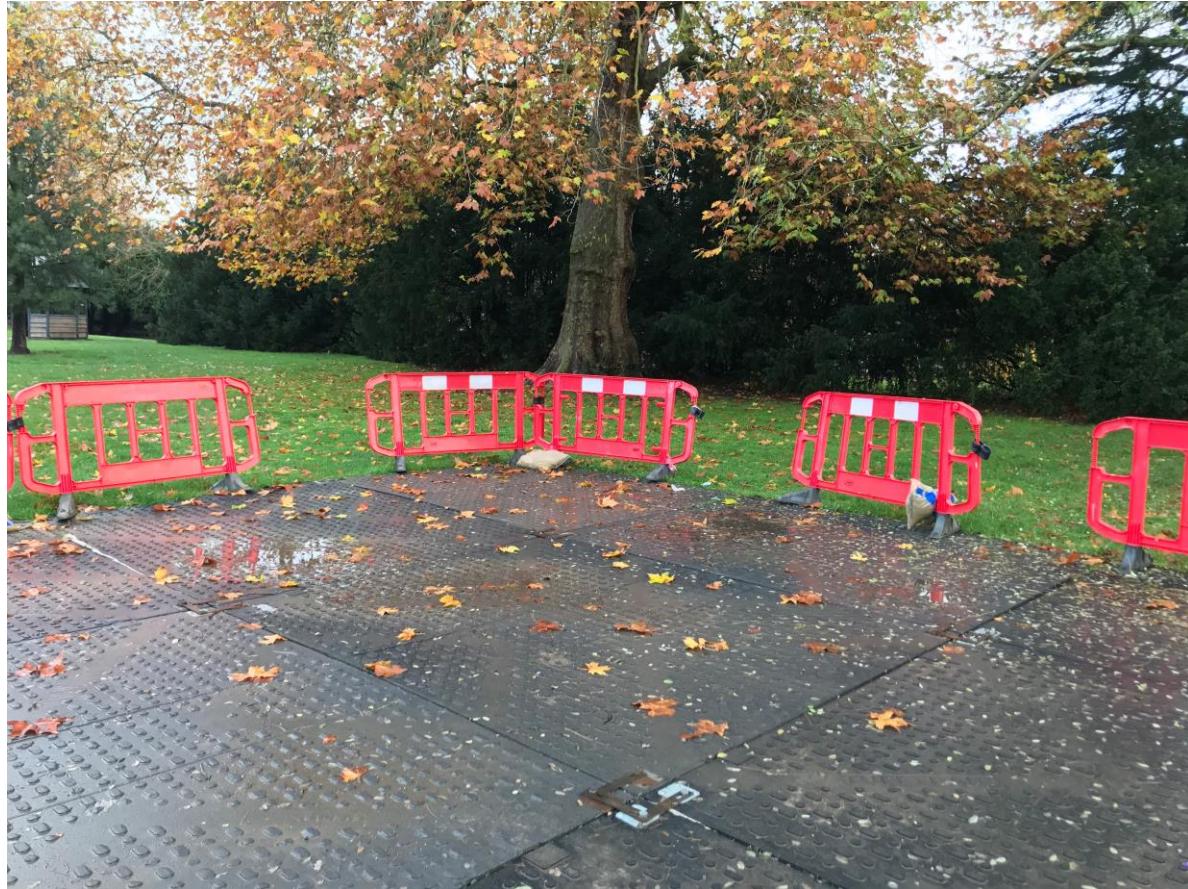
Photo 2. An example of heavy-duty ground protection.

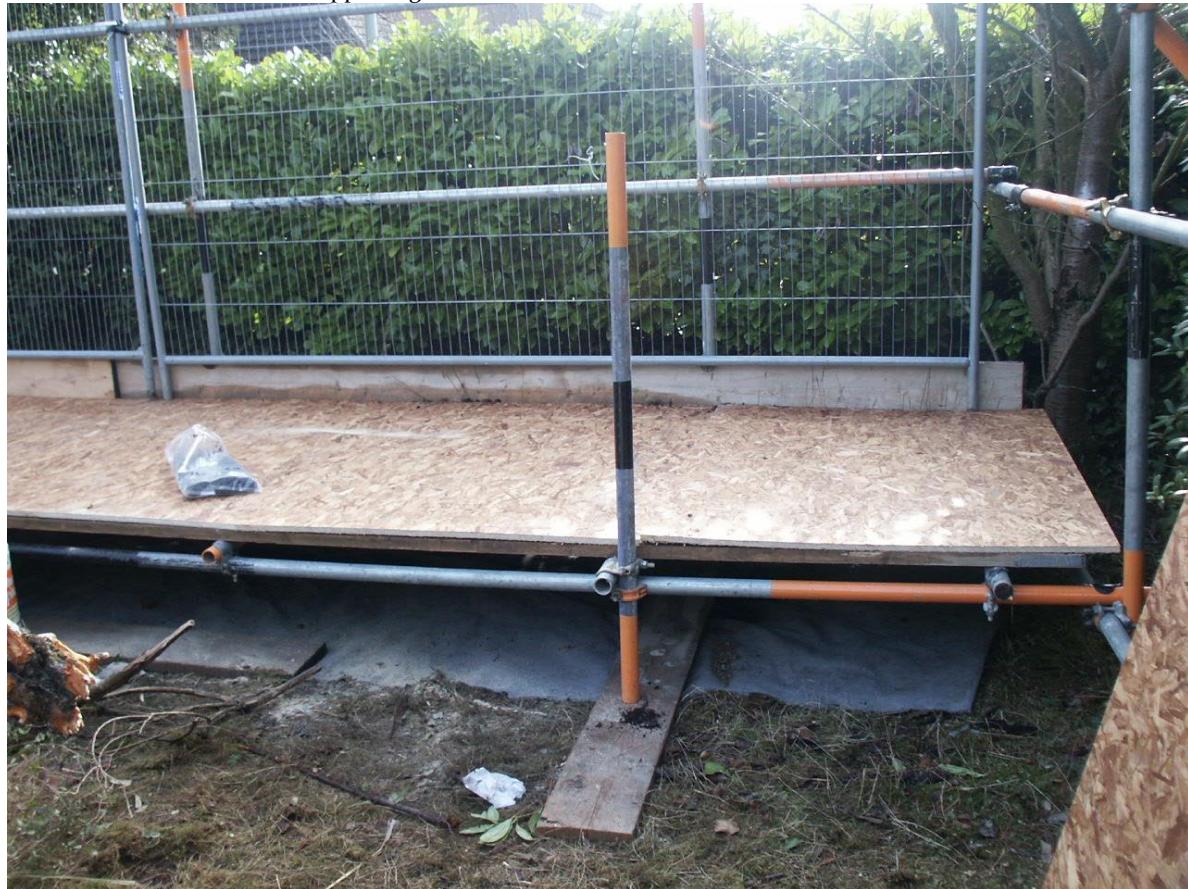
Photo 2 Scaffold framework supporting wooden boards

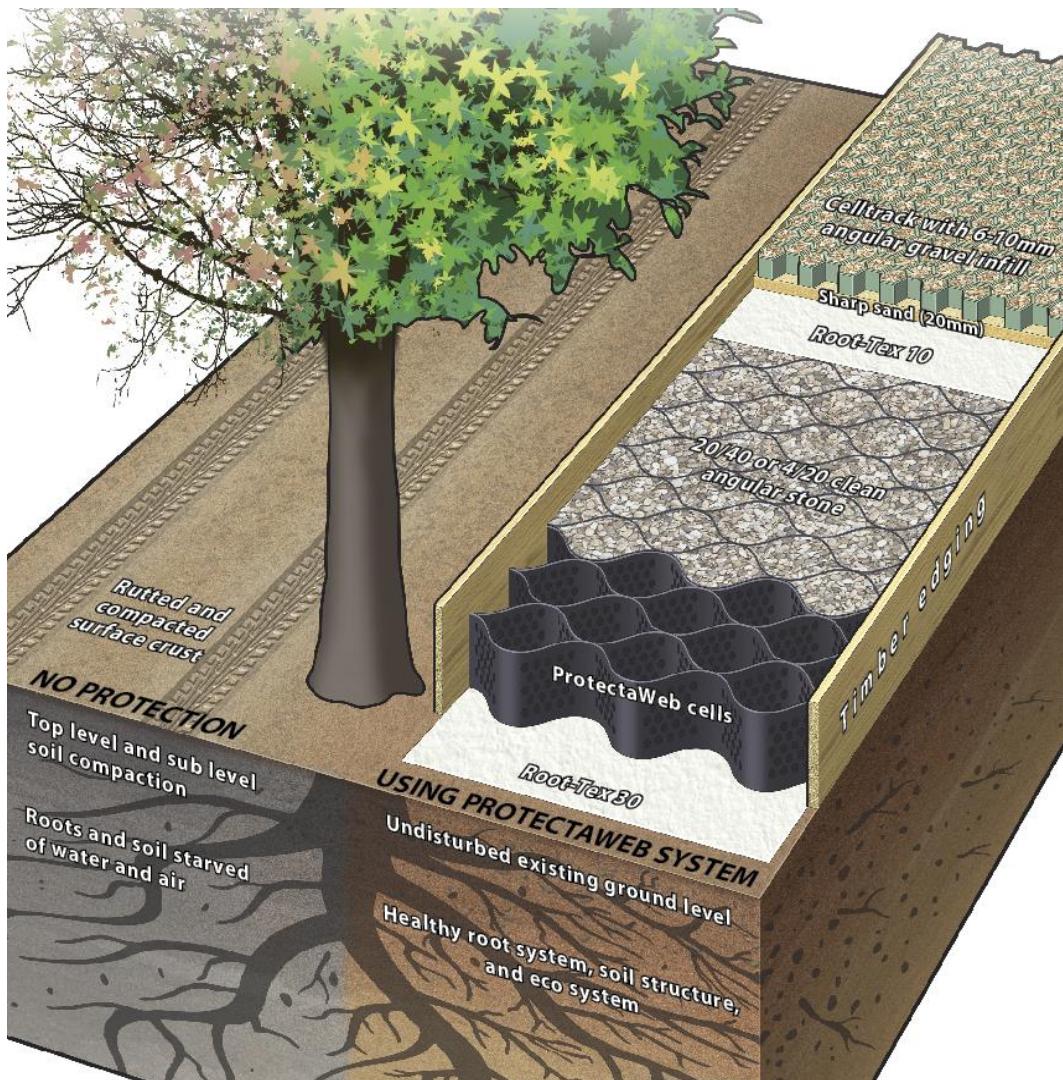
Figure 4: A good example of the principles of a no-dig surface.

The no-dig construction principles are outlined below and the areas to which they apply are shown on the TPP (shaded with orange honeycomb). A useful example diagram (by Protectoweb) is shown below (Figure 4).

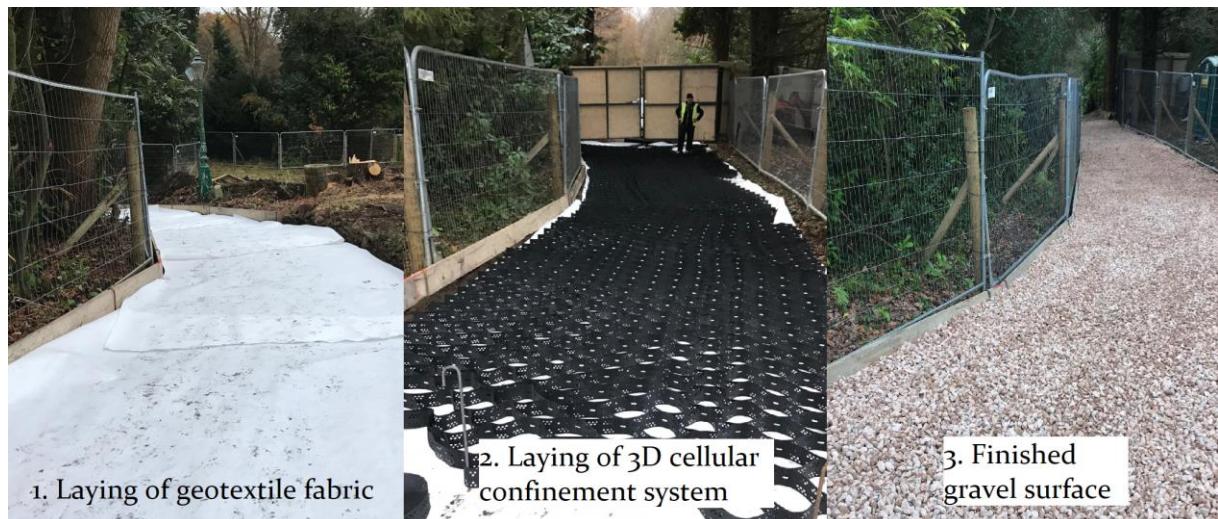
Photo 3: Three stages of a 'no-dig' driveway under construction.

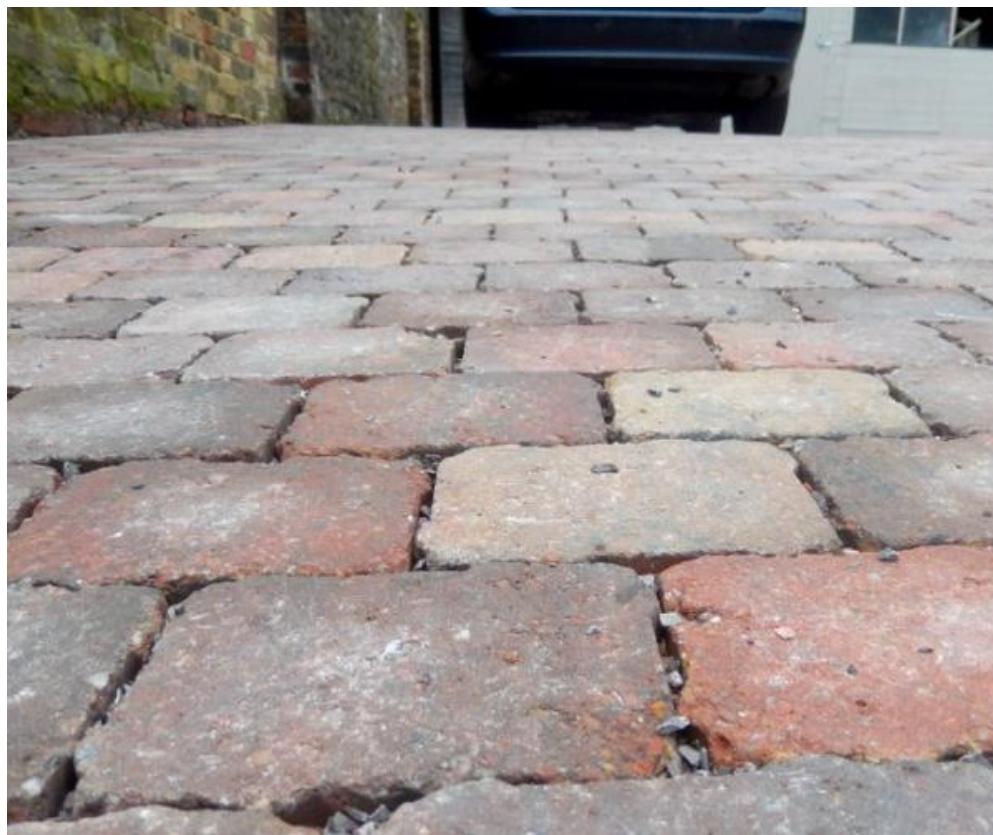
Photo: An example of a finished permeable block paved driveway

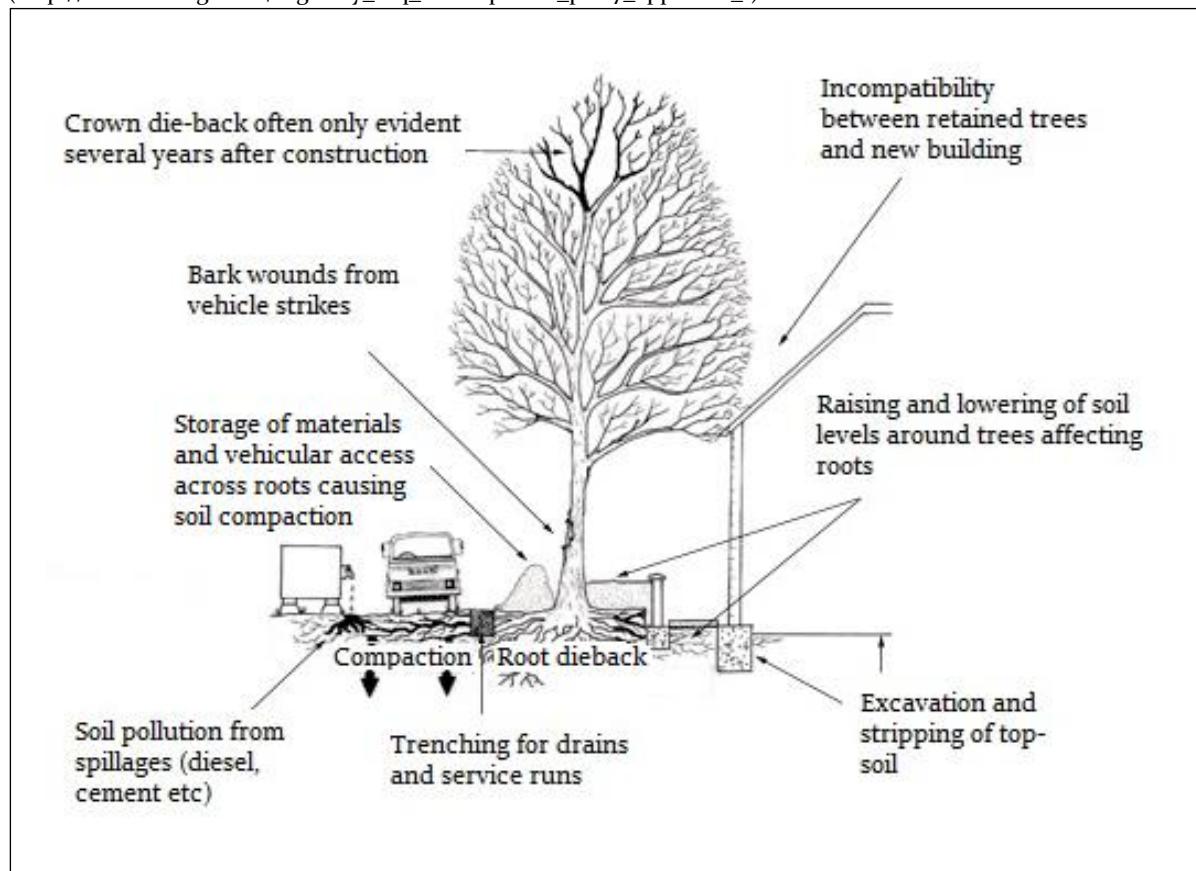
Figure 4: Common problems for trees on development sites
(http://www.leics.gov.uk/highway_req_development_part7_appendix_f)
