## Crack and Level Monitoring

Job Reference: 9649924

Address: Sweetcroft Residential Care Home, 53 Sweetcroft Lane, Uxbridge, Middlesex, UB10 9LE

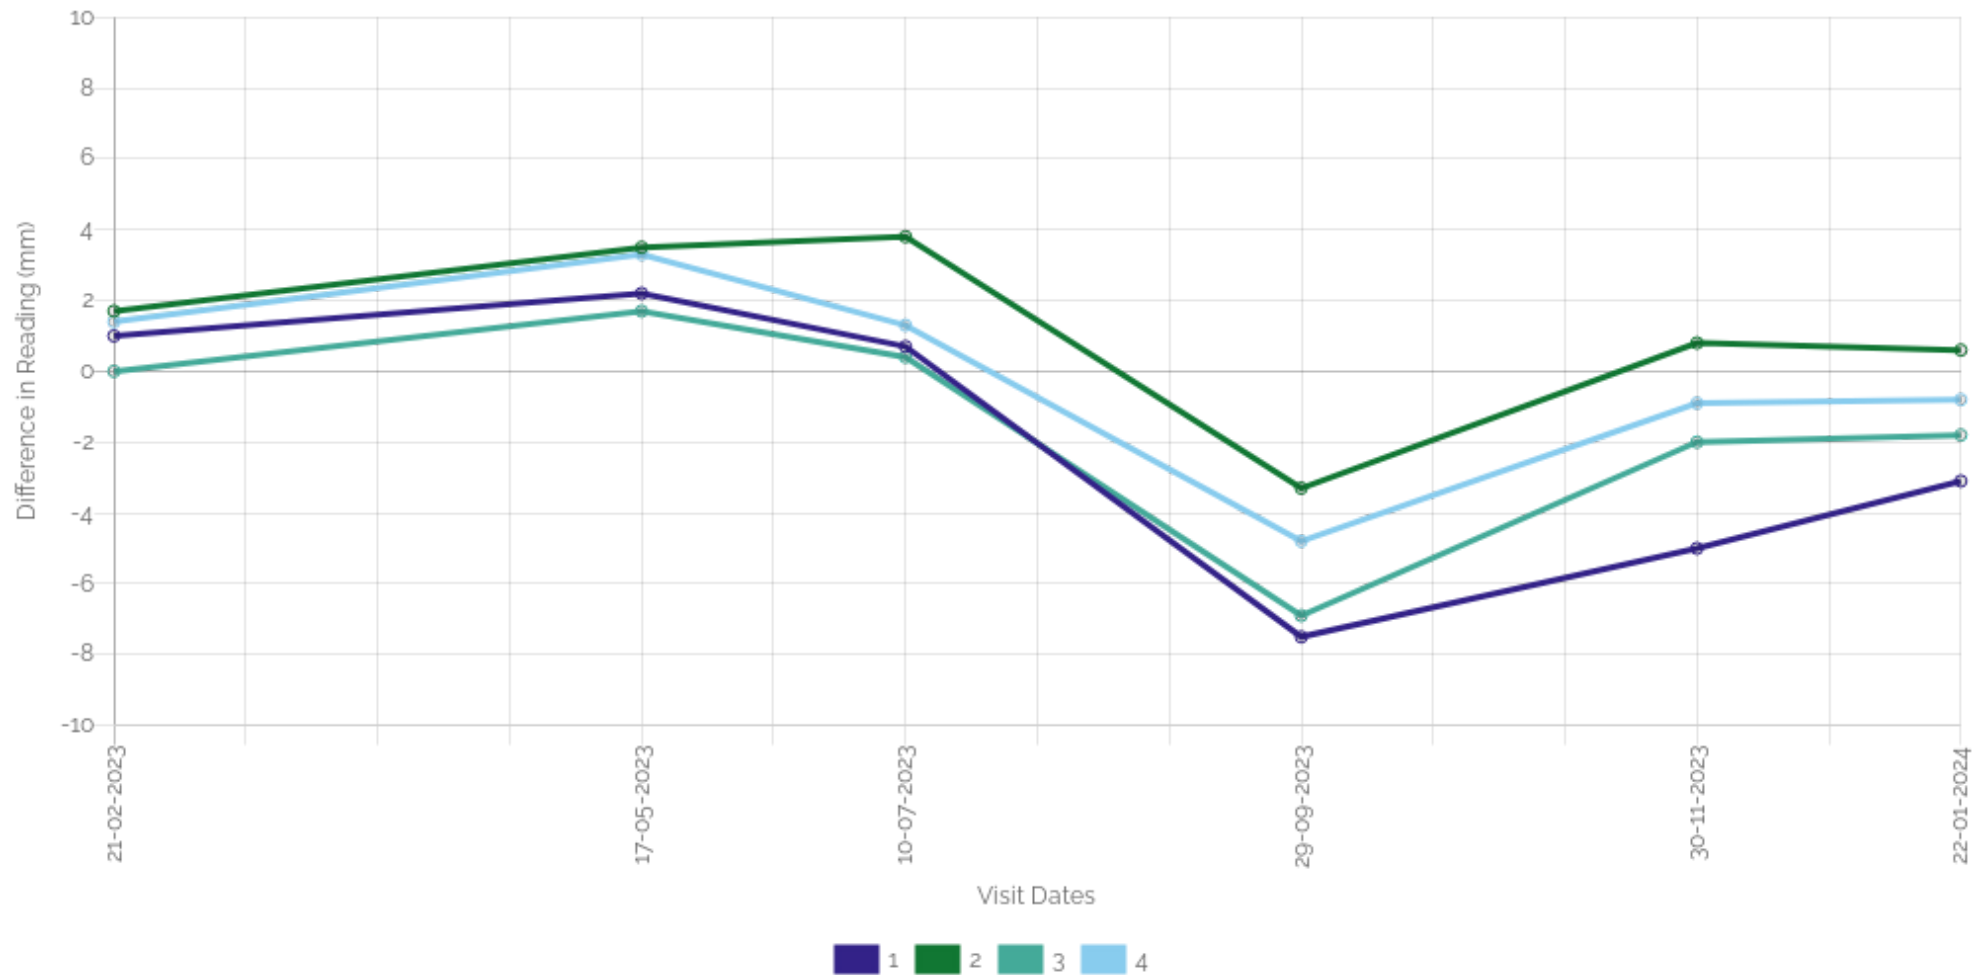
## Level Readings Chart (Points 1 - 4)

| | Visit 1 | Visit 2 | Visit 3 | Visit 4 | Visit 5 | Visit 6 | Visit 7 | Visit 8 |
|---|---|---|---|---|---|---|---|---|
| 1 | +1 | +2.2 | +0.7 | -7.5 | -5 | -3.1 | | |
| 2 | +1.7 | +3.5 | +3.8 | -3.3 | +0.8 | +0.6 | | |
| 3 | 0 | +1.7 | +0.4 | -6.9 | -2 | -1.8 | | |
| 4 | +1.4 | +3.3 | +1.3 | -4.8 | -0.9 | -0.8 | | |

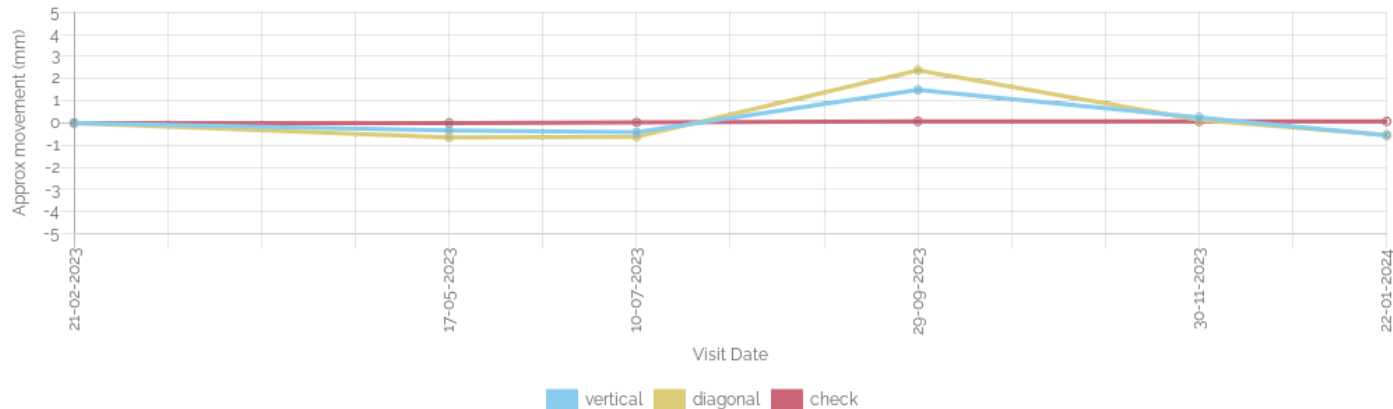
Int first floor front left bedroom bottom right of window - Crack Readings Differences (Displayed in Millimetres)

| | Visit 1 | Visit 2 | Visit 3 | Visit 4 | Visit 5 | Visit 6 | Visit 7 | Visit 8 |
|---|---|---|---|---|---|---|---|---|
| V | -0.21 | -0.54 | -0.63 | 1.28 | 0.04 | -0.77 | | |
| D | -0.18 | -0.83 | -0.8 | 2.2 | -0.05 | -0.72 | | |
| C | -0.03 | -0.03 | -0 | 0.04 | 0.04 | 0.04 | | |

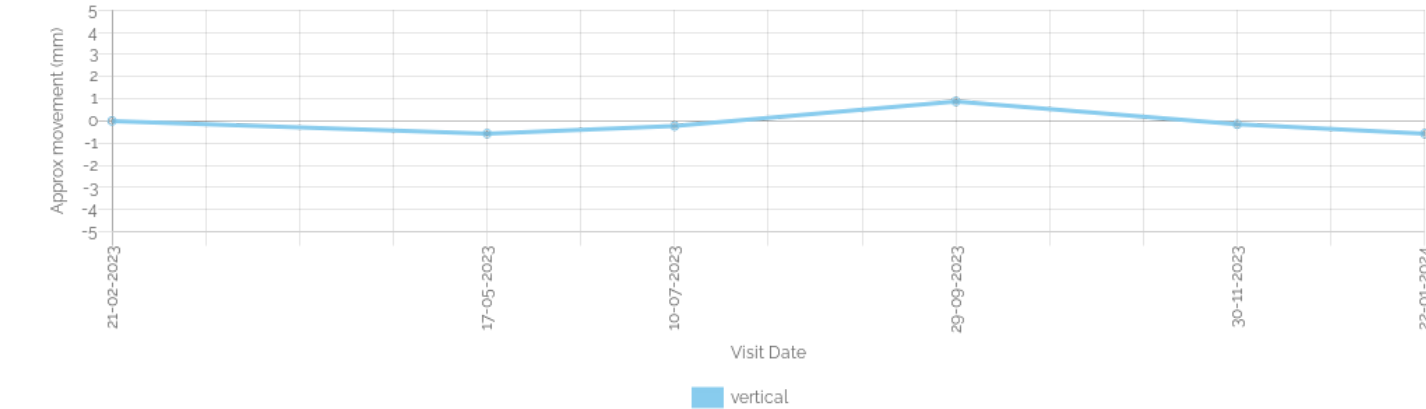
Ext front elevation between windows - Crack Readings Differences (Displayed in Millimetres)

| | Visit 1 | Visit 2 | Visit 3 | Visit 4 | Visit 5 | Visit 6 | Visit 7 | Visit 8 |
|---|---|---|---|---|---|---|---|---|
| V | -0.02 | -0.59 | -0.25 | 0.86 | -0.17 | -0.59 | | |

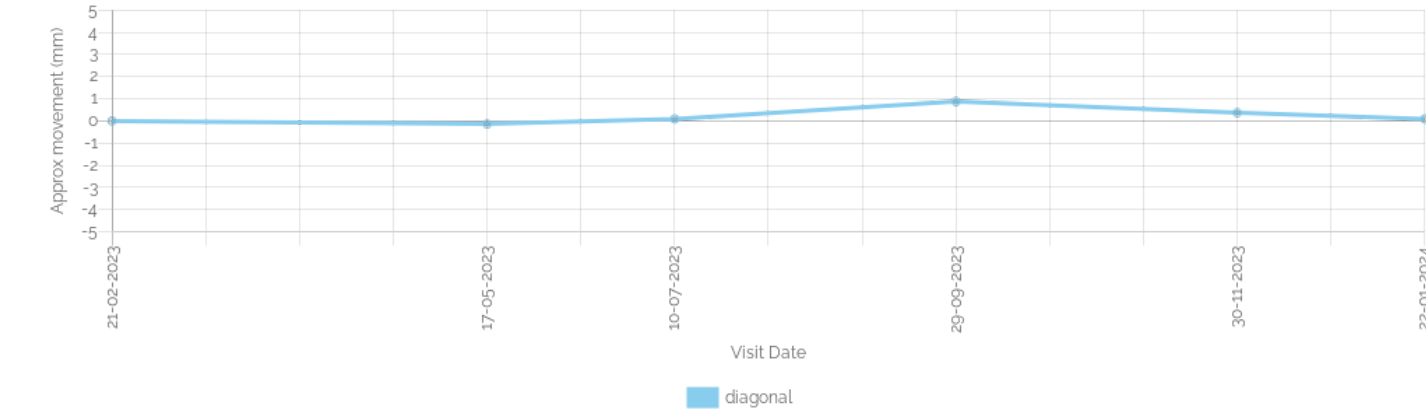
Front left corner above kitchen door - Crack Readings Differences (Displayed in Millimetres)

| | Visit 1 | Visit 2 | Visit 3 | Visit 4 | Visit 5 | Visit 6 | Visit 7 | Visit 8 |
|---|---|---|---|---|---|---|---|---|
| D | 0.02 | -0.12 | 0.11 | 0.89 | 0.39 | 0.11 | | |
