# 2 Sandy Lodge Way Northwood HA6 2AJ

**Phase II Arboricultural Impact Assessment (AIA)**  
**(Ref. 101 806)**

**Date: 15/07/2024**

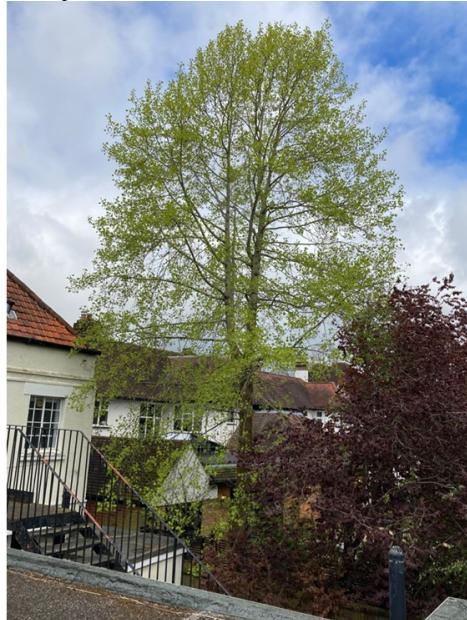
To the left of T5, note the pitched roof of the new rear extension at no. 4 Sandy Lodge Way

Firstly, see the Note 2 on the appended Tree Constraints Plan and the photo below where it can be seen that the recently added rear extensions at no. 4 Sandy Lodge Way were not plotted on the supplied topo survey. With the latter extensions and the attached boiler house at the rear of the subject property, the tulip tree T5 is clearly has not grown in open ground/garden space and as such will outgrow its close building proximity. The circular RPA on the T5 whilst notional is in our opinion a best-fit.

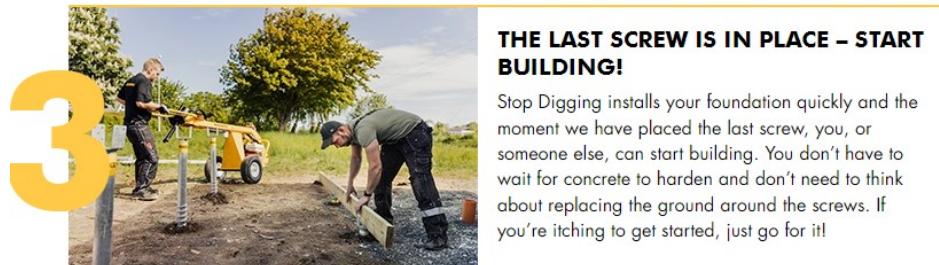
**Rear Cycle Store:** Firstly, this area of the site would be fenced during the build - to protect the RPAs of T2 and T10. With the build complete, and all machinery and Tree Protection Barriers removed off site, the *existing* outbuilding would be removed by operatives using only hand operated tools (i.e. not with a JCB). Thereafter, the cycle store would be constructed on a foundation of screw piles. As a wheeled piling unit (vs. a mini-piling rig), no temporary ground protection would be required (see picture below). The number, location and depth of these piles would be specified by the installation company.

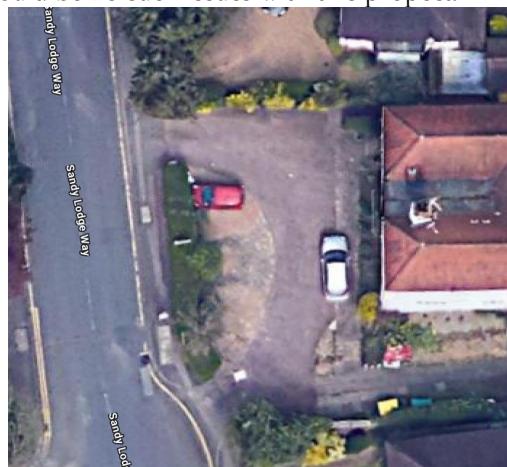
**Construction Vehicle Site Access (access facilitation pruning):** As this is an open site (see below) there would be no such issues with this proposal.

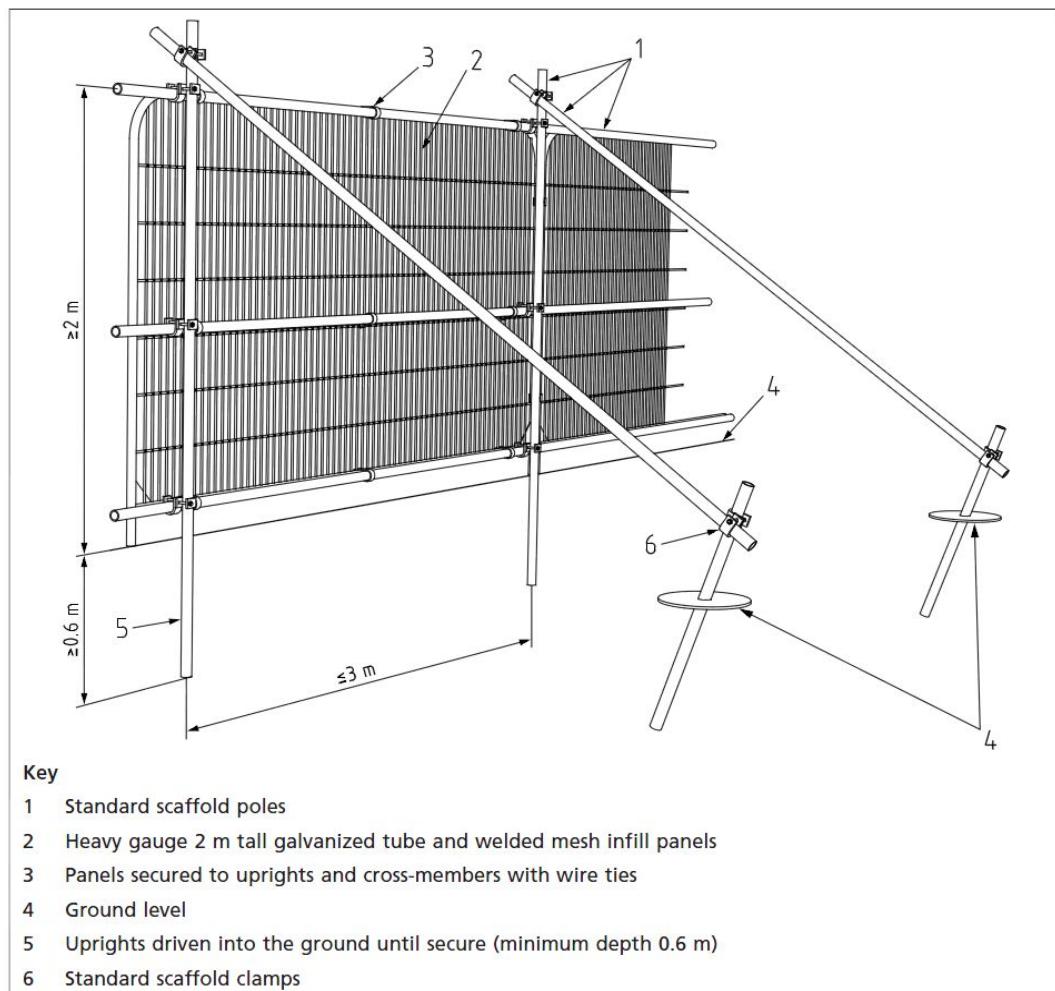
Figure 2 Default specification for protective barrier

**Temporary Tree Protection Barrier (Specification taken from BS:5837 -2012)**

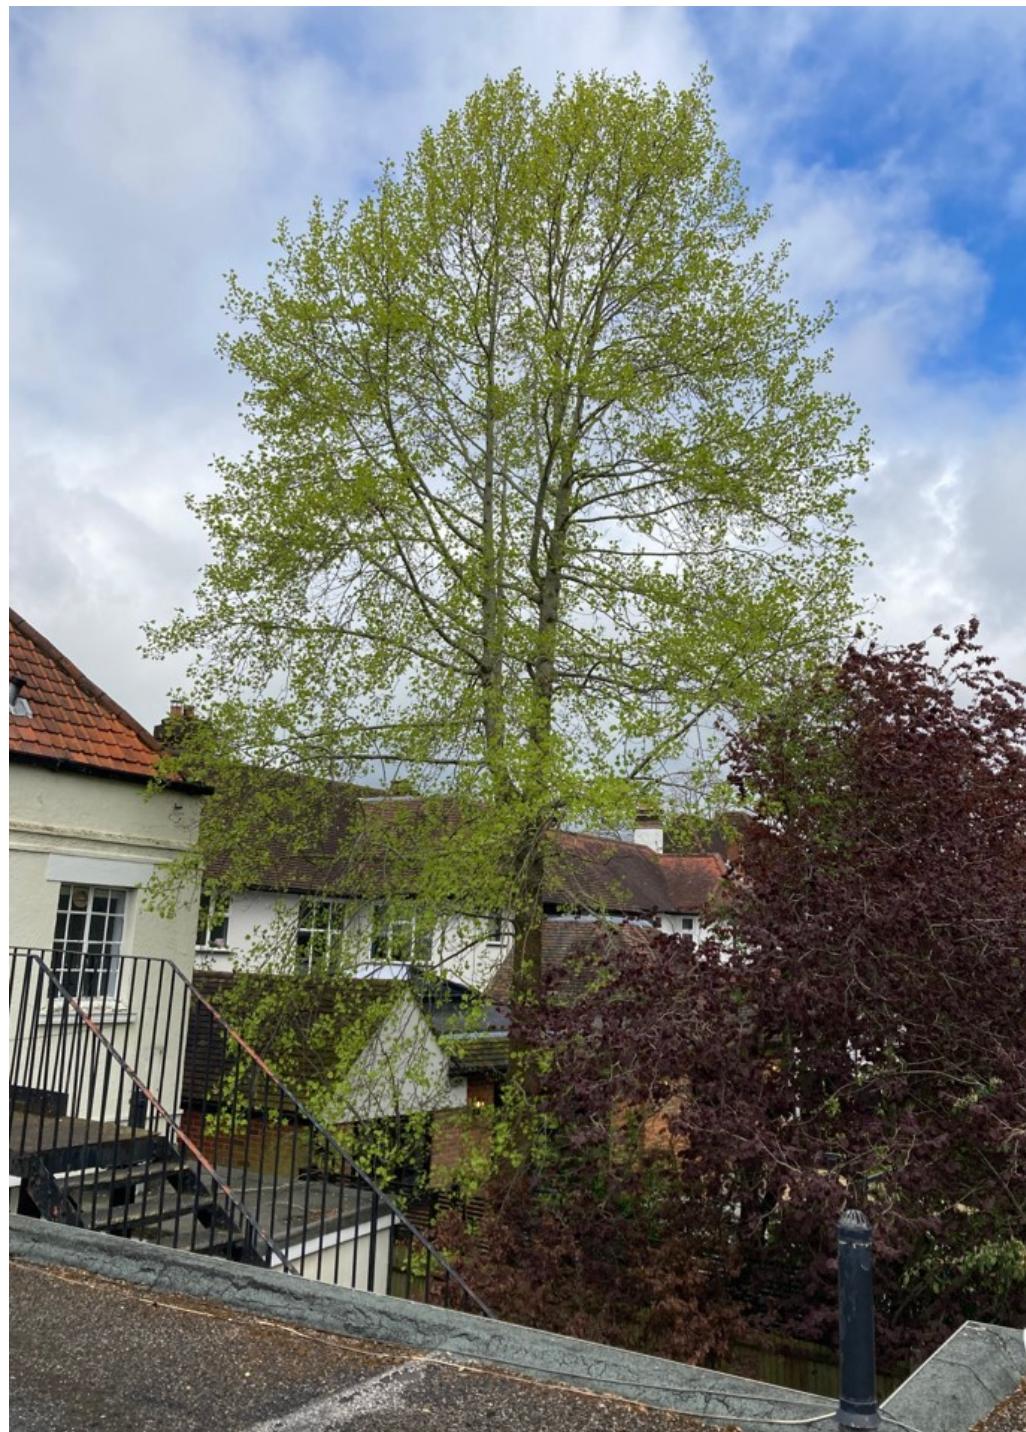
Photo No. 1 to show the close building-proximity of T5  
Note the (a) southern-crown already making contact with the subject property and (b) close-proximity third-party single storey extension – where T5 is sited.

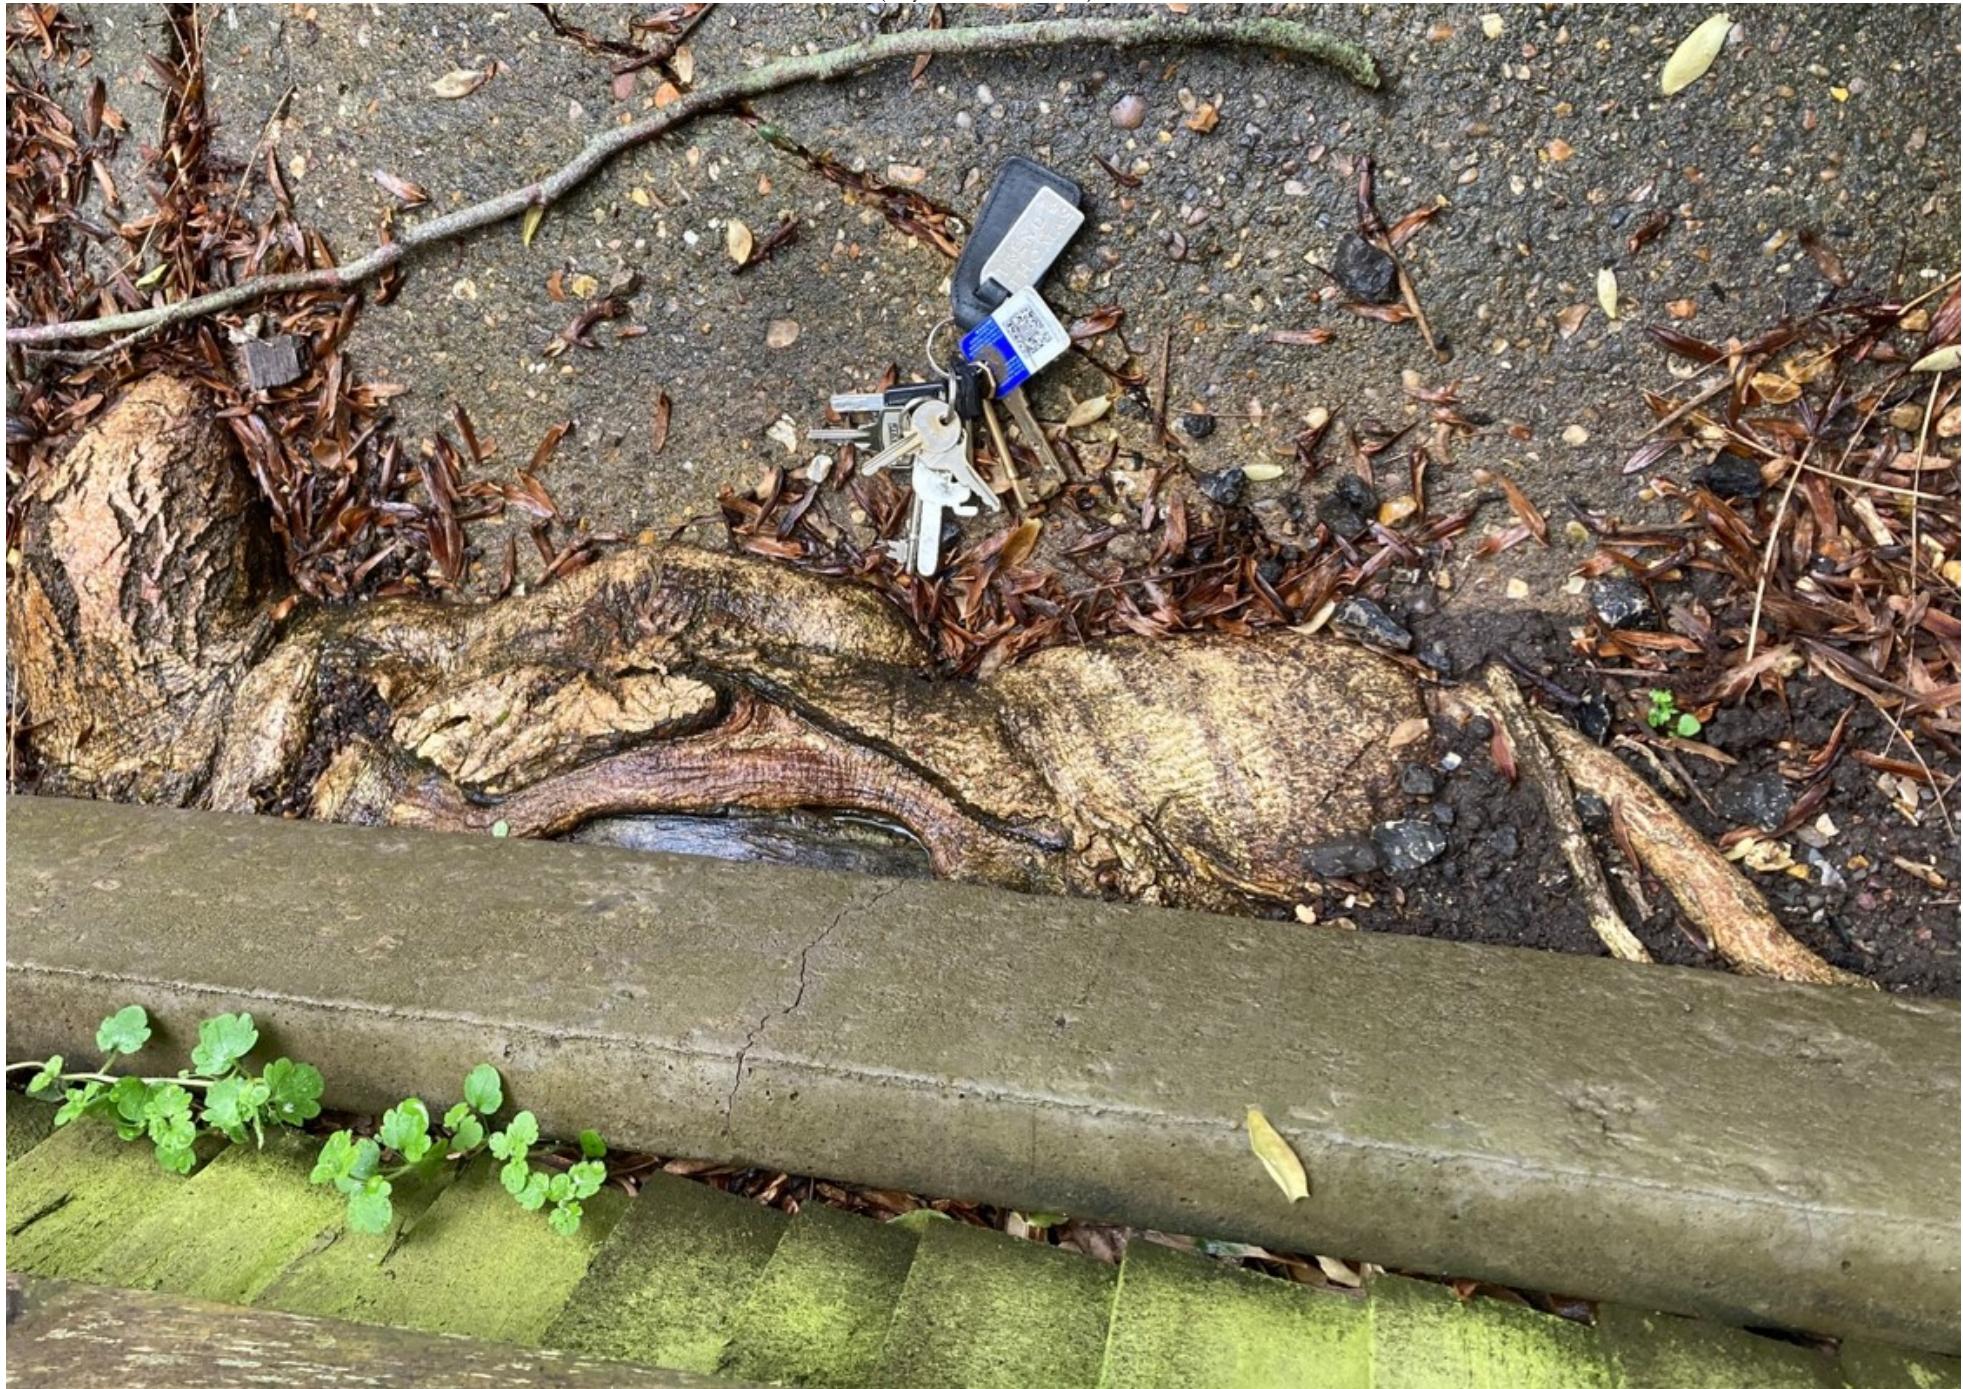
Photo No. 2 to show woody roots from T5 damaging the boundary fence concrete lintel as these have expanded in diameter  
This damage will worsen as T5 matures and these root continue to expand  
(Keys include for scale)

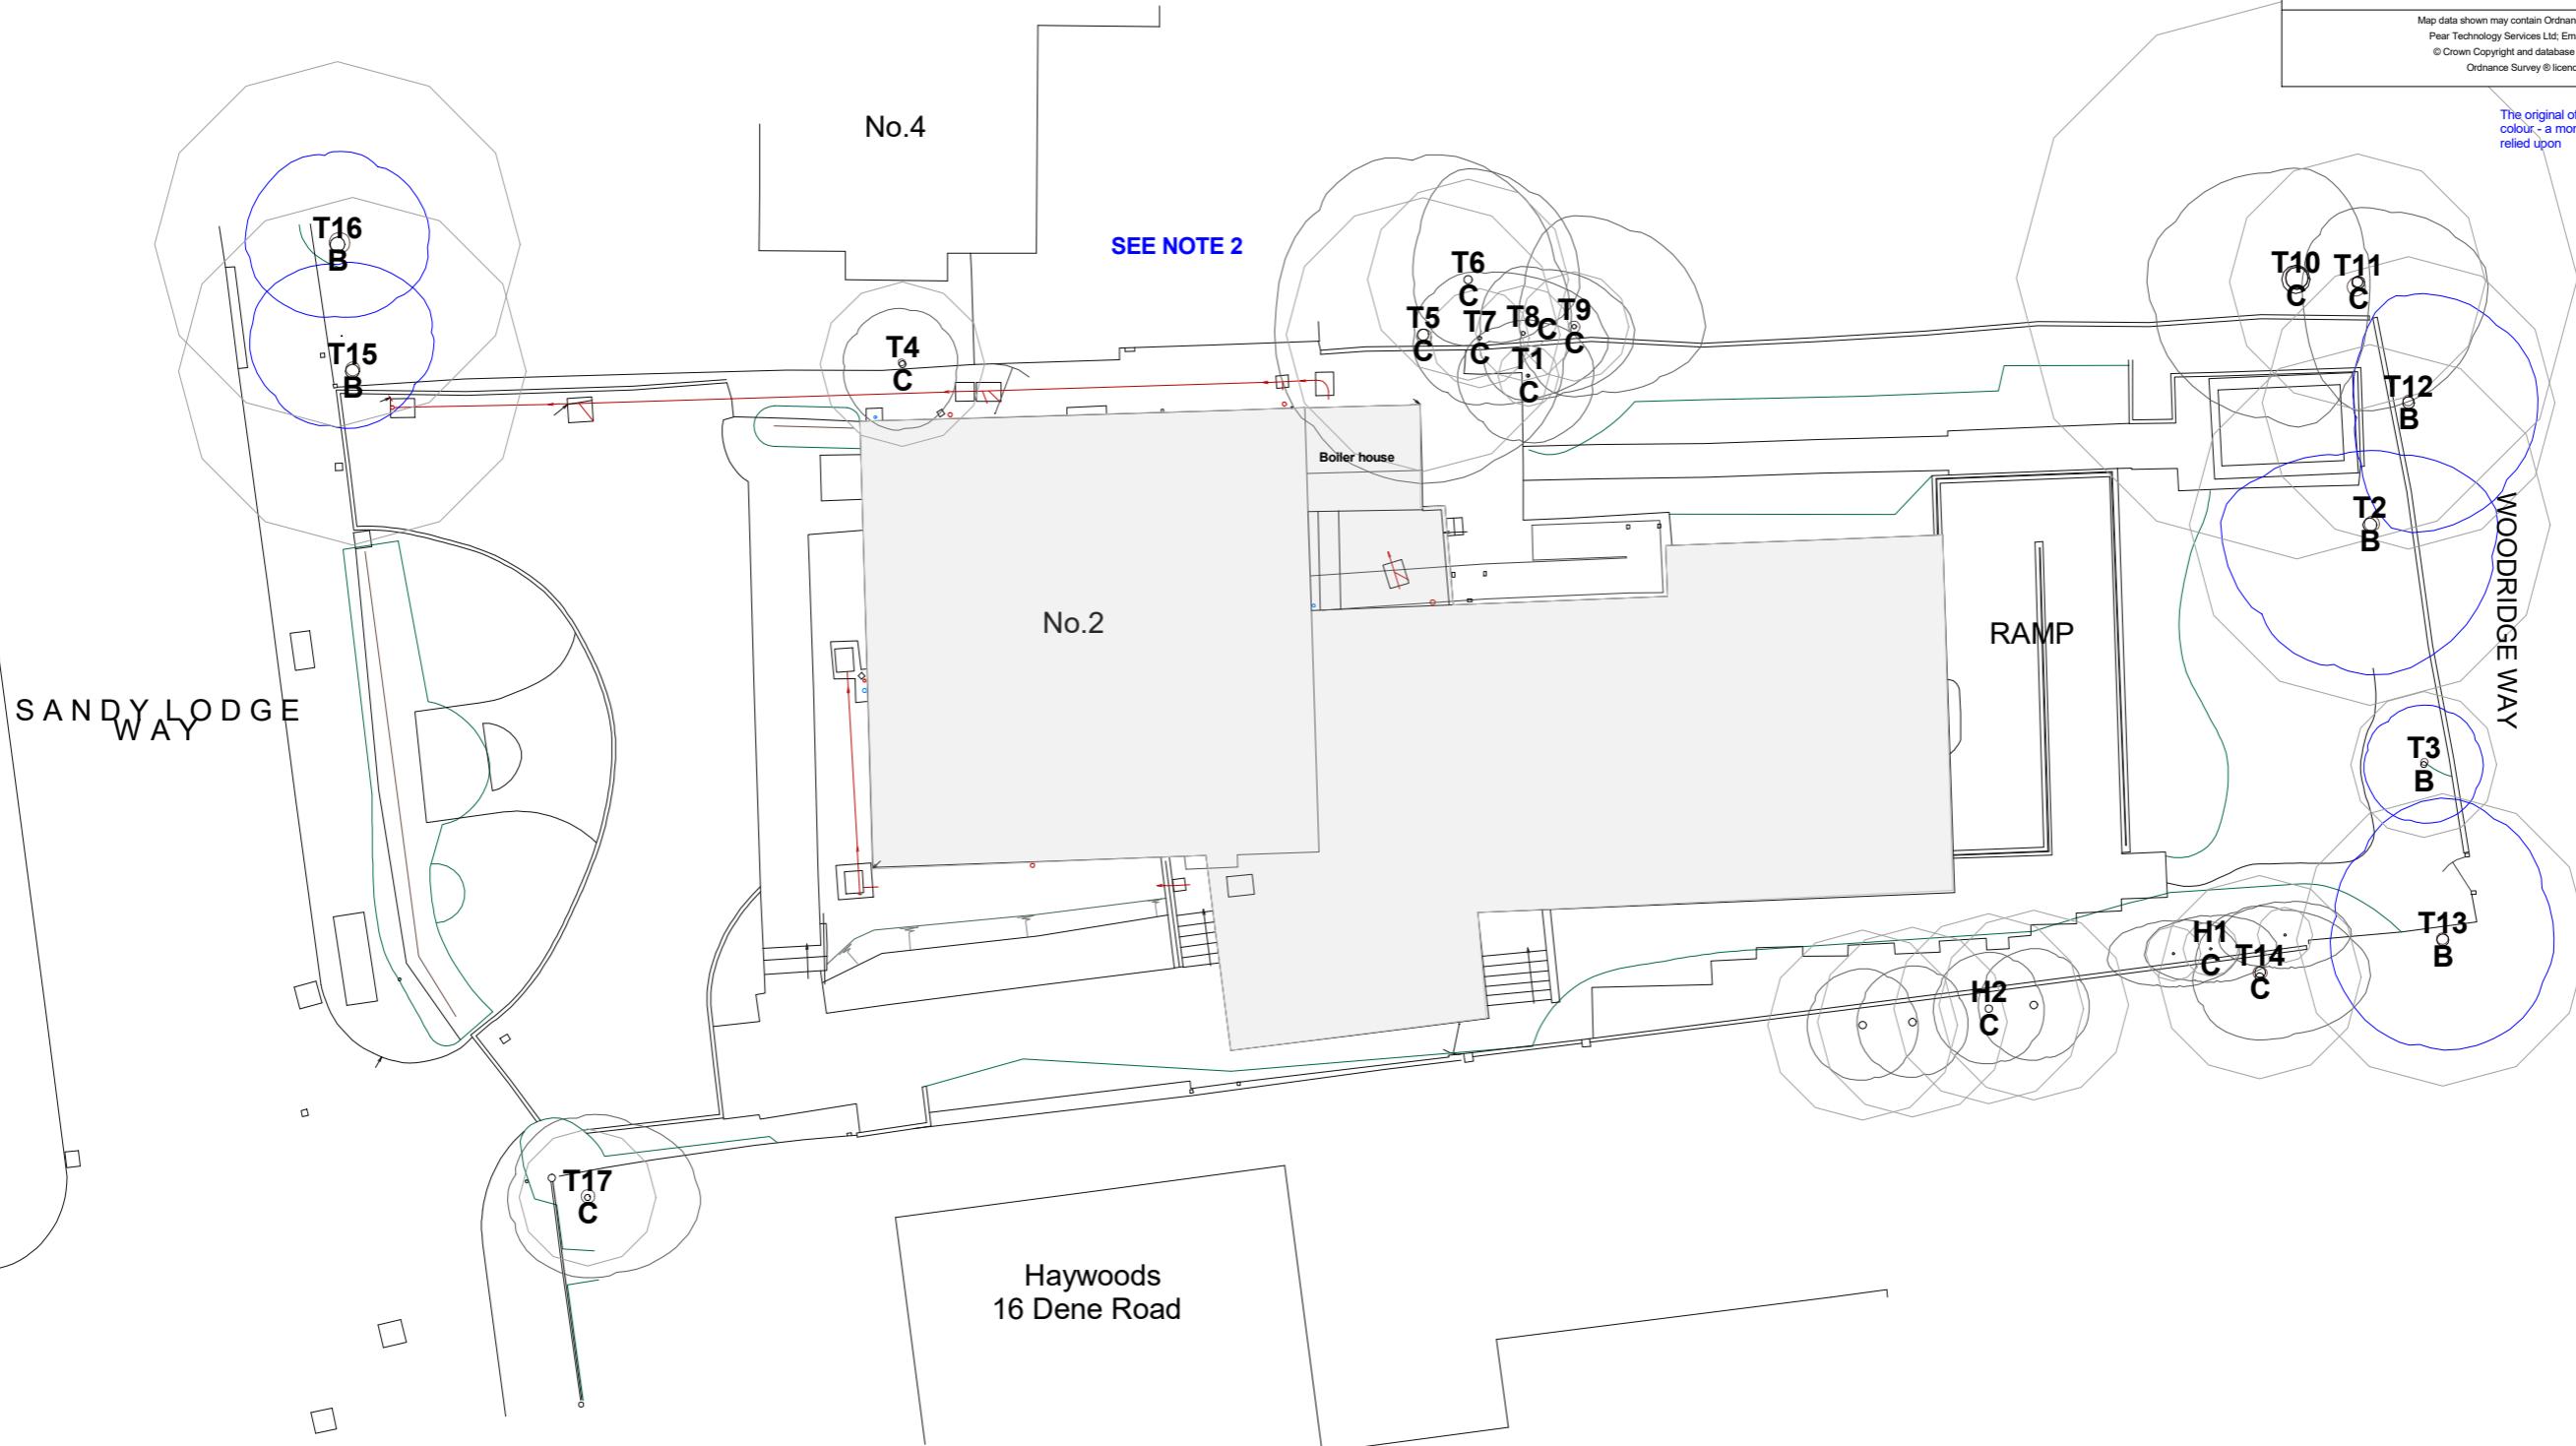
1. The existing property is gray-shaded and note the attached boiler house.
2. The recently added rear extensions at no. 4 Sandy Lodge Way - as seen in photo. no. 1 of the Tree Survey - were not plotted on the supplied topo survey.

The location and detail of the proposed development and the positioning and numbering of the trees can be found plotted on the Tree Protection Plan at Appendix 2. **NB** The original of this plan was produced in colour – a monochrome copy should not be relied upon.
