Arboricultural and Planning Integration Report: 2 Ebury Close, Northwood, HA6 2PF

Ref: GHA/DS/123160:22

Arboricultural Report

Location: 2 Ebury Close, Northwood, HA6 2PF

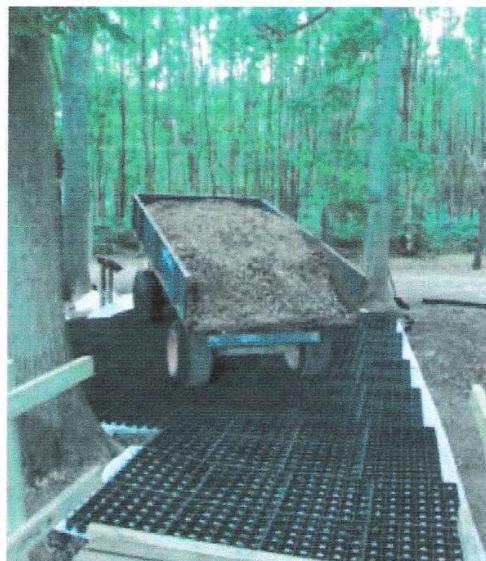
Glynebourne Wood.

Pedestrian path to recreational woodland built using a CellWeb™ foundation which was covered with DuoBlock and then filled with woodchip to create a porous surface.
