## Monitoring Details:

Client: Sedgwick

Job Reference: 6856747

Address: 14 Watford Road, NORTHWOOD, Middlesex, HA6 3NR

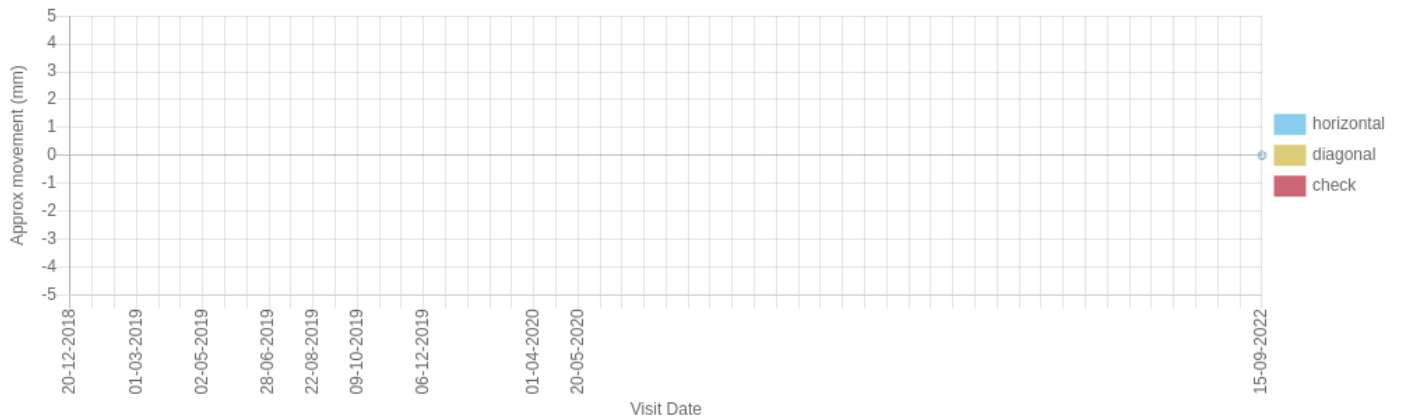
## INT above front door refit - Crack Readings Differences (Displayed in Millimetres)

| | Visit 1 | Visit 2 | Visit 3 | Visit 4 | Visit 5 | Visit 6 | Visit 7 | Visit 8 | Visit 9 | Visit 10 |
|---|---|---|---|---|---|---|---|---|---|---|
| H | | | | | | | | | | 0 |

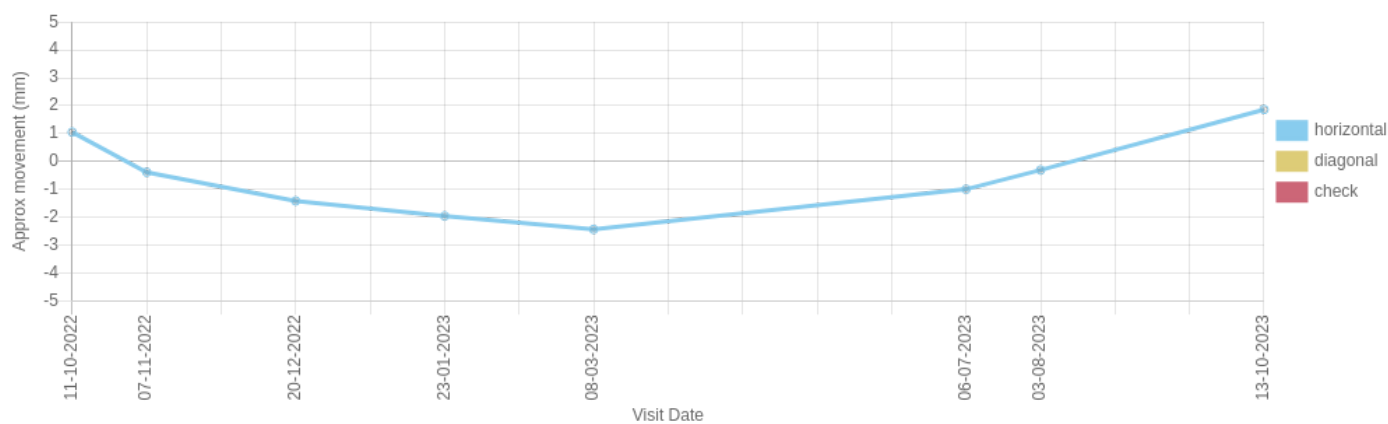
## INT above front door refit - Crack Readings Differences (Displayed in Millimetres)

| | Visit 11 | Visit 12 | Visit 13 | Visit 14 | Visit 15 | Visit 16 | Visit 17 | Visit 18 | Visit 19 | Visit 20 |
|---|---|---|---|---|---|---|---|---|---|---|
| H | 1.05 | -0.39 | -1.42 | -1.96 | -2.44 | -1 | -0.31 | 1.86 | | |

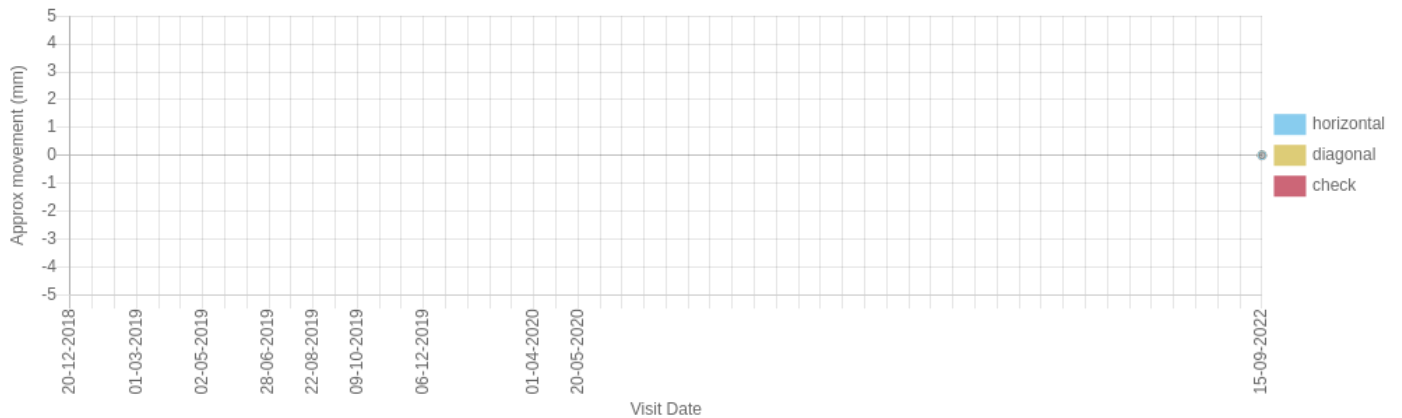
## INT under study bay window REFIT - Crack Readings Differences (Displayed in Millimetres)

| | Visit 1 | Visit 2 | Visit 3 | Visit 4 | Visit 5 | Visit 6 | Visit 7 | Visit 8 | Visit 9 | Visit 10 |
|---|---|---|---|---|---|---|---|---|---|---|
| H | | | | | | | | | | 0 |
| D | | | | | | | | | | 0 |
| C | | | | | | | | | | 0 |

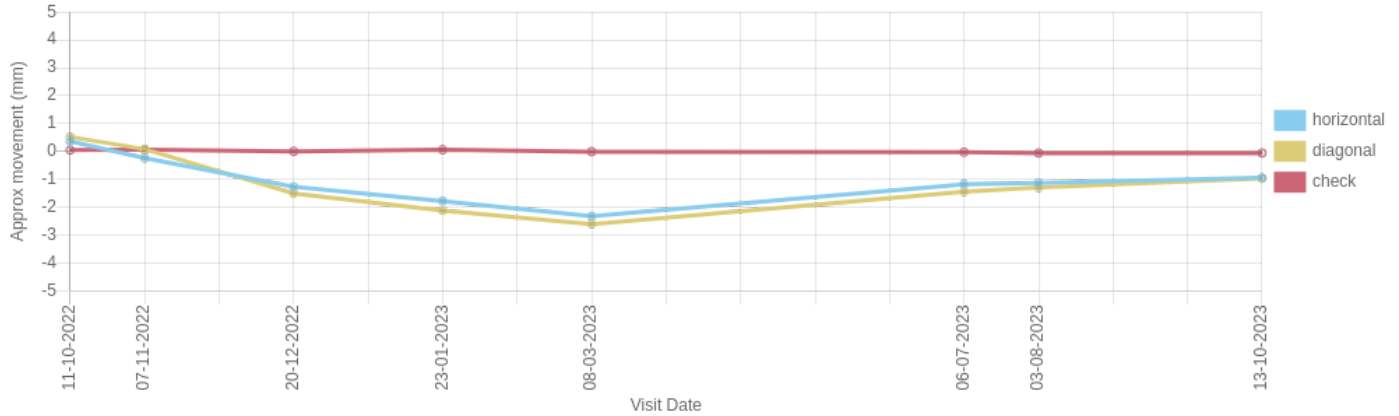
## INT under study bay window REFIT - Crack Readings Differences (Displayed in Millimetres)

| | Visit 11 | Visit 12 | Visit 13 | Visit 14 | Visit 15 | Visit 16 | Visit 17 | Visit 18 | Visit 19 | Visit 20 |
|---|---|---|---|---|---|---|---|---|---|---|
| H | 0.36 | -0.24 | -1.27 | -1.78 | -2.33 | -1.18 | -1.13 | -0.95 | | |
| D | 0.52 | 0.08 | -1.51 | -2.12 | -2.61 | -1.45 | -1.3 | -0.97 | | |
| C | 0.05 | 0.06 | 0 | 0.06 | -0.01 | -0.03 | -0.06 | -0.06 | | |

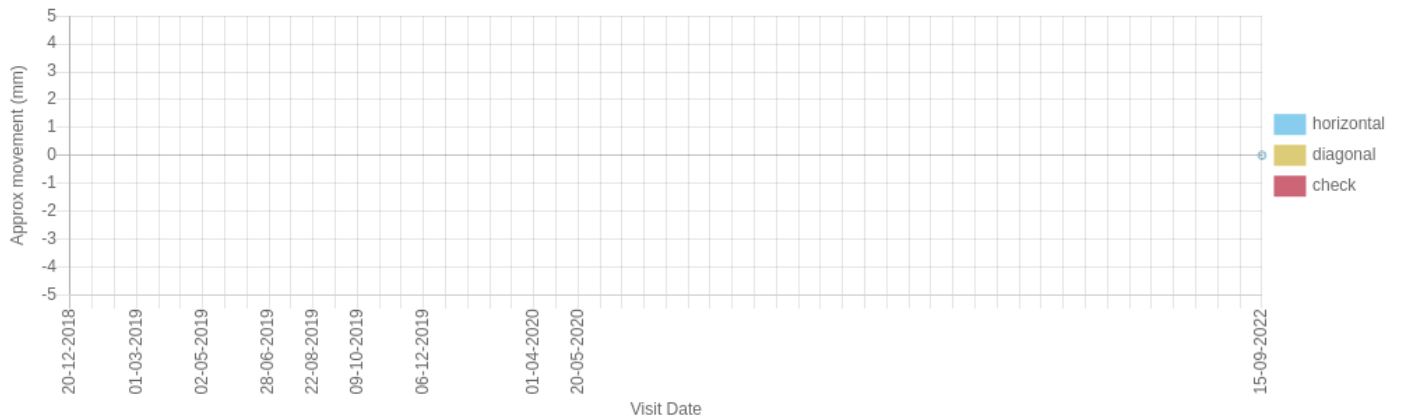
## INT 1st floor landing side wall - Crack Readings Differences (Displayed in Millimetres)

| | Visit 1 | Visit 2 | Visit 3 | Visit 4 | Visit 5 | Visit 6 | Visit 7 | Visit 8 | Visit 9 | Visit 10 |
|---|---|---|---|---|---|---|---|---|---|---|
| H | | | | | | | | | | 0 |

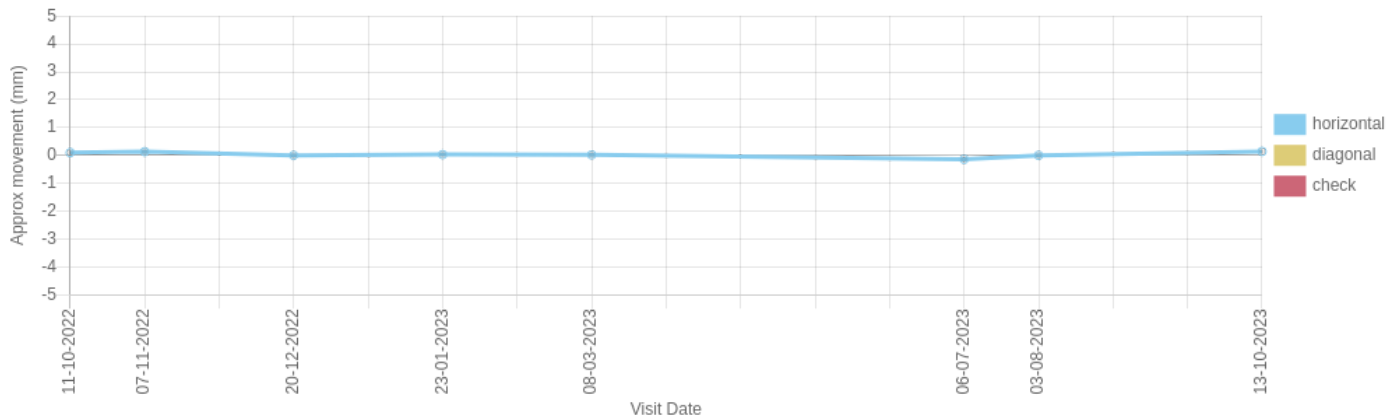
## INT 1st floor landing side wall - Crack Readings Differences (Displayed in Millimetres)

| | Visit 11 | Visit 12 | Visit 13 | Visit 14 | Visit 15 | Visit 16 | Visit 17 | Visit 18 | Visit 19 | Visit 20 |
|---|---|---|---|---|---|---|---|---|---|---|
| H | 0.1 | 0.13 | 0 | 0.03 | 0.02 | -0.14 | 0 | 0.14 | | |
