Arboricultural and Planning Integration Report: 29 Nicholas Way, Northwood, HA6 2TR

Ref: GHA/DS/122060:24b

Arboricultural Report

Location: 29 Nicholas Way, Northwood, HA6 2TR

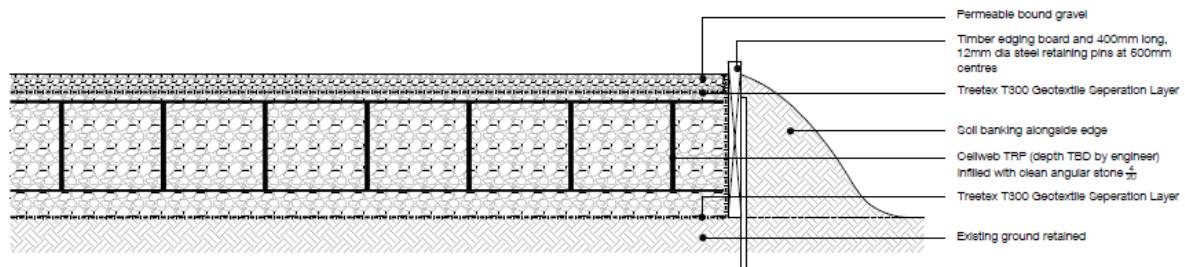
No dig drive makeup

Below is a diagram detailing the makeup of the new drive and also a typical cross the installation methodology is included below this diagram.

The sections of the new driveway that are within the RPA's of the retained trees **MUST** be constructed as follows.

- Eradication of all existing ground vegetation **MUST** be undertaken using a translocated herbicide. Any product used for this purpose **MUST** be selected to ensure that it will not have an adverse affect on the health of the retained trees, and carried out by a suitably trained operative.
- Any major protrusions within the soil **MUST** be removed, such as large rocks or existing tree stumps. Any holes **MUST** be filled with sharp sand.

- Lay a geotextile membrane over the entire area(s) to be protected, ensuring a one 1m overlap where necessary.
- Construction of the edging of the area is to be implemented with the use of vertical steel pegs driven into the ground at intervals of 500mm with side supports firmly attached. **CHECK FOR UNDERGROUND SERVICES PRIOR TO THE COMMENCEMENT OF SUCH WORK.**
- The three dimensional cellular confinement system (e.g cellweb or similar) must be cut to size and placed within the pre-prepared area. This area **MUST** now be filled with a no-fines aggregate infill. This **MUST** then be compacted to avoid the possibility of future “rutting”.
- Lay a final layer of the geotextile membrane on top of this surface.
- A porous material can now be placed on top to complete the construction.
- Graded top soil will be used to bring the adjacent grassed areas to the same level as the new driveway.

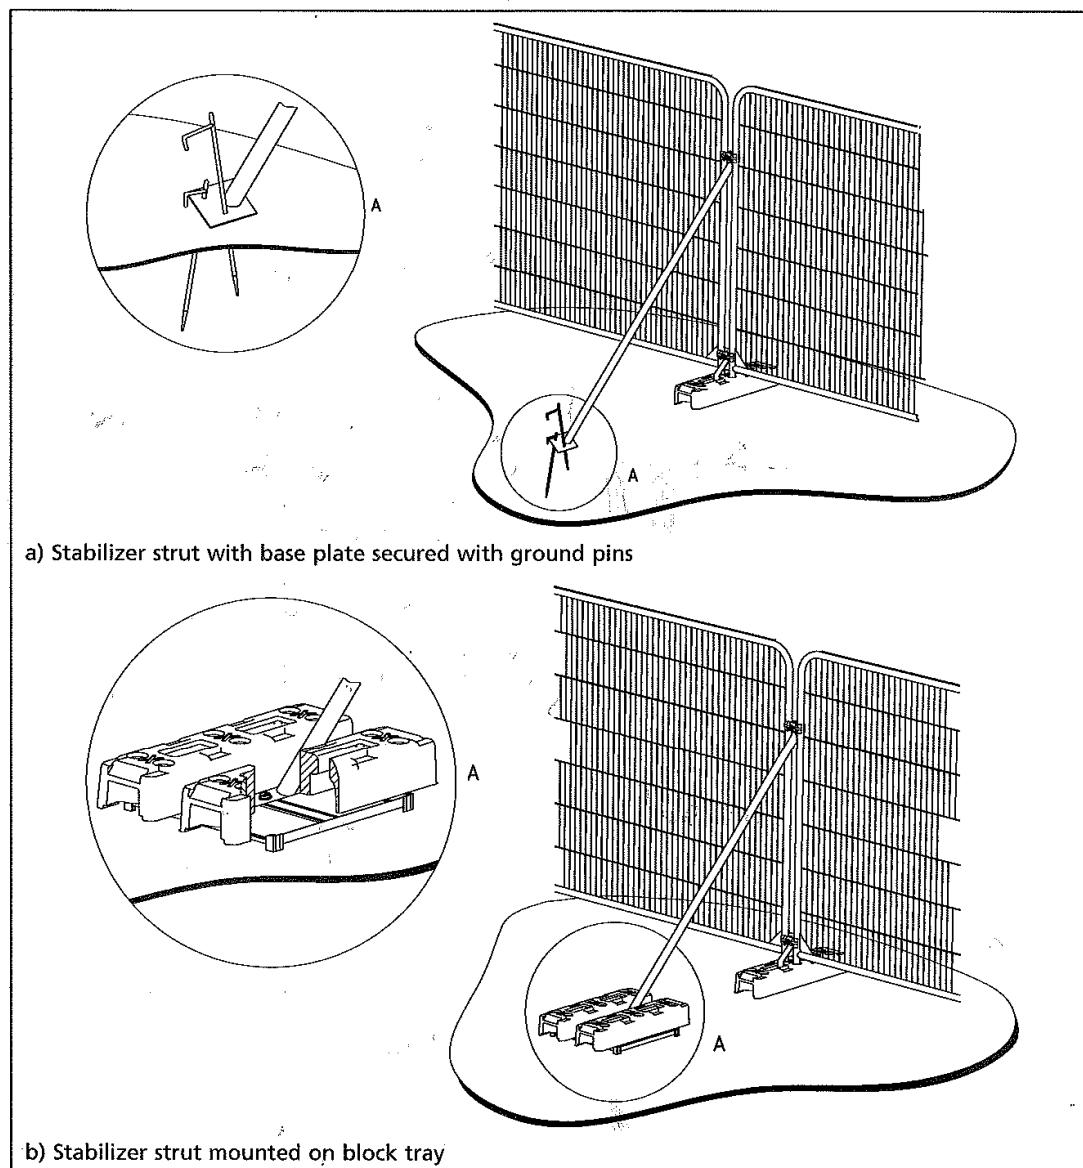
Figure 3 Examples of above-ground stabilizing systems

Appendix C
TREE FENCING DETAIL

It is essential for the future health of the trees to be retained on site, that **all** development activity is undertaken outside the root protection zone of these trees. The position of the fence **MUST** be marked out with biodegradable marker paint on site and agreed with appropriate representatives from the LPA and contractor. The fencing **MUST** be erected **prior** to any works in the vicinity of the trees and removed only when all development activity is complete. The protective fencing **MUST** be as that shown in BS 5837 (see Appendix C). The herras panels **MUST** be joined together using a minimum of two anti-tamper couplers which **MUST** be installed so they can only be removed from the inside of the fence. The panels **MUST** be supported by stabilizer struts, which **MUST** be installed on the inside and secured to the ground using pins or appropriate weights.
