# LEVEL MONITORING

## for Subsidence Management Services

**29 Nicholas Way, Northwood, Middlesex, HA6 2TR**

| Our Ref: | M13065 |

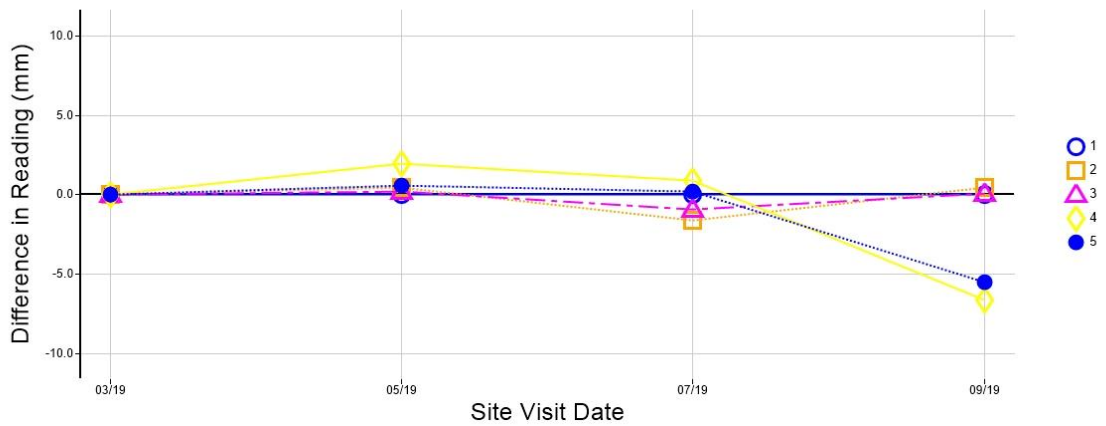
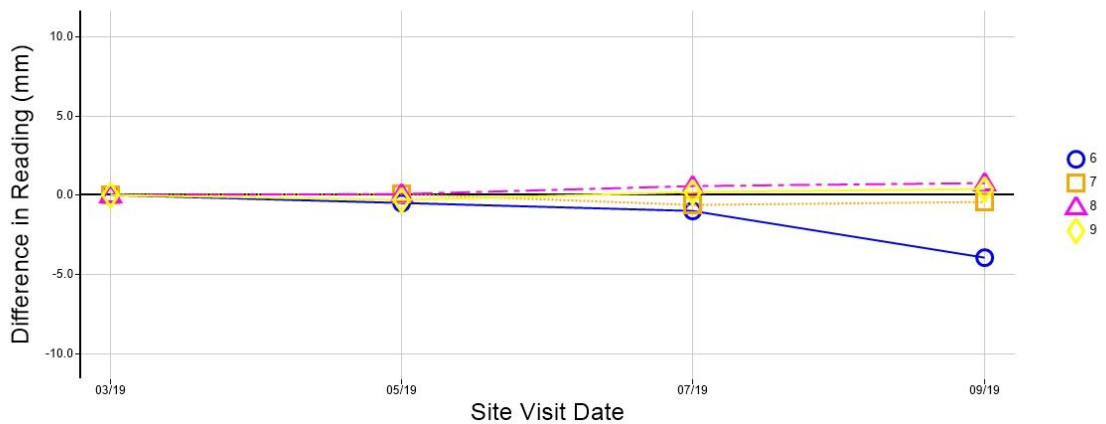
## Level Monitoring Difference Graphs

The following graphs display the progressive movement that each Level Monitoring Station recorded at each separate site visit date to give an overall look at how much the property is moving.

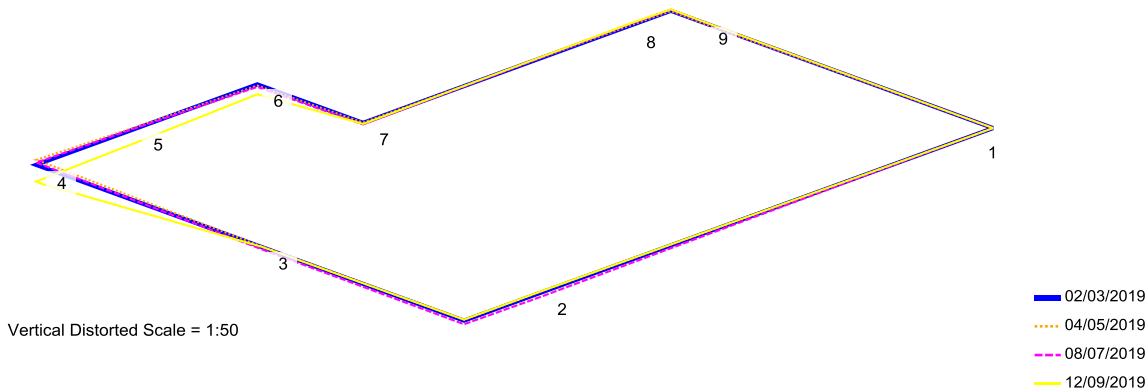
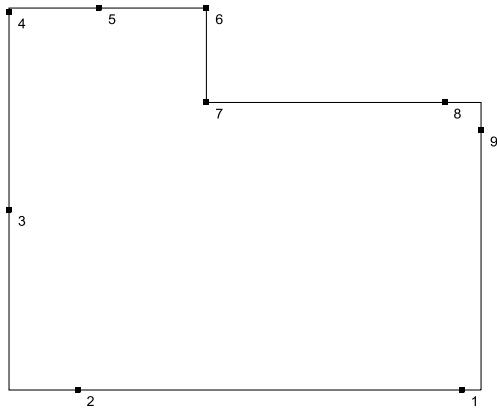
## Level Monitoring Displacement Map

The following image shows an isometric representation of the movement of the property, based on the Level Monitoring Stations that were installed.

FRONT

Points 4, 5 & 6 re-checked - Close to tree.
