### Arboricultural Impact Assessment

### Method Statement & Tree Protection Plan

Former CAB site, 9 Eastcote Road

Ref: TH 5560

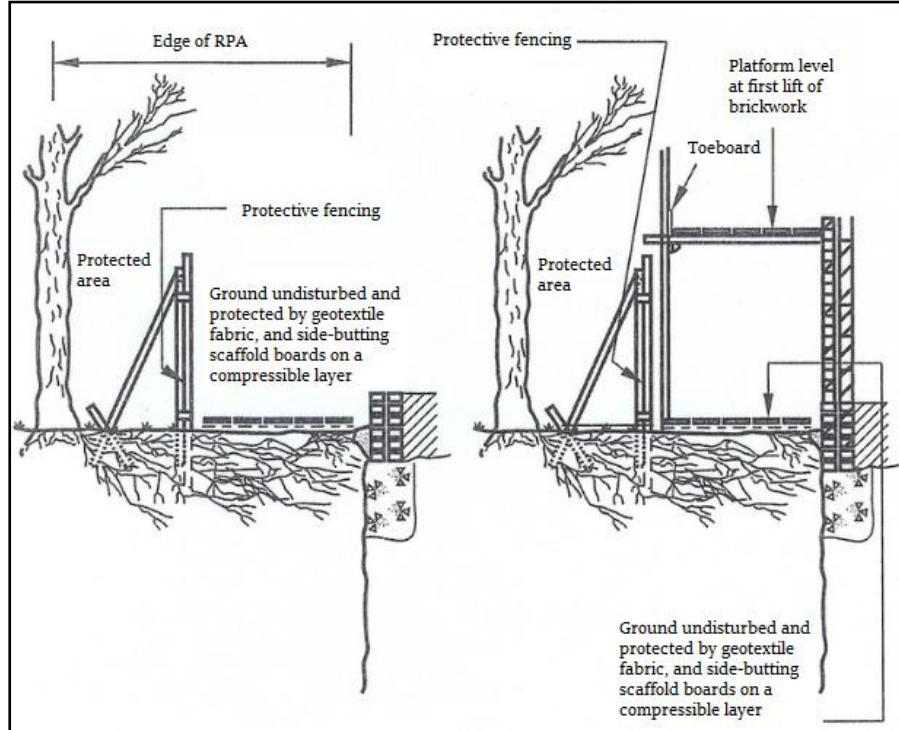
**Figure 1:** An example of ground protection on work areas within a RPA (BS 5837:2005).

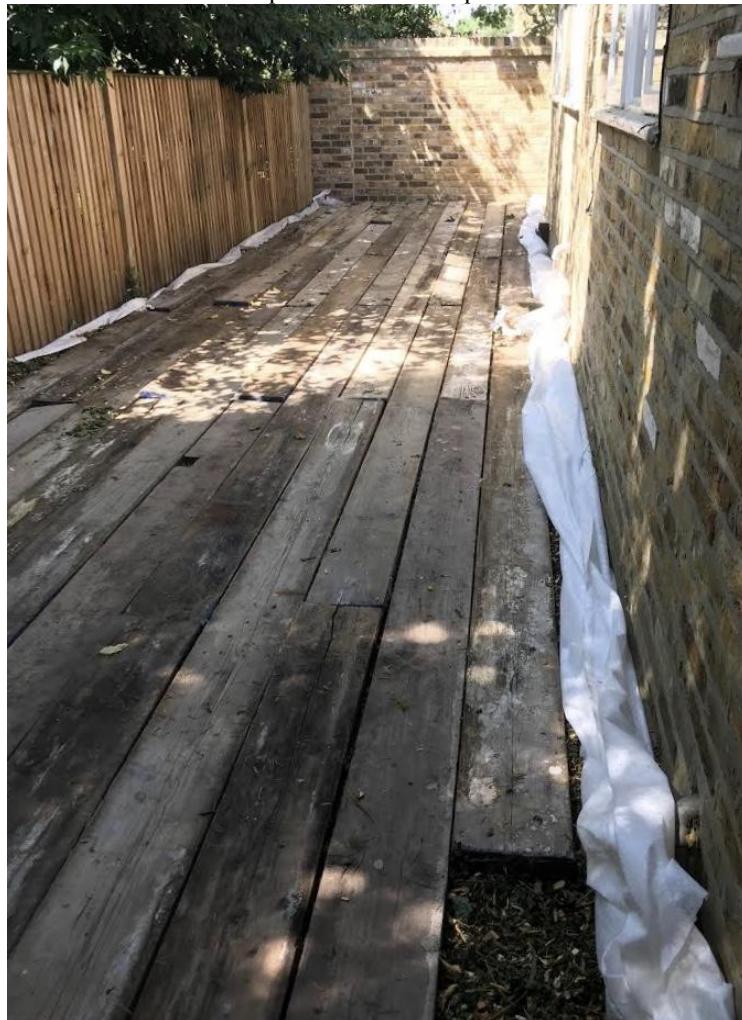
**Photo 1.** Scaffold boards placed on woodchip

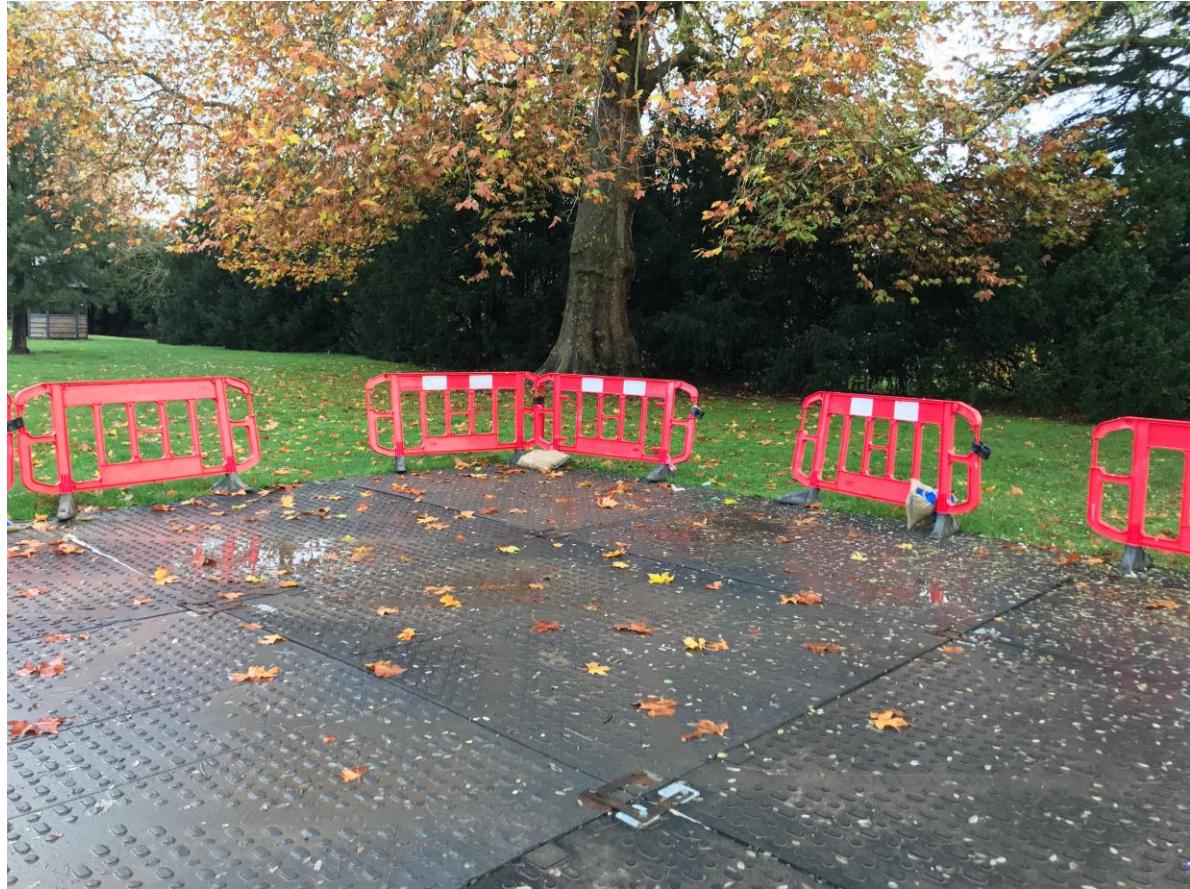
**Photo 2.** An example of heavy-duty ground protection.

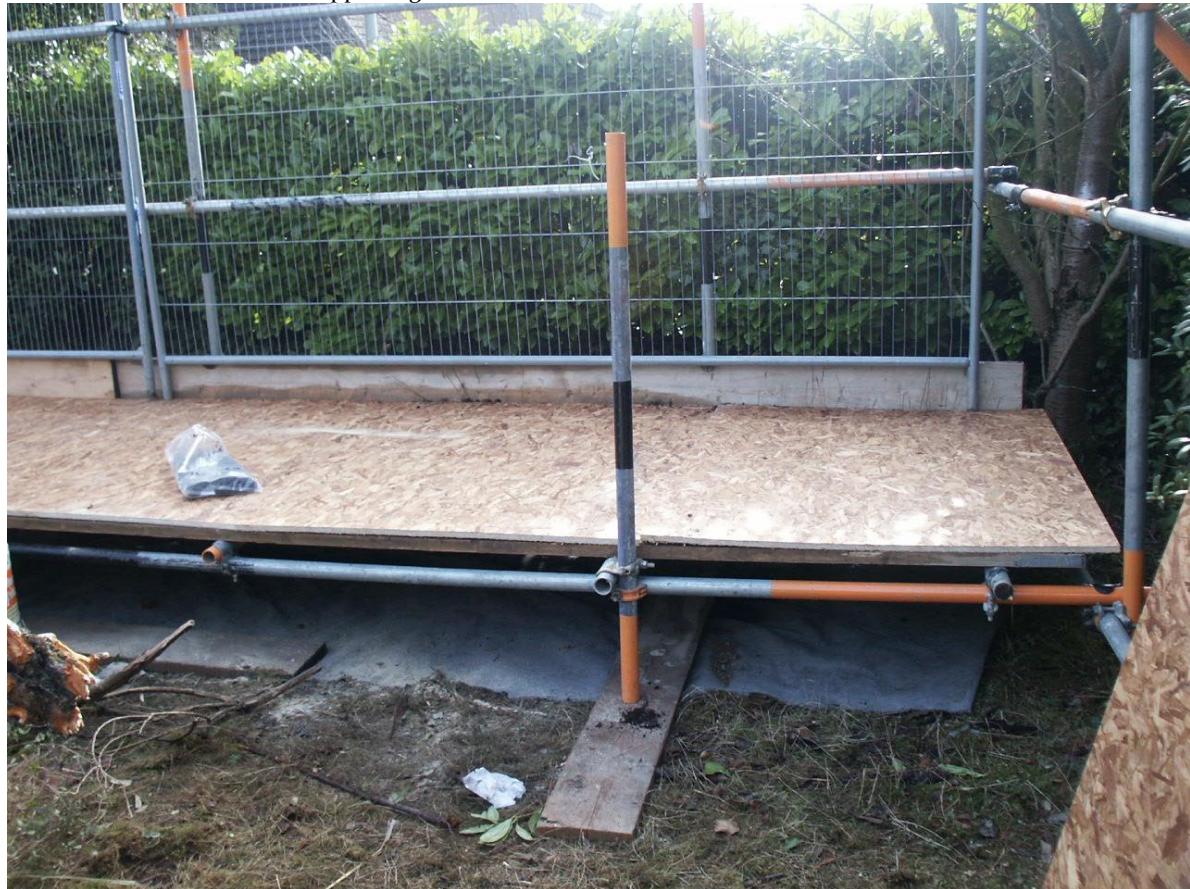
**Photo 2** Scaffold framework supporting wooden boards

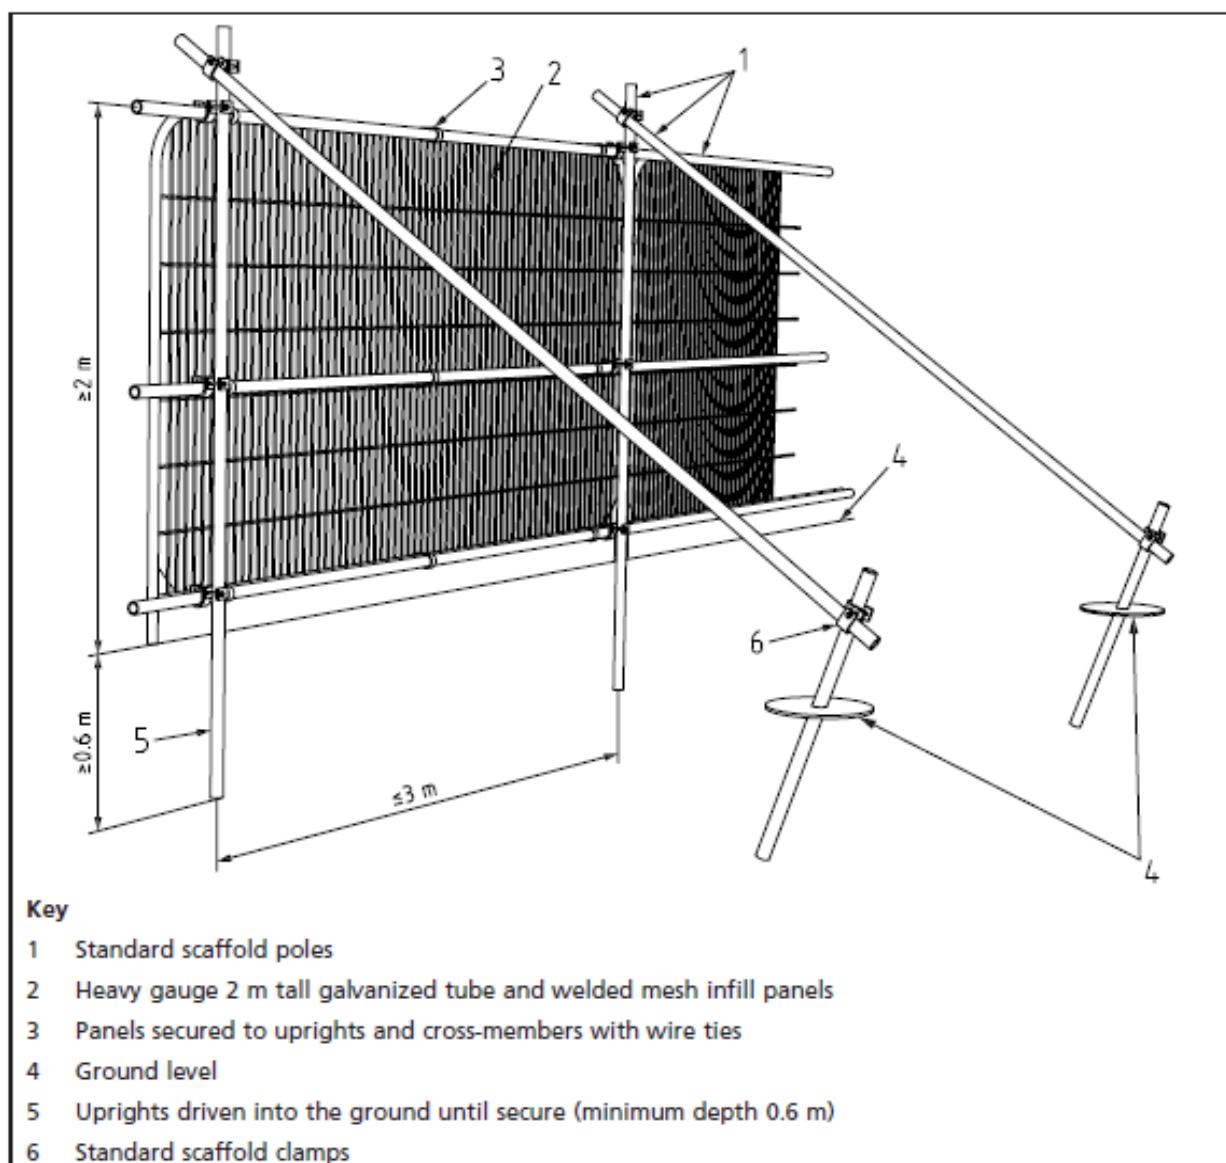
Figure 2: Default specification for protective barrier (BS 5837:2012)

The framework support (shown in Figure 2 and photo 1) is the usual method of support for 'Heras' fencing. Some variations are possible if site conditions are appropriate; i.e. support by wooden posts (75mm x 75mm x 2.75m) dug or concreted into the ground (dry mix concrete contained within a plastic bag), or if there is no pressure for access, a lighter form of netting on stakes.

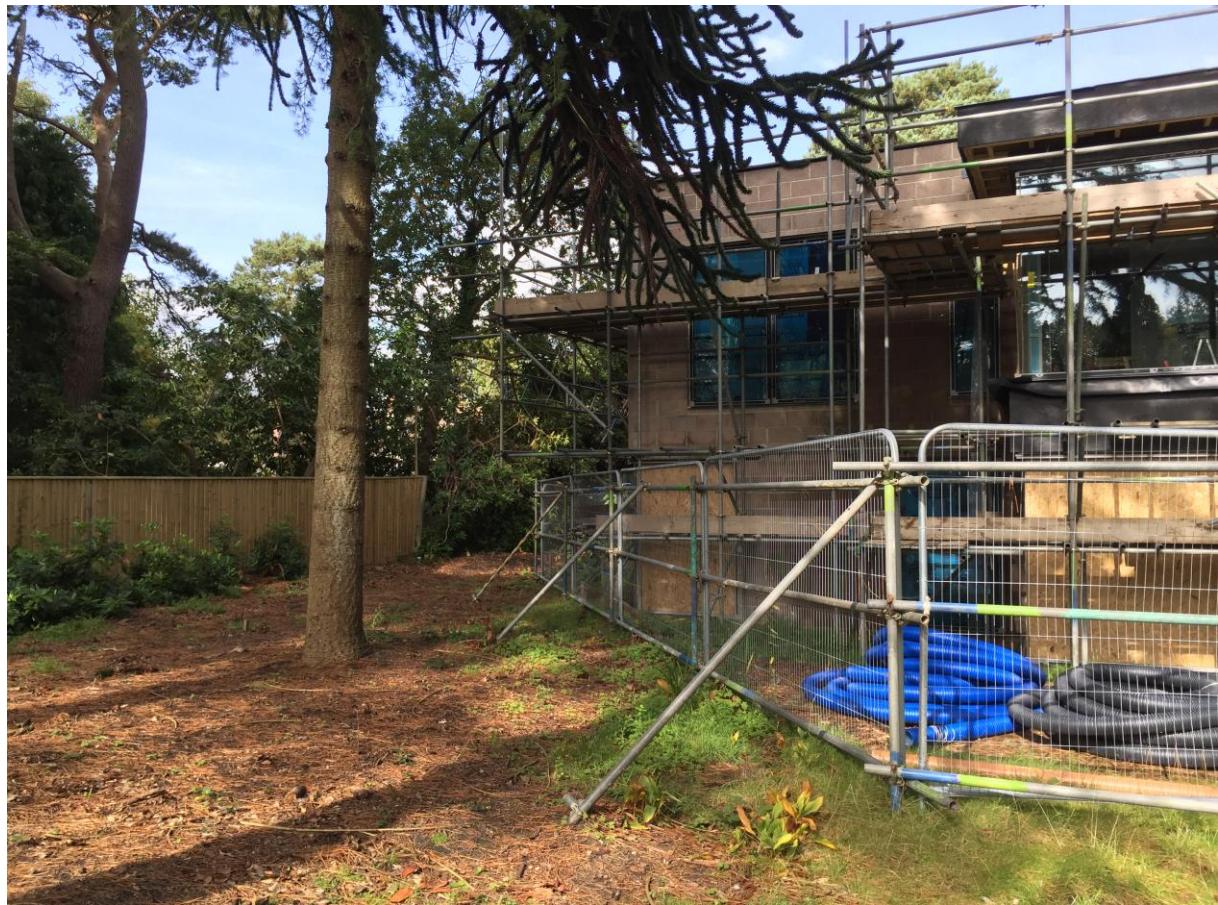
**Photo 1:** A worked example of the default specification for protective barrier (BS 837:2012)

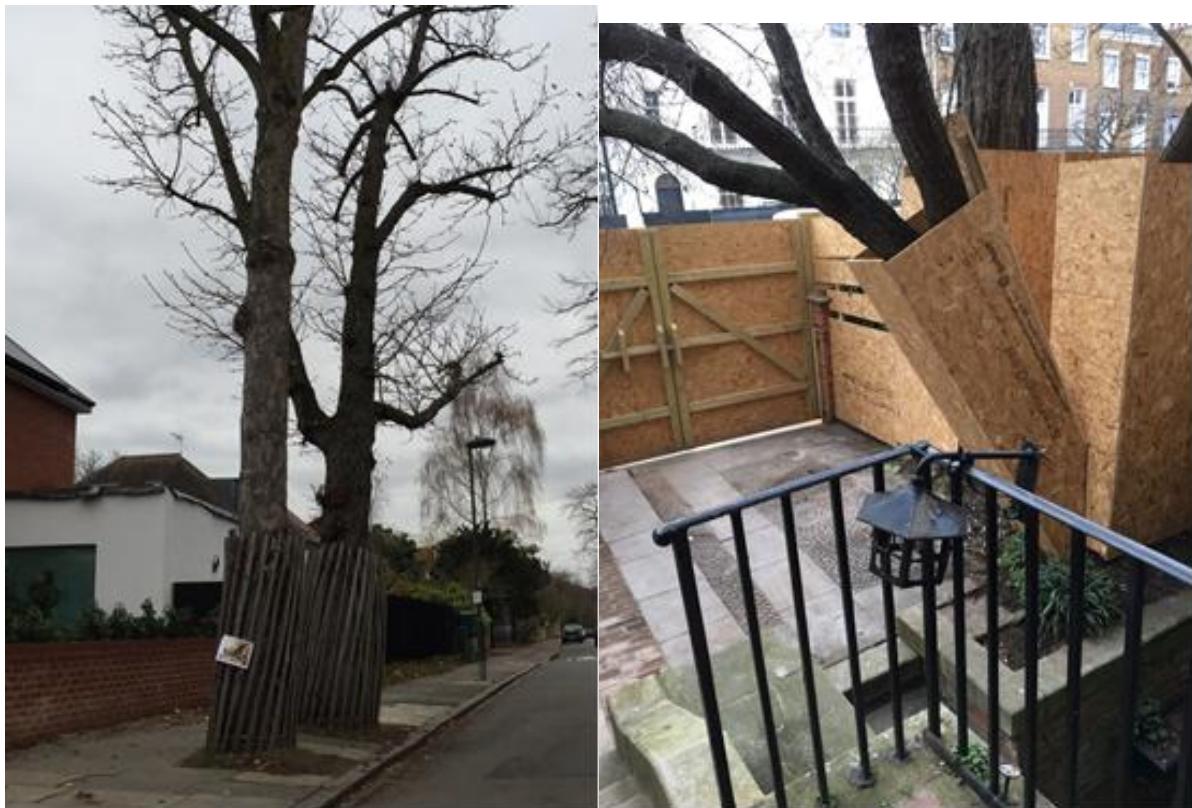
**Photo 2:** Trees protected by hessian & chestnut pale fencing / limbs protected by wooden boxing

Where specified in the AMS, the tree(s) stem/s shall be boxed off with wooden ply boards or wrapped in hessian and chestnut pale fencing / trunk protection (see example below). This will help avoid any direct damage to tree stems from passing machinery (see photo 2).

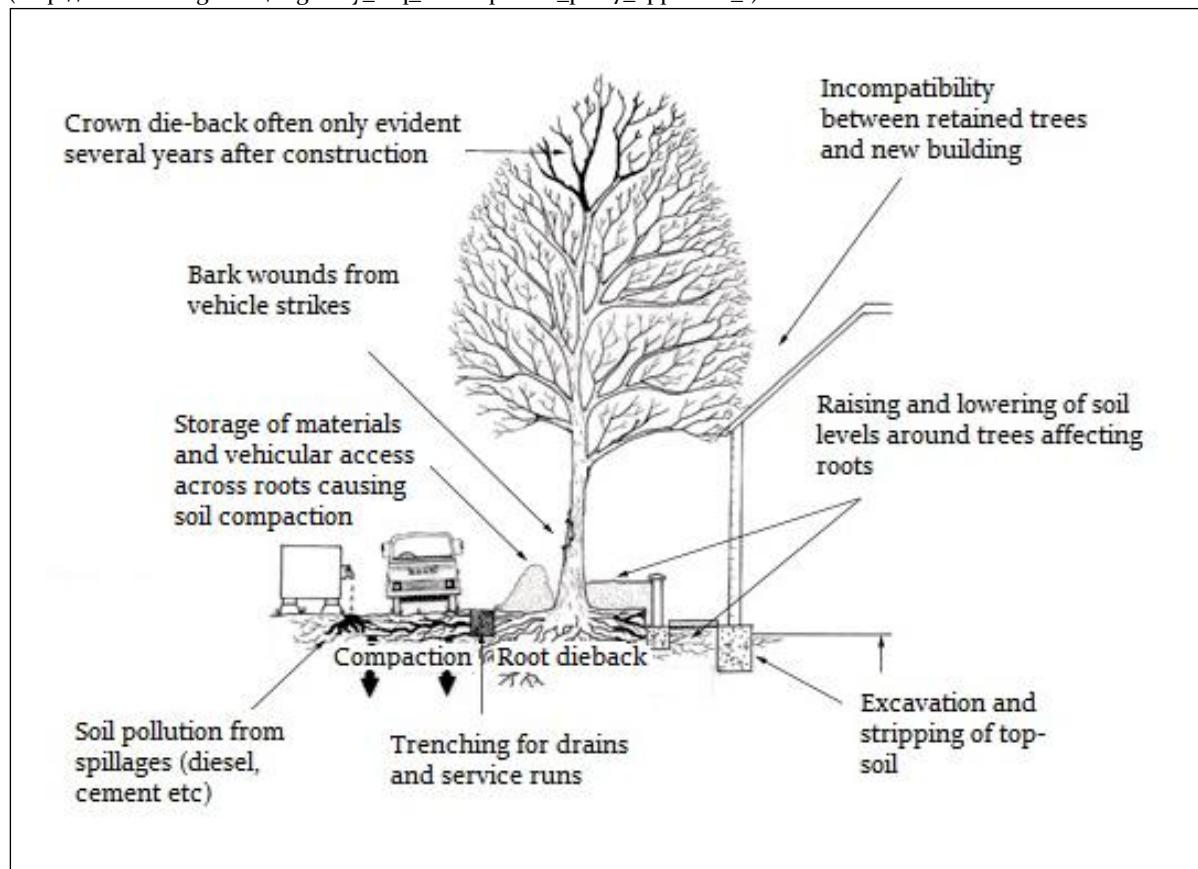
**Figure 4:** Common problems for trees on development sites  
([http://www.leics.gov.uk/highway\\_req\\_development\\_part7\\_appendix\\_f](http://www.leics.gov.uk/highway_req_development_part7_appendix_f))

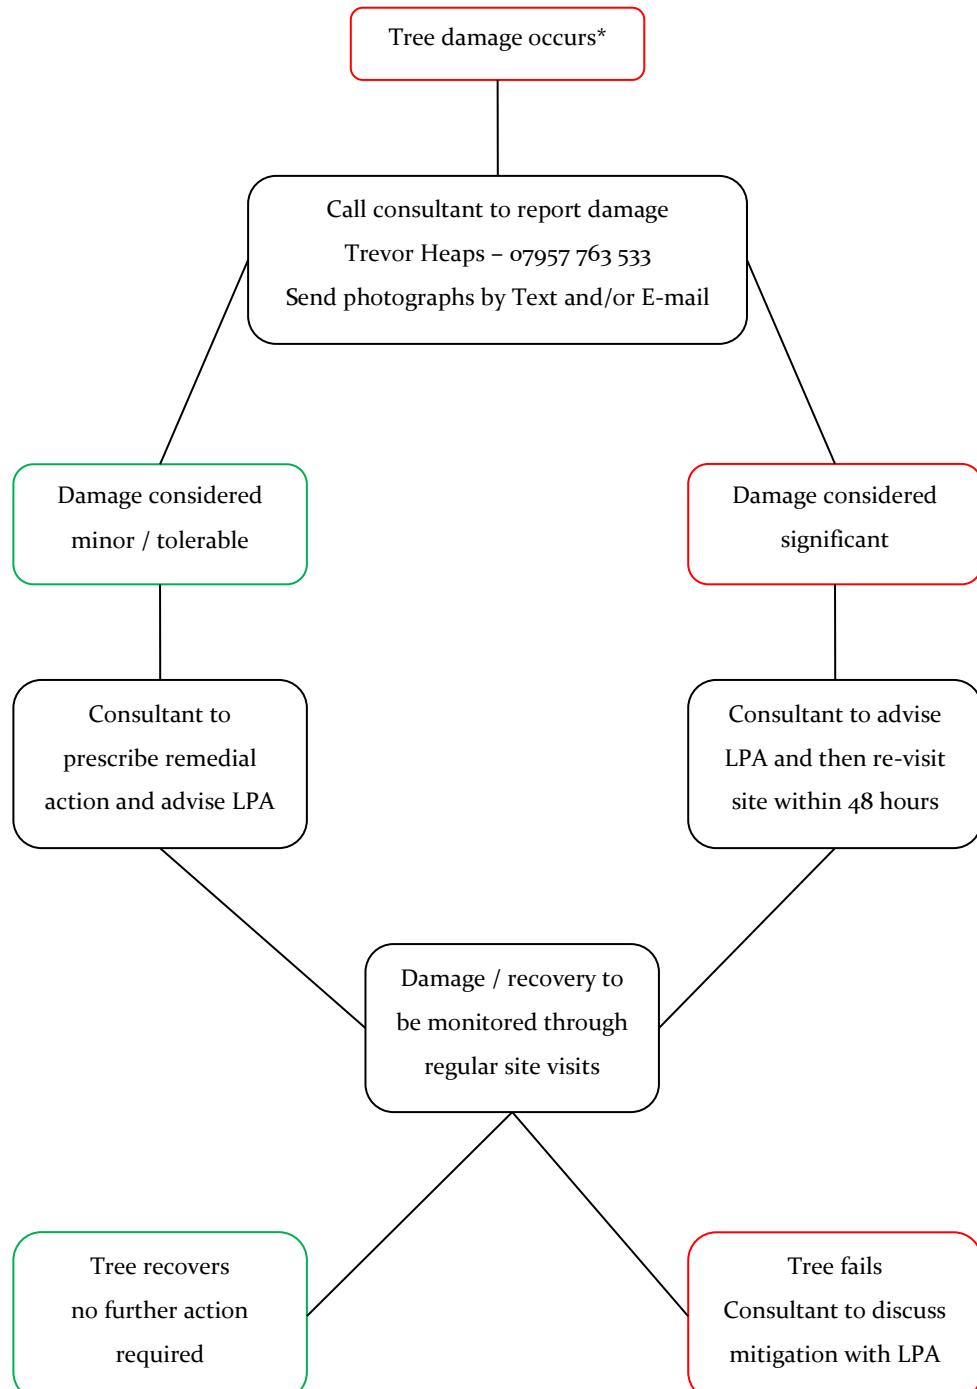
## Appendix 6 - Procedure to follow in case of damage to retained trees

\*Tree damage could include: unauthorised branch / root pruning; accidental damage to roots, stem, branches or crown; bark damage to vehicle / machinery strikes; and spillage of toxic materials within root protection areas (RPAs)
