# ARBORICULTURAL IMPACT ASSESSMENT AT 7B COURT ROAD, ICKENHAM

Prepared for Mialex

**By A.T. Coombes Associates Ltd.**

Chartered Foresters and Consulting Arboriculturists

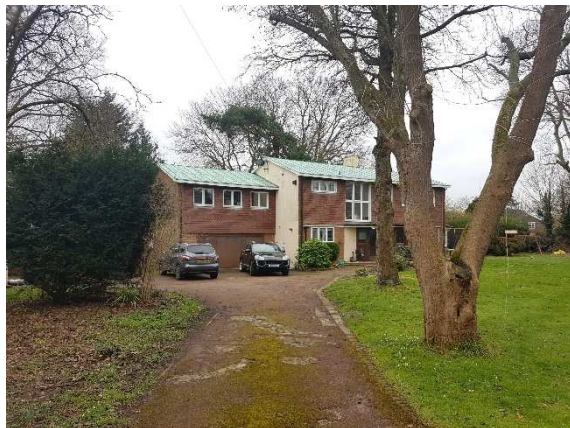
Fig 1: Site access with walnut and liquidambar adjacent to drive

- 2.2 There are numerous large trees situated within the property and on the boundary line, although most are away from the proposed development area. Adjacent to the drive are a mature walnut and liquidambar, as well as a small yew (Fig 1). The property has a parking area, adjacent to which is a

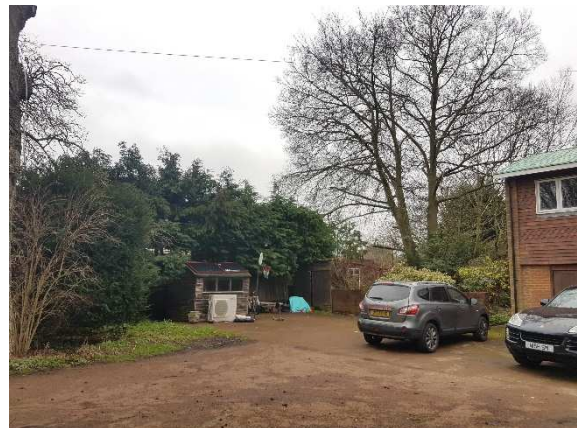
Fig 2: Parking area with Leyland cypress hedgerow. Large beech is in a neighbouring property

row of Leyland cypress which is under separate ownership. There is a large beech close to the eastern corner of the site, and this is also within separate ownership (Fig 2).

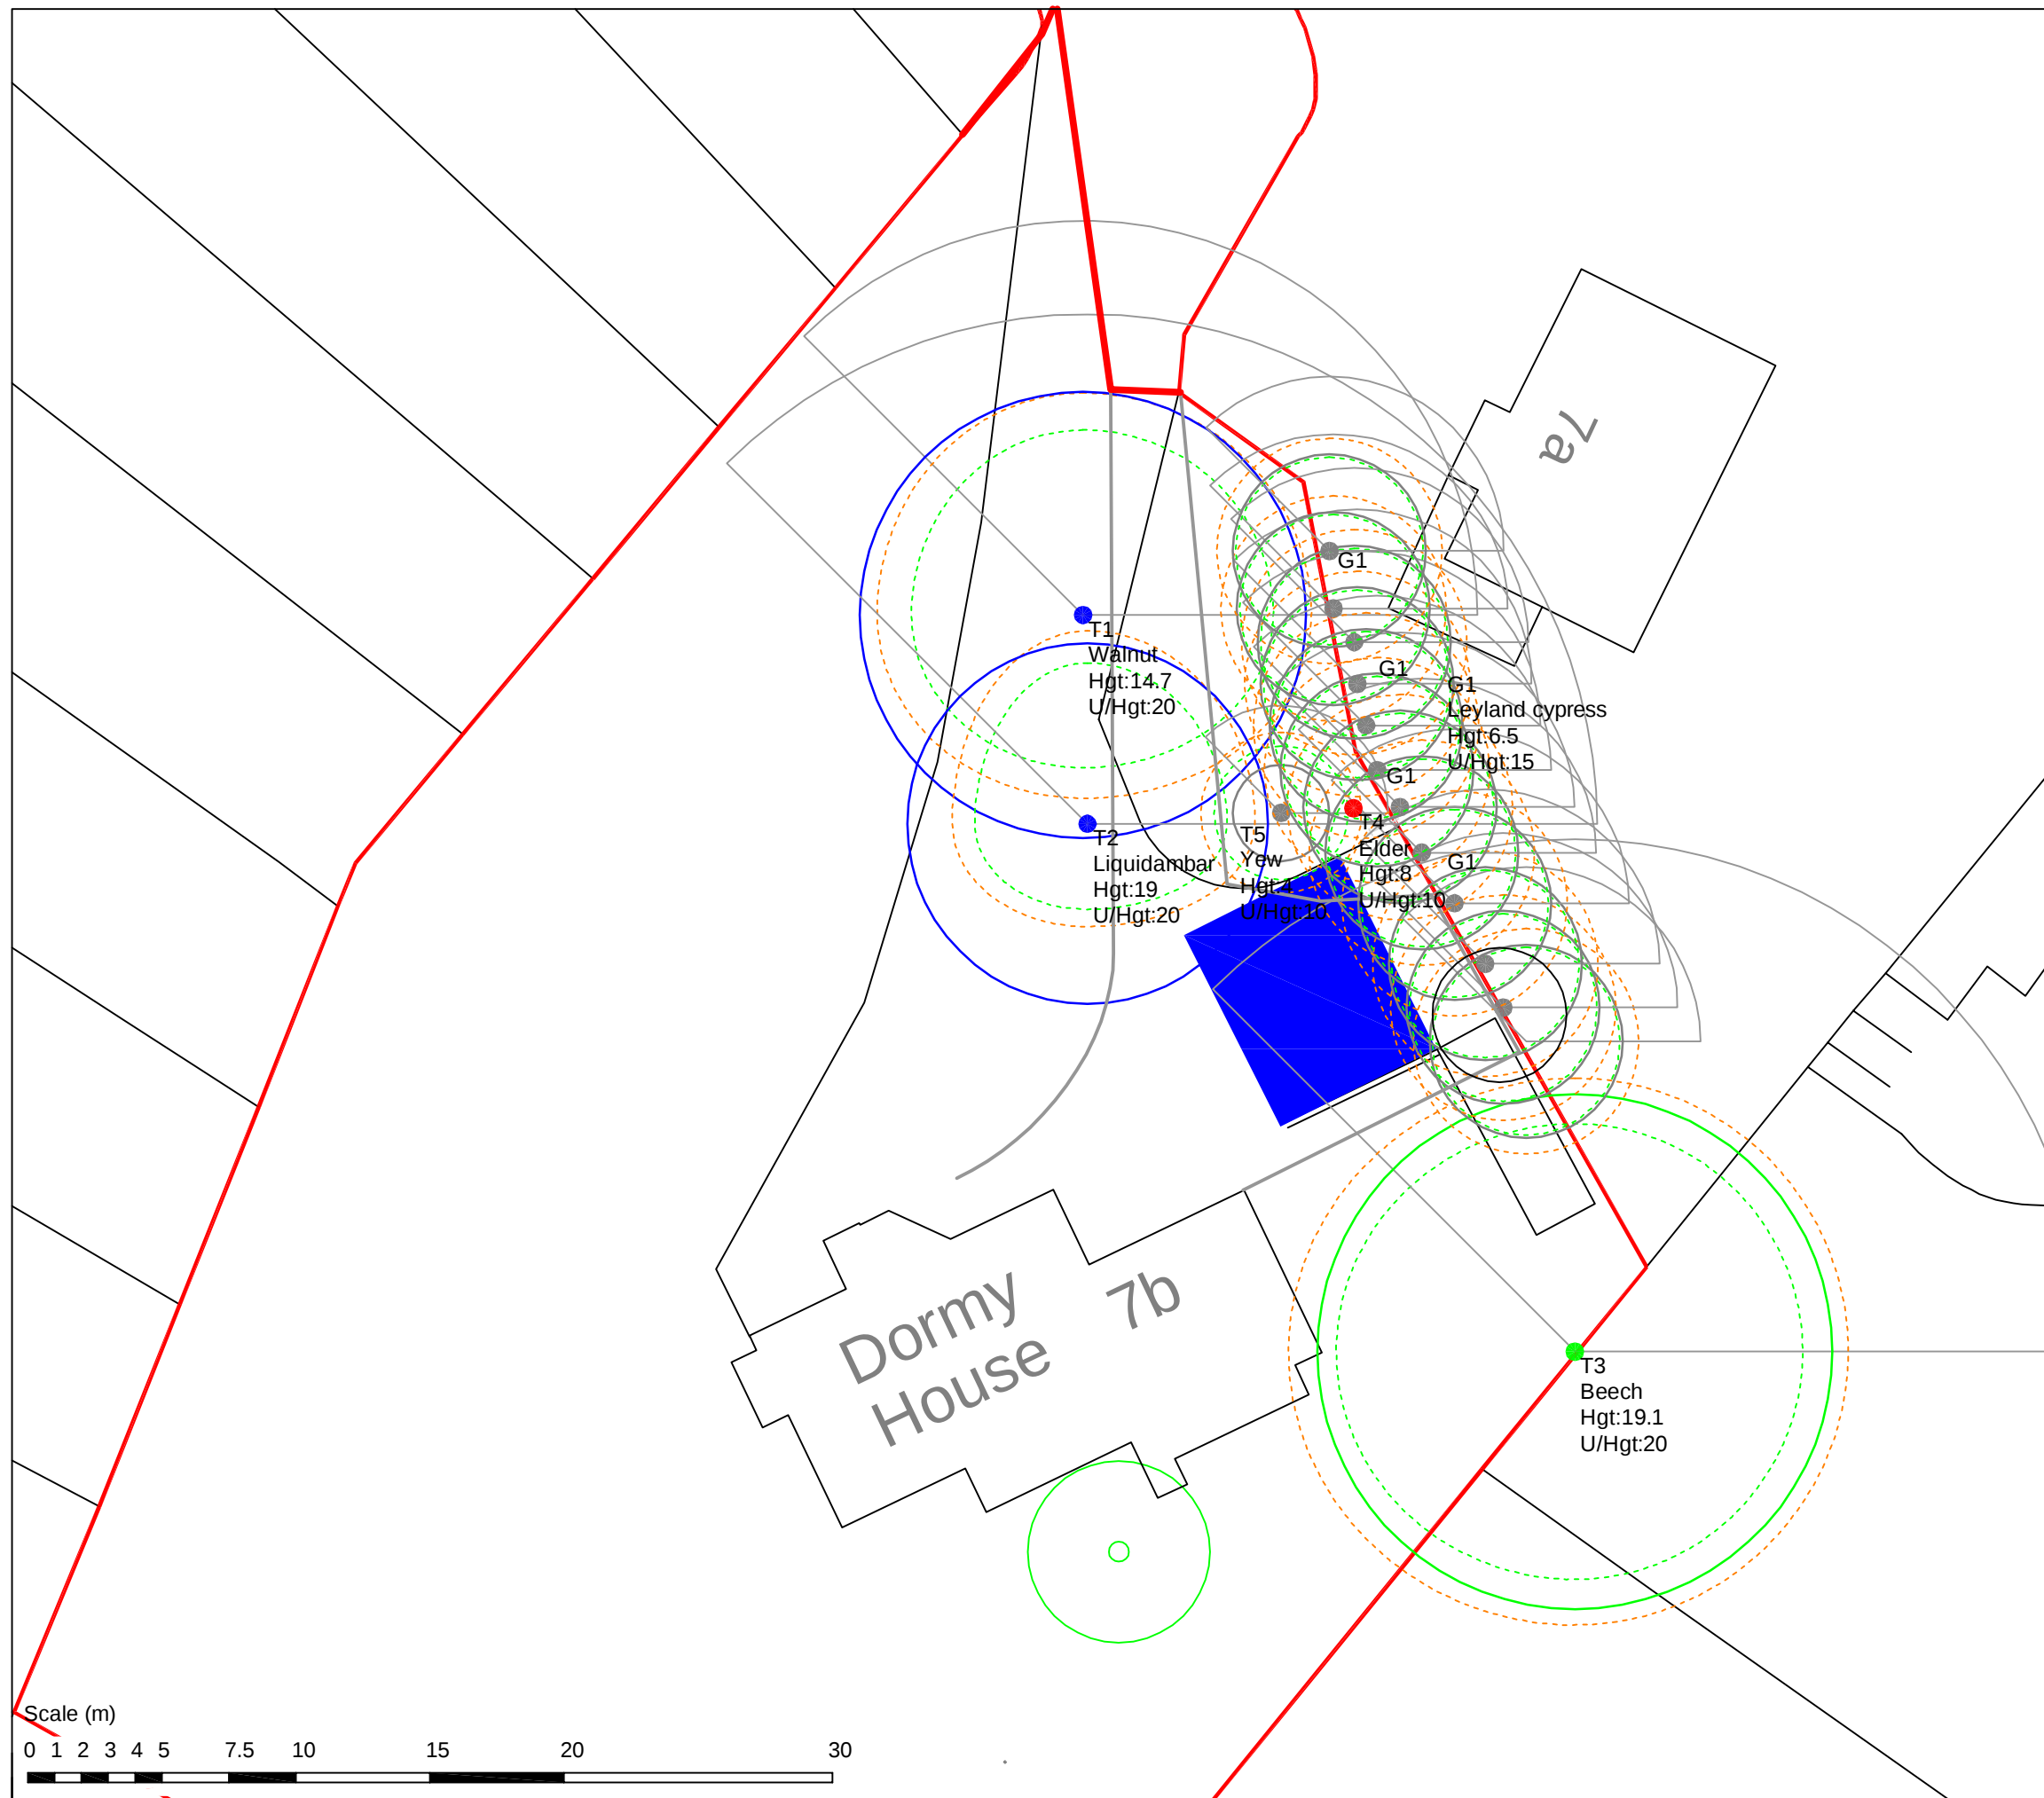
Drawing Title:  
**Appendix 3 - Tree Constraints Plan**

- 4.4 The Root Protection Areas (RPA) for the trees are shown as a coloured circle to match the retention category colour. The RPA will be used to help inform the closest positions of any future buildings. The RPA will be protected during any development work with temporary barriers as prescribed by the British Standard.

- 4.5 The branch spreads were measured at the four cardinal compass points, with a shape drawn around these points to indicate approximate branch spread, represented by green broken lines on the plan.

The ultimate crown spread has been shown with an orange dashed line. This is a predicted distance and is based on personal experience of how far it is likely the crown will grow.

- 4.6 A shade pattern has been shown for each tree forming an arc from northwest to due east. This gives an indication of the patterns of shadows created by the trees around mid-day in the summer. This is as recommended in BS5837:2012 (Section 5.2.2) but actual shade patterns throughout the year will vary widely. If shading is likely to be a serious constraint a more detailed analysis of shade pattern using proprietary software may be deemed necessary.

- 4.1 To facilitate the proper assessment of tree constraints a Tree Constraints Plan (TCP) has been prepared and forms Appendix 3. The plan has been produced as a basis for the assessment of the constraints imposed by existing trees on the proposed design.
- 4.2 Appendix 3 shows the position of trees marked by a coloured dot matching the retention category status and a reference number (as listed in Appendix 1). Heights (Ht) are marked in metres for each tree, together with the predicted ultimate heights (U/Hgt).
- 4.3 The plan deals with constraints that the trees may place on the development in two areas as follows:

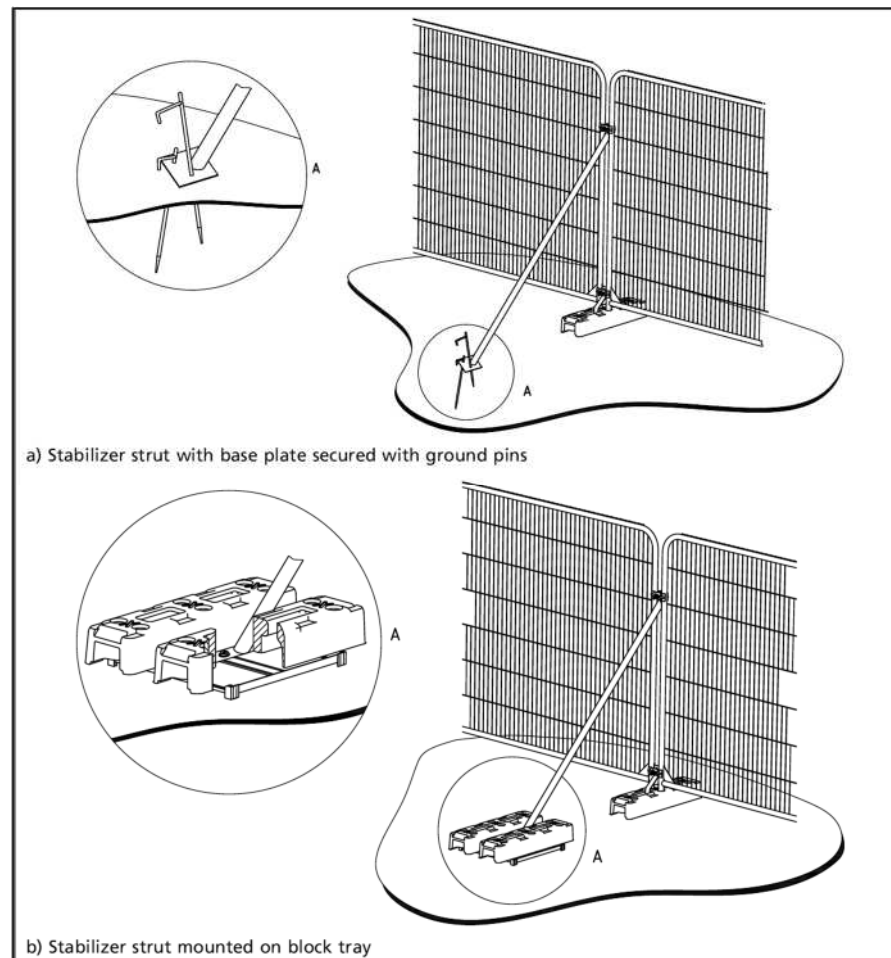
Fig 1: Temporary protective fencing as recommended by the British Standards (2012).

- 3.4 Figure 1 is an extract from BS5837:2012 showing the method of supporting the panels with ground pins and a block mounted tray for use on hard surfaces. Stabiliser struts should be fitted at each panel junction.
- 3.5 At least two all-weather notices should be erected on the barriers forming each CEZ stating “Construction Exclusion Zone – No Access “. These should face outwards towards the work area. Signs must be maintained in good condition and remain in place until completion of the works.
- 3.6 Barriers will be maintained throughout the duration of the works, ensuring that access is denied to the CEZ throughout the process.

- 3.3 Panels should be supported on the inner side by stabilizer struts which should normally be attached to a base plate and secured with ground pins. Where the fence will be erected on hard surfacing, or it is otherwise unfeasible to use ground pins the struts should be mounted on a block tray.
