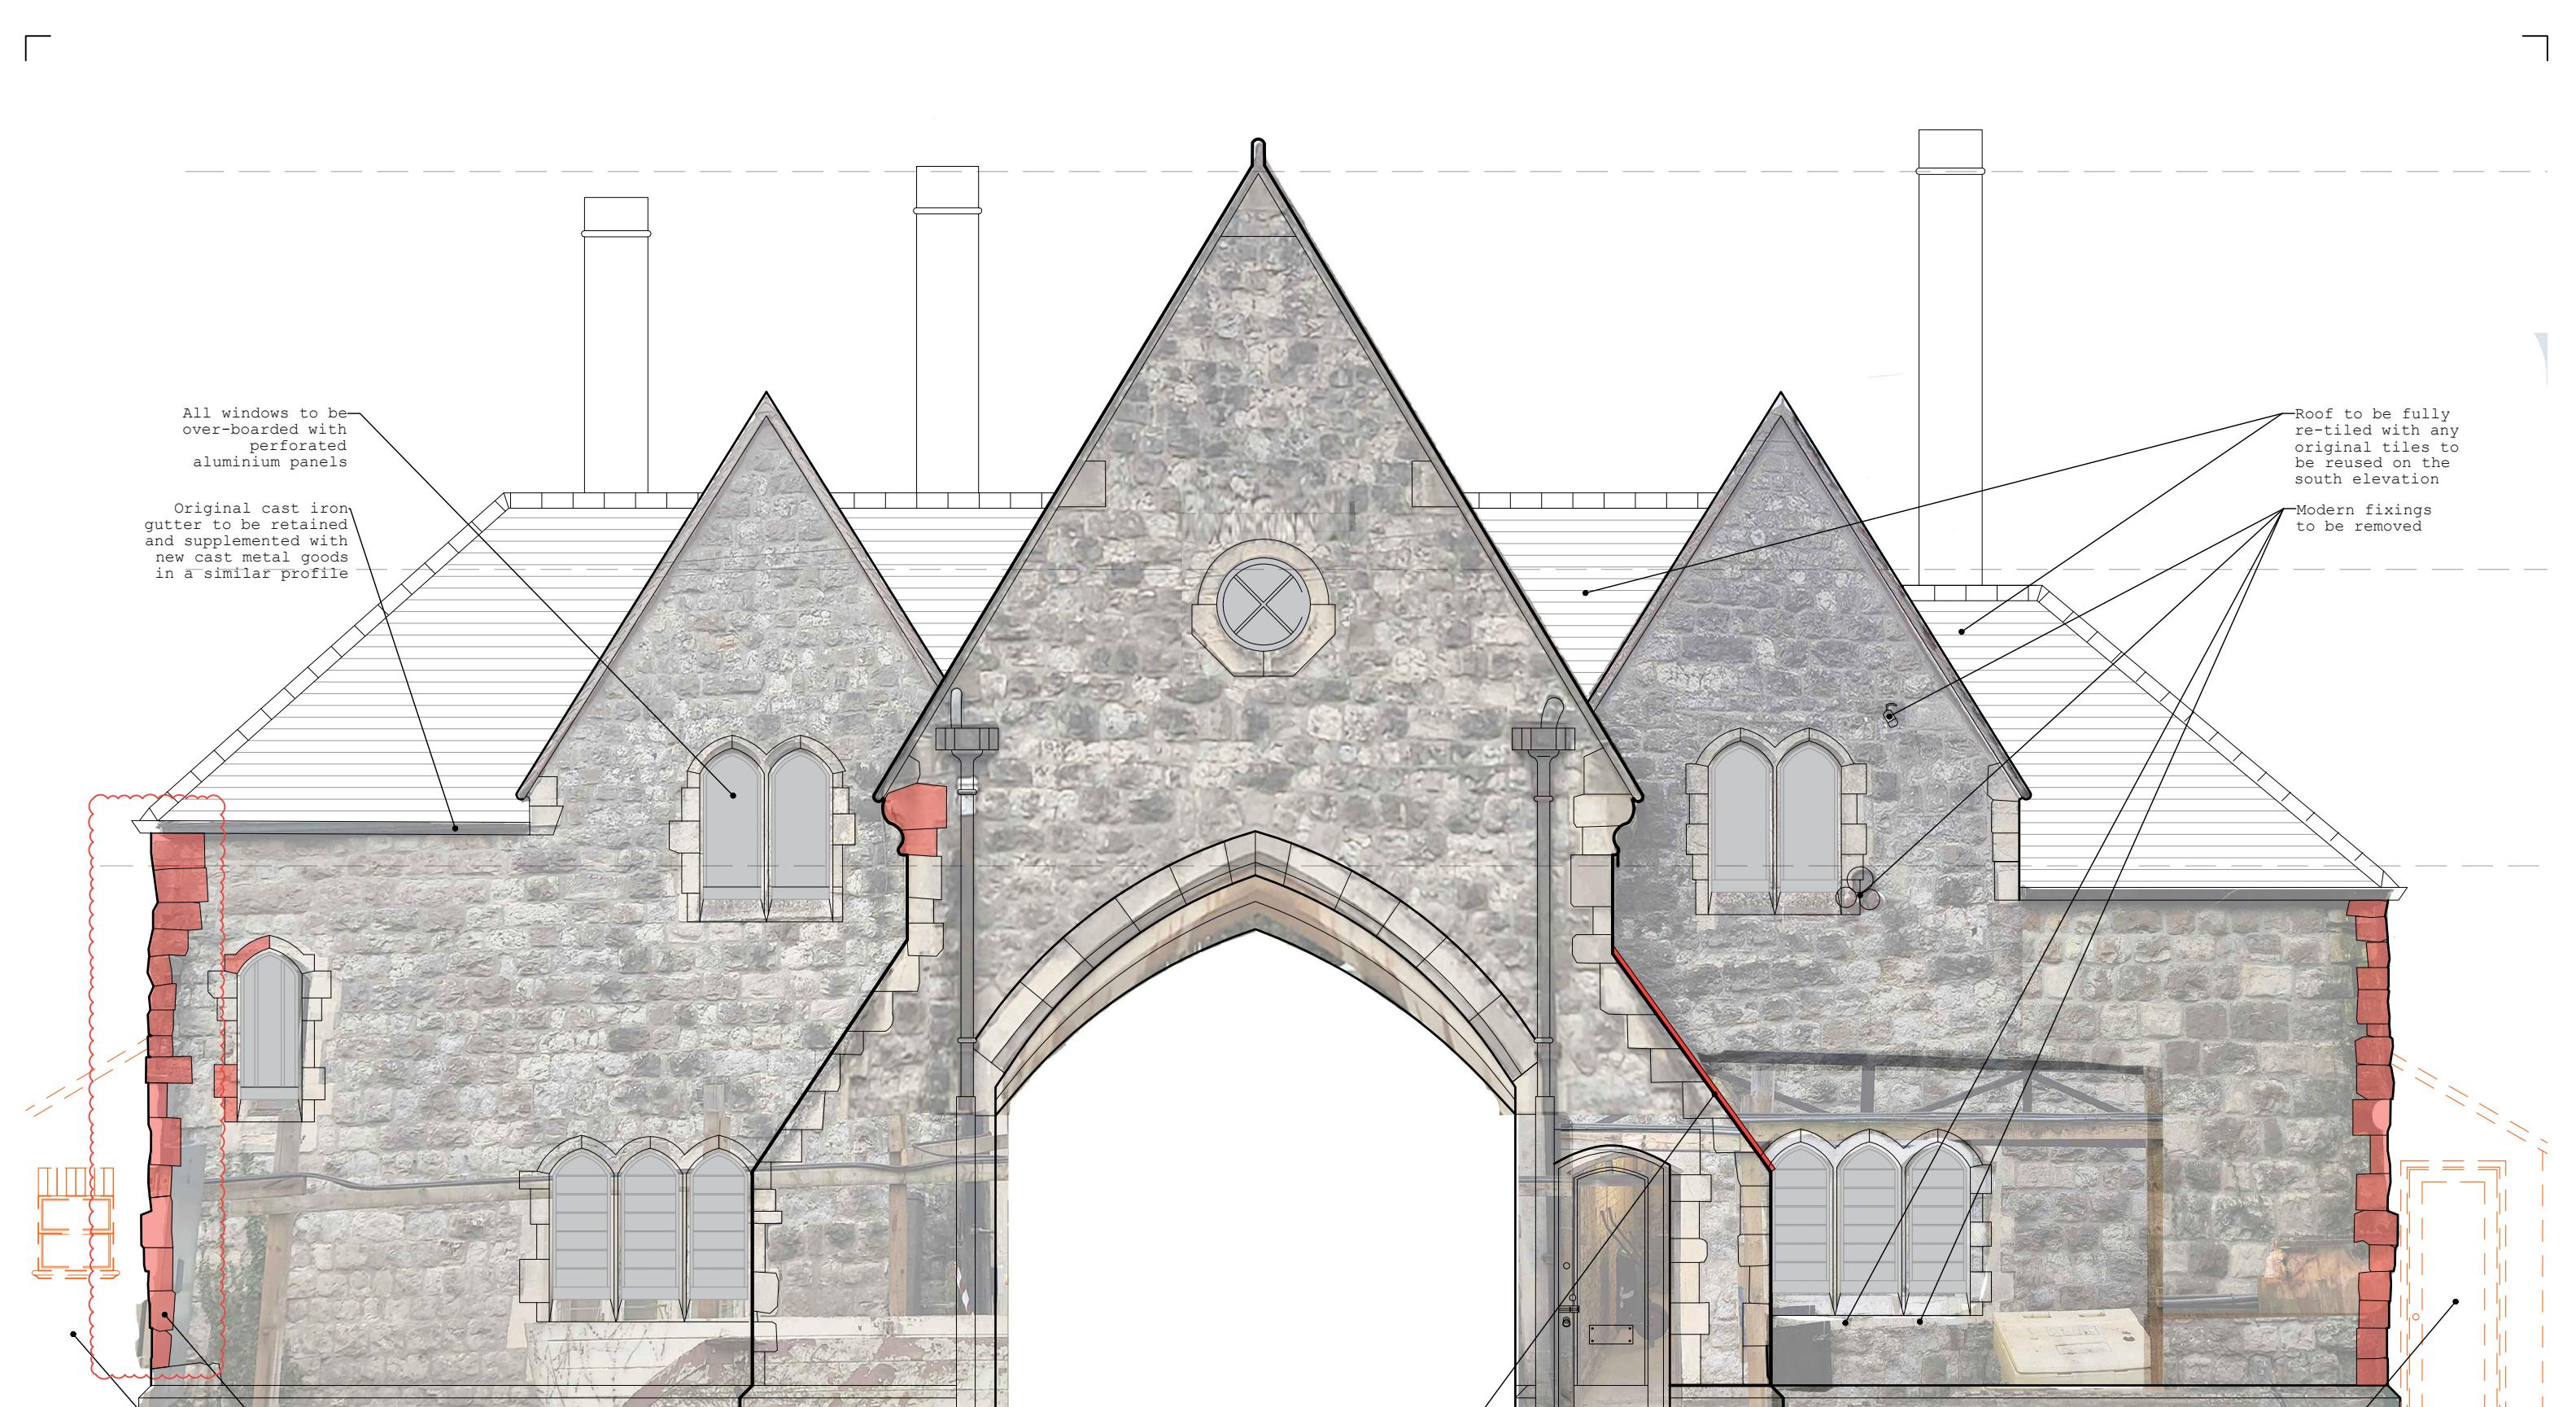
stone quoins have been lost where modern extension was added. to be repaired and new stones inserted to ensure a clean corner is reinstated.

Modern brick structure to be taken down and all evidence removed including lead flashing and cement wall plaster and made good with lime mortar

Thick cement flaunching to be removed and structural engineer to inspect behind, structural engineer stabilisation recommendations to be advised and repairs made in lime mortar
