project  
**Dower House, 393 High Street, Harlington**

title  
**North Elevation- Proposed repairs and alterations.**

scale 1:50 @A2	status <b>PLANNING</b>
job no. 784	status/revision D-036 PL01

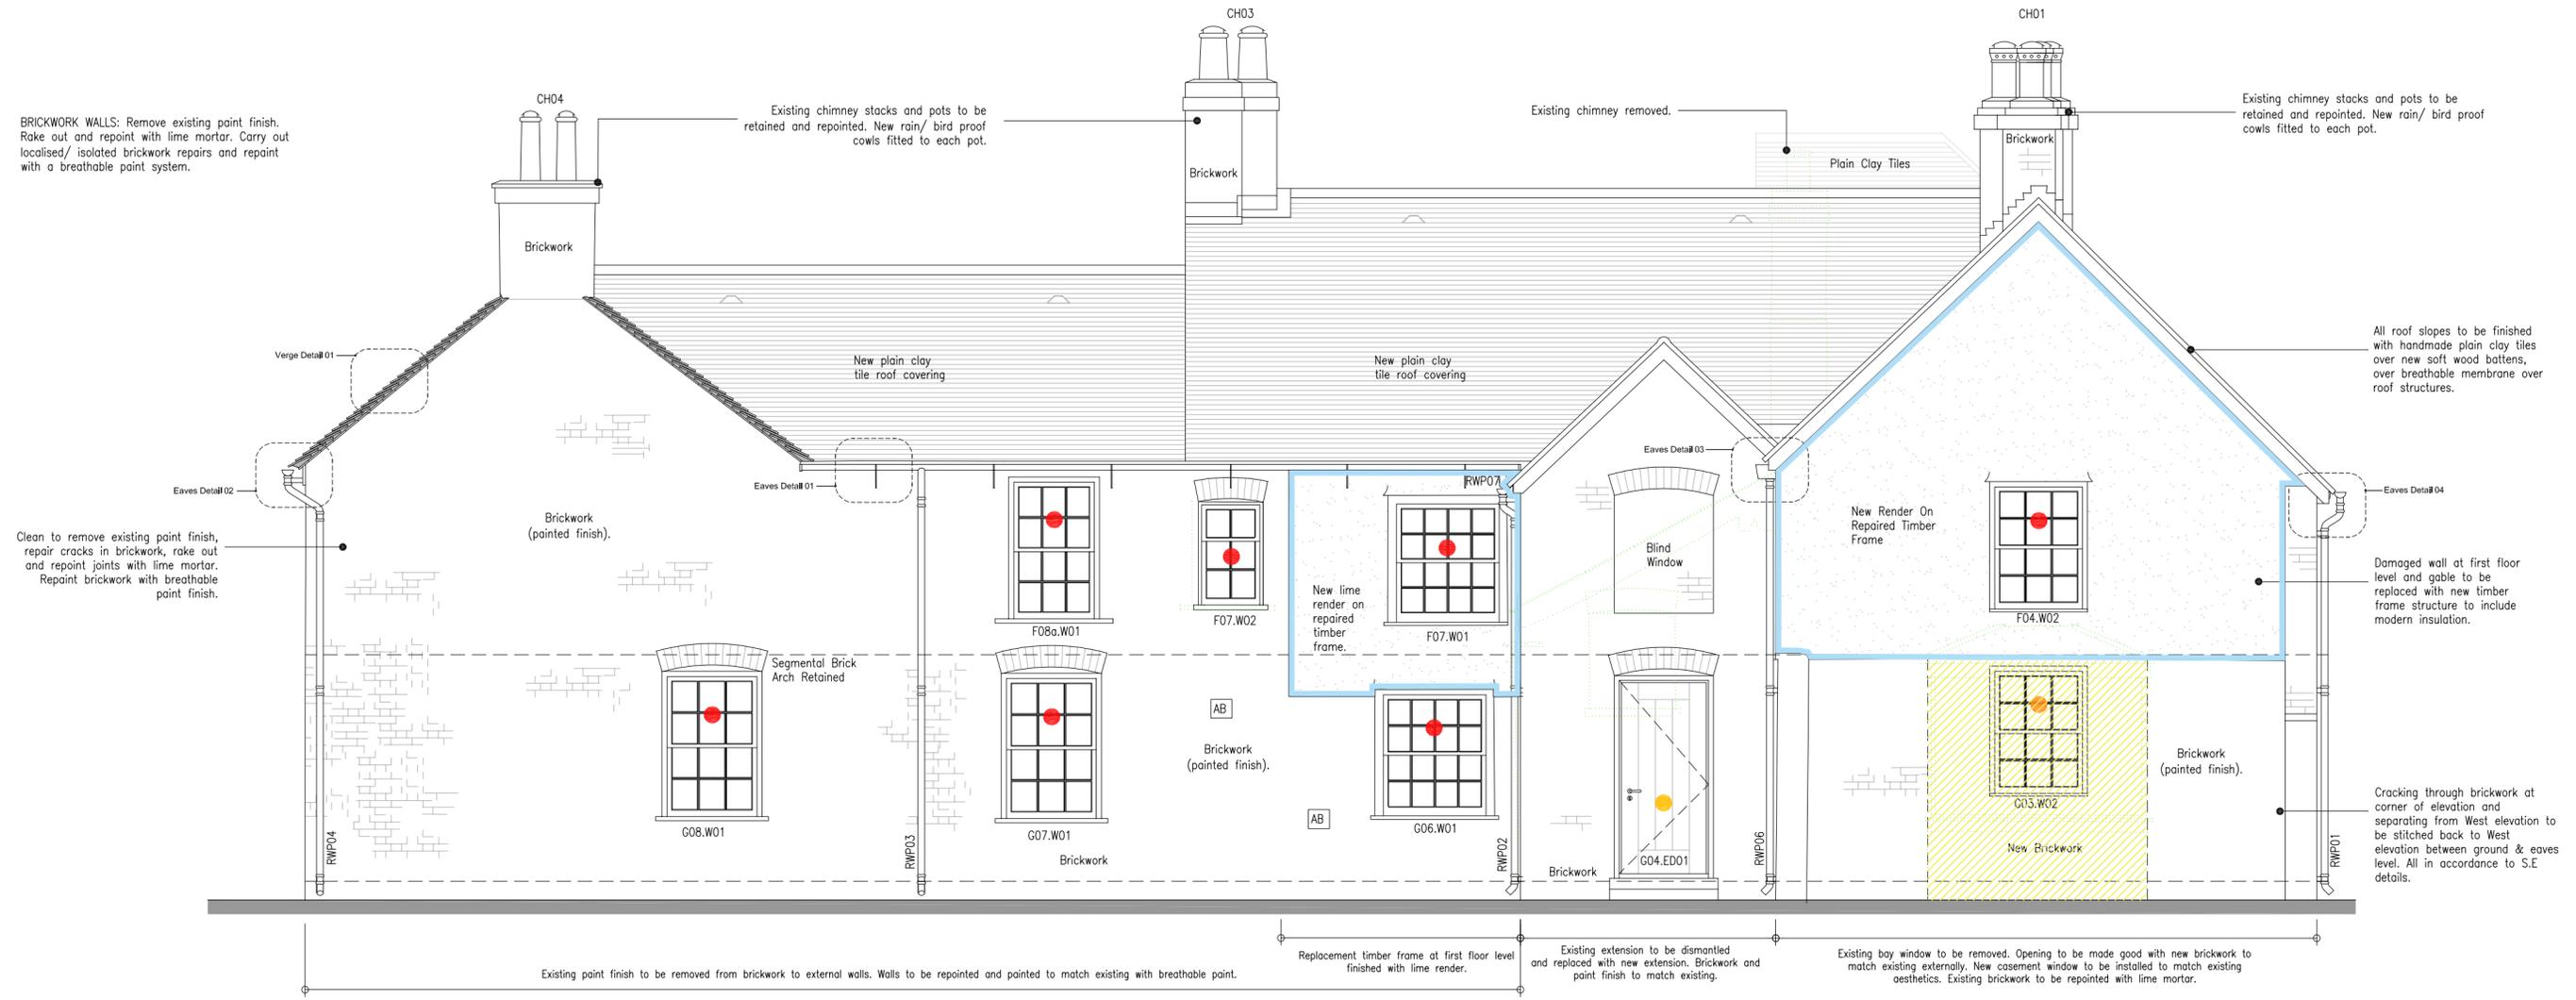
**01 NORTH ELEVATION**  
1:50

- Key**
- Taking down/demolition & removal.
  - External doors all to be replaced with new door and frame.
  - Replace existing timber sash / casement timber window and associated frame. Paint to match existing on a like for like basis including moulding and cill details.

- Existing sash window removed or door. Existing window opening adjusted to . New timber vertical sliding sash window installed and opening adjusted to suit.

- New external door and frame in new brickwork opening with segmental arch.
  - Existing external brickwork wall to be dismantled and rebuilt to match existing on a 'like for like basis'.

- Existing fire damaged timber frame to external wall to be dismantled, repaired and re-assembled in former position with new timber frame elements to replace existing timbers beyond repair.

- New brickwork bedded and jointed in lime mortar to match existing bond & course heights on a 'like for like' basis.

**ROOF COVERINGS:** Remains of existing roof coverings to be removed. New reinstated and existing roofs to be covered in new handmade plain clay tiles with long Back ridge tiles, bonnet hip tiles and swept valley tiles.

**RAINWATER GOODS:** All existing eaves, gutters, downpipes and associated brackets and fixings are to be removed and replaced with cast iron rainwater goods.
