### **Arboricultural Impact Assessment Method Statement & Tree Protection Plan (to BS:5837 2012)**

**4 Rofant Road, Northwood  
HA6 3BE**

Ref: TH 3299 B

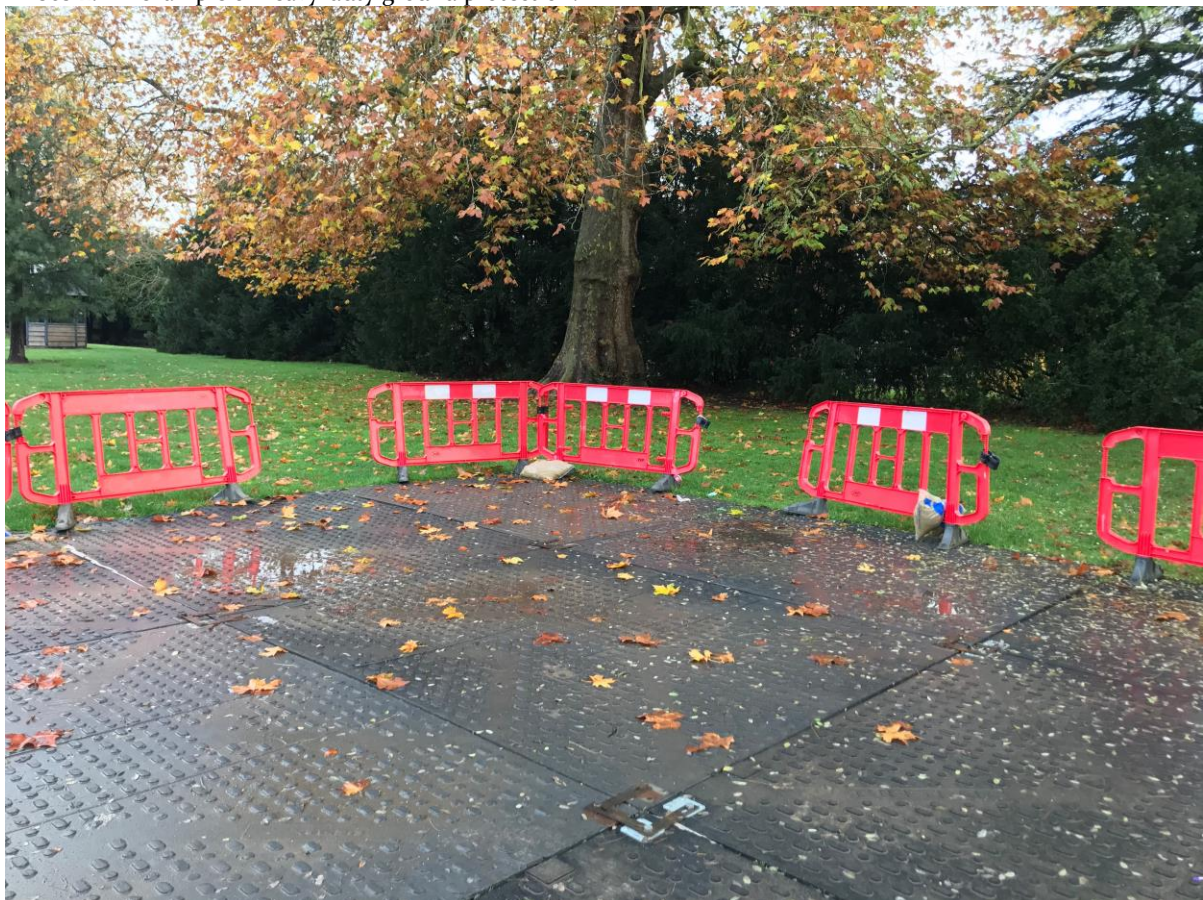
**Photo 2.** An example of heavy-duty ground protection.

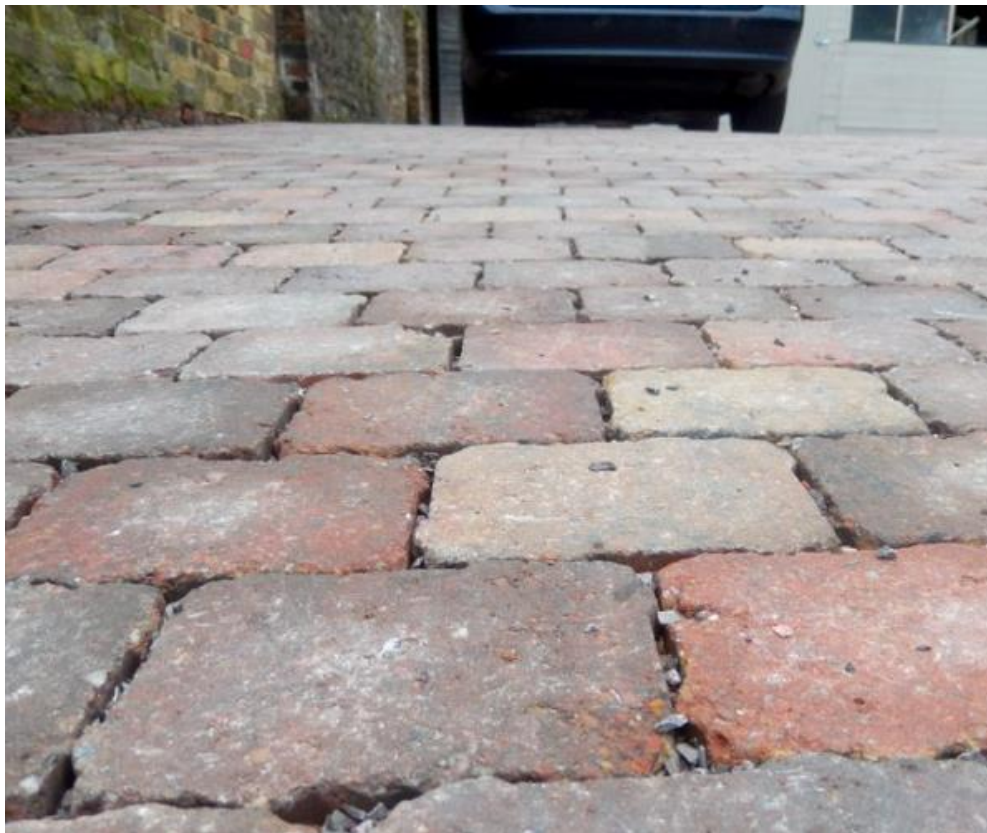
**Photo:** An example of a finished permeable block paved driveway

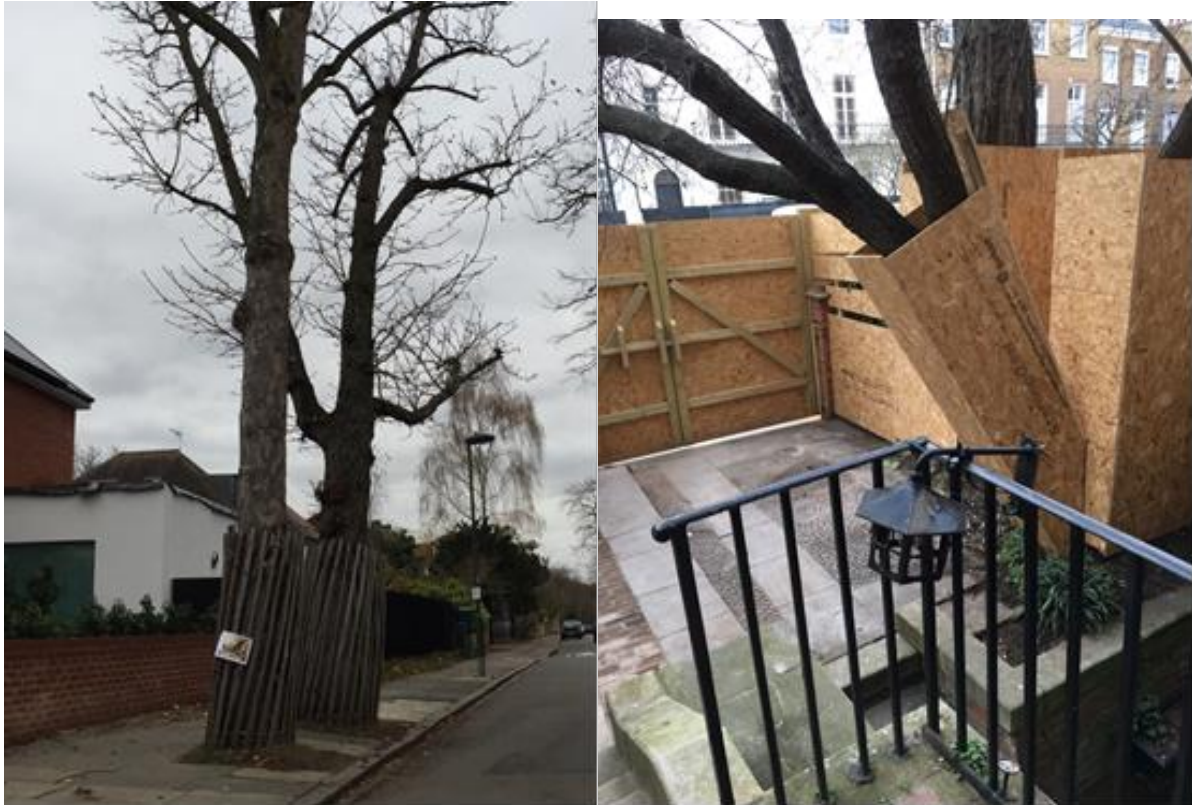
**Photo 2:** Trees protected by hessian & chestnut pale fencing / limbs protected by wooden boxing

Where specified in the AMS, the tree(s) stem/s shall be boxed off with wooden ply boards or wrapped in hessian and chestnut pale fencing. This will help avoid any direct damage to tree stems from passing machinery (see photo 2).
