Flush Casement IPA Accoya Windows
Mortise and tenon jointed

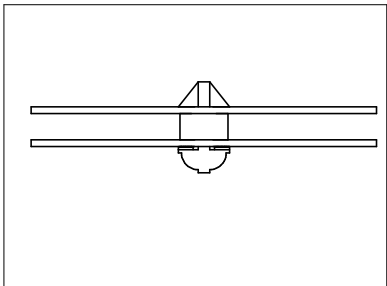
Cross section of Plant on beading
Putty bead chamfer outside
Ovolo inside

Vertical bead on top pane and horizontal beads on bottom
two panes are plant on to match width of beading on
existing windows
