### **Arboricultural Impact Assessment Method Statement & Tree Protection Plan (to BS:5837 2012)**

**Tuscany, Oak Glade, Northwood  
HA6 2TY**

Ref: TH 2440/B

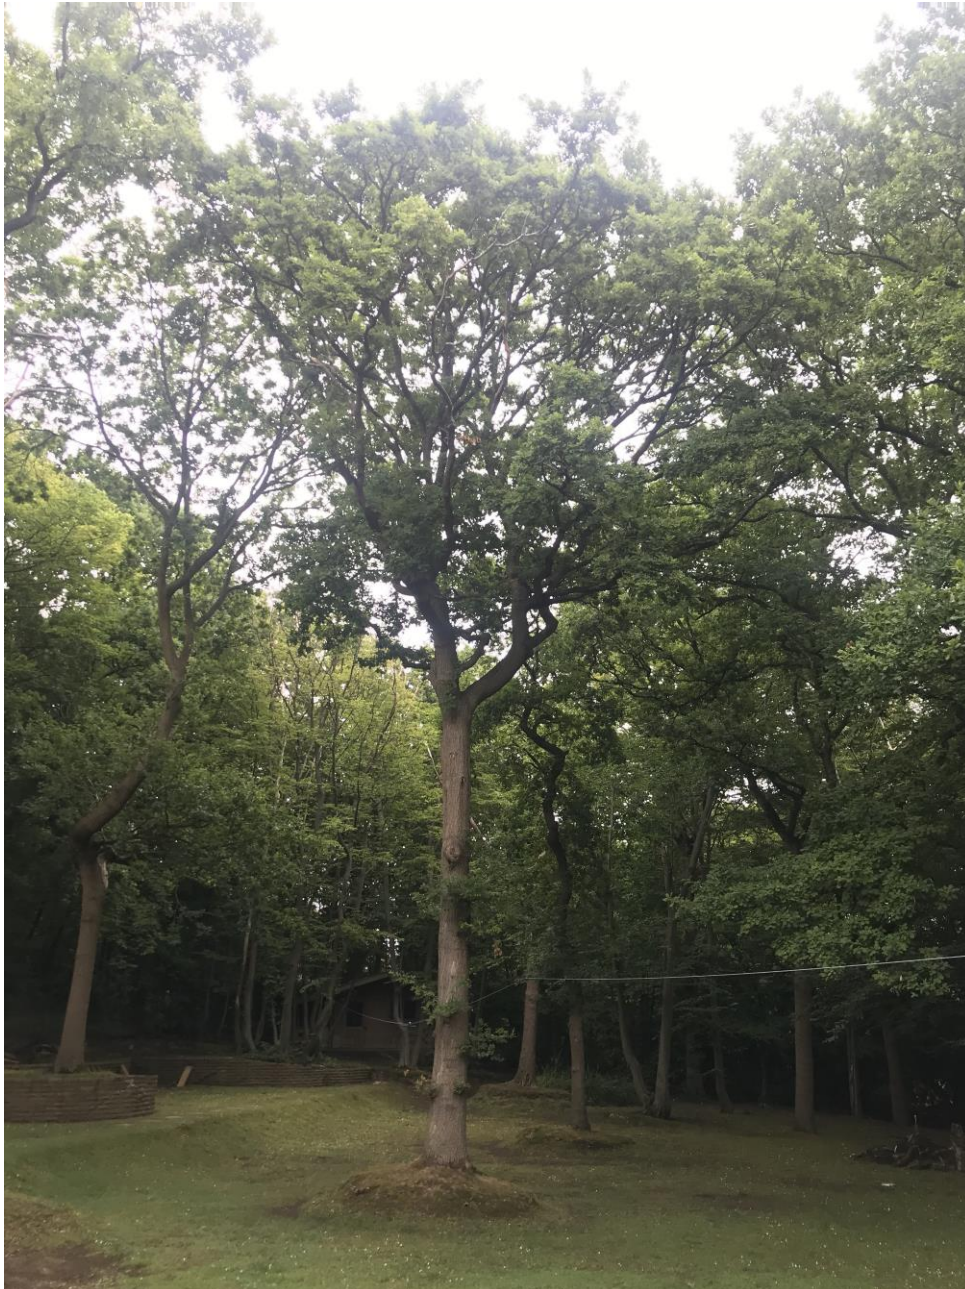
**Photo 1**

9.3.1 The proposals will require the removal of six trees. Most are low value, but some are rear garden Oaks (to provide a useable rear garden space). As can be seen from the photo below, some are in raised planters and it appears others were once in raised planters that have been removed. Subsequently, the ground levels around these trees are uneven and practically unusable.

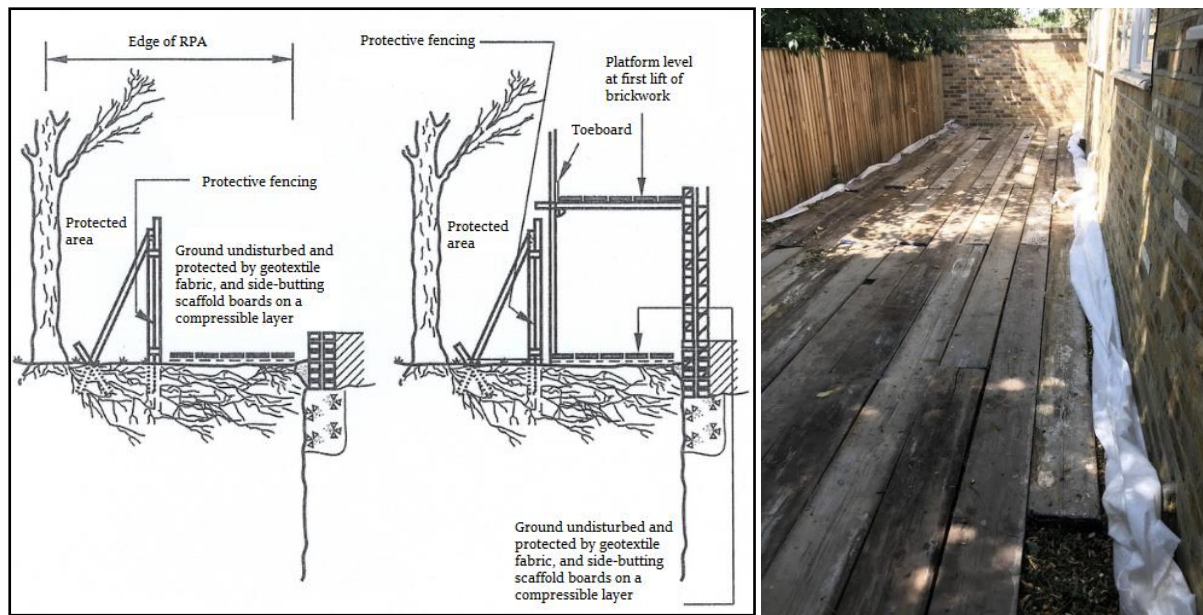
**Figure 1:** An example of ground protection on work areas within a RPA (BS 5837:2005).

All ground protection is to be maintained in good order, so it is fit for purpose throughout development. The ground protection will not be altered in any way, or prematurely removed without prior consent of the project arboriculturist or the LPA arboricultural officer.

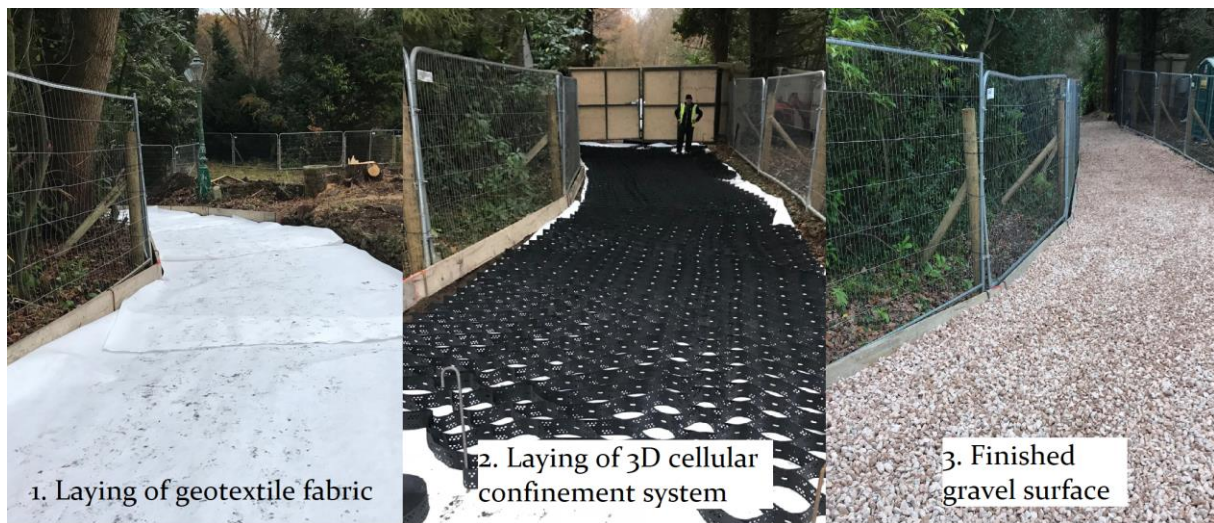
**Photo 3:** Three stages of a 'no-dig' driveway under construction.

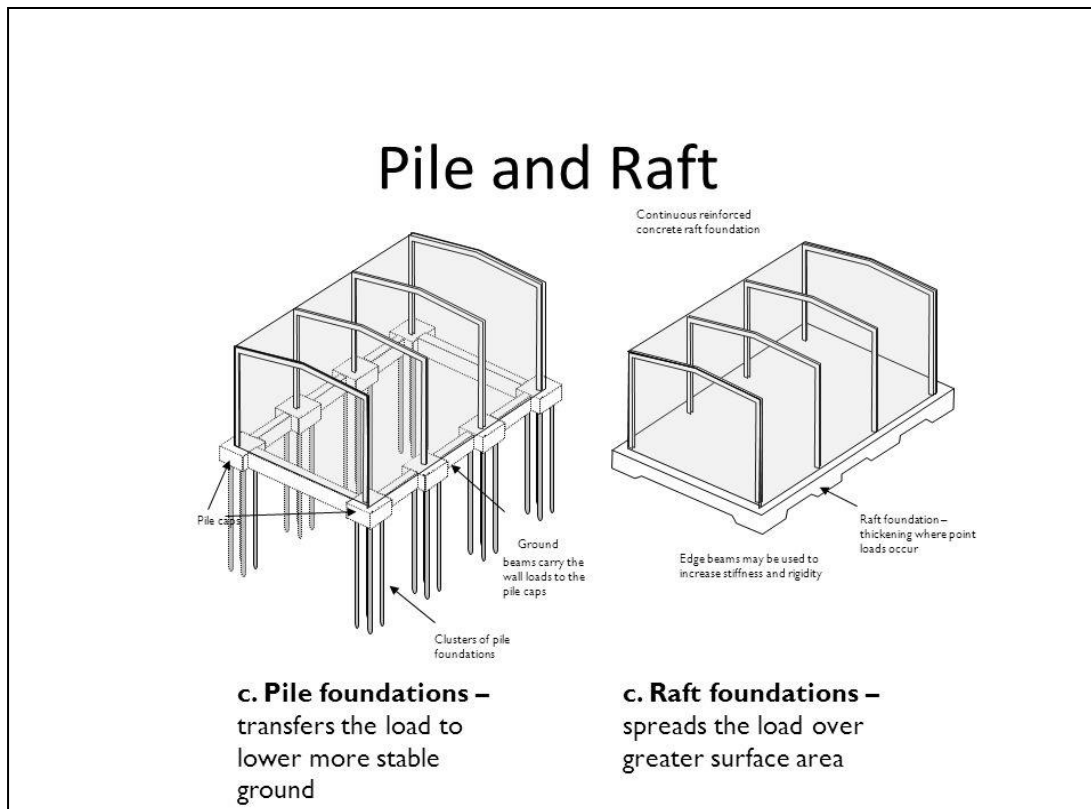
**Figure 3:** A good example of commonly used non-invasive foundations.

**Note – to avoid tree root damage, the ground beam / raft MUST sit at / above ground level.**

To minimise root disruption, non-invasive foundations (such as pile and beam or ground screws) will be used to support the structure and the following guidance shall be followed: A useful example diagram (by Professor Chris Gorse & Ian Dickinson) is provided below (Figure 3).

If roots below 25mm in diameter are discovered, they can be severed cleanly back to a suitable growth point with sharp secateurs or a sharp pull saw. If roots over 25mm in diameter are discovered, they will be bent / relocated as best as possible. If impractical, then the process (from 4.4.4) will be repeated.

When the location(s) for the piles / ground screws have been determined, the piling / screwing rig (which shall be as small as practically possible) shall work from on top of suitable ground protection (see 4.1) or a pre-existing hard surface.

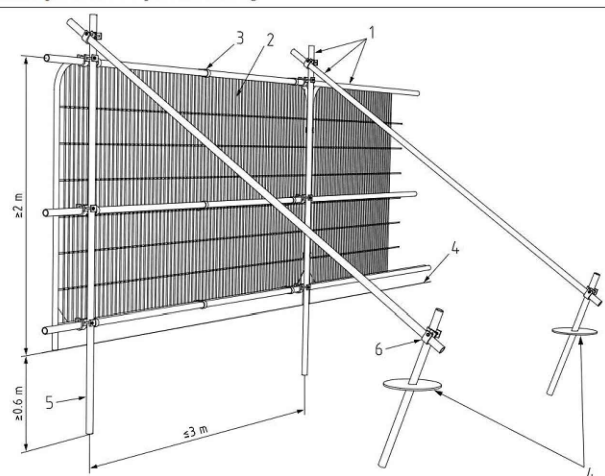
Default specification for protective fencing

- Key
- Standard scaffold poles
  - Heavy gauge 2 m tall galvanized tube and welded mesh infill panels
  - Panels secured to uprights and cross-members with wire ties
  - Ground level
  - Uprights driven into the ground until secure (minimum depth 0.6 m)
  - Standard scaffold clamps

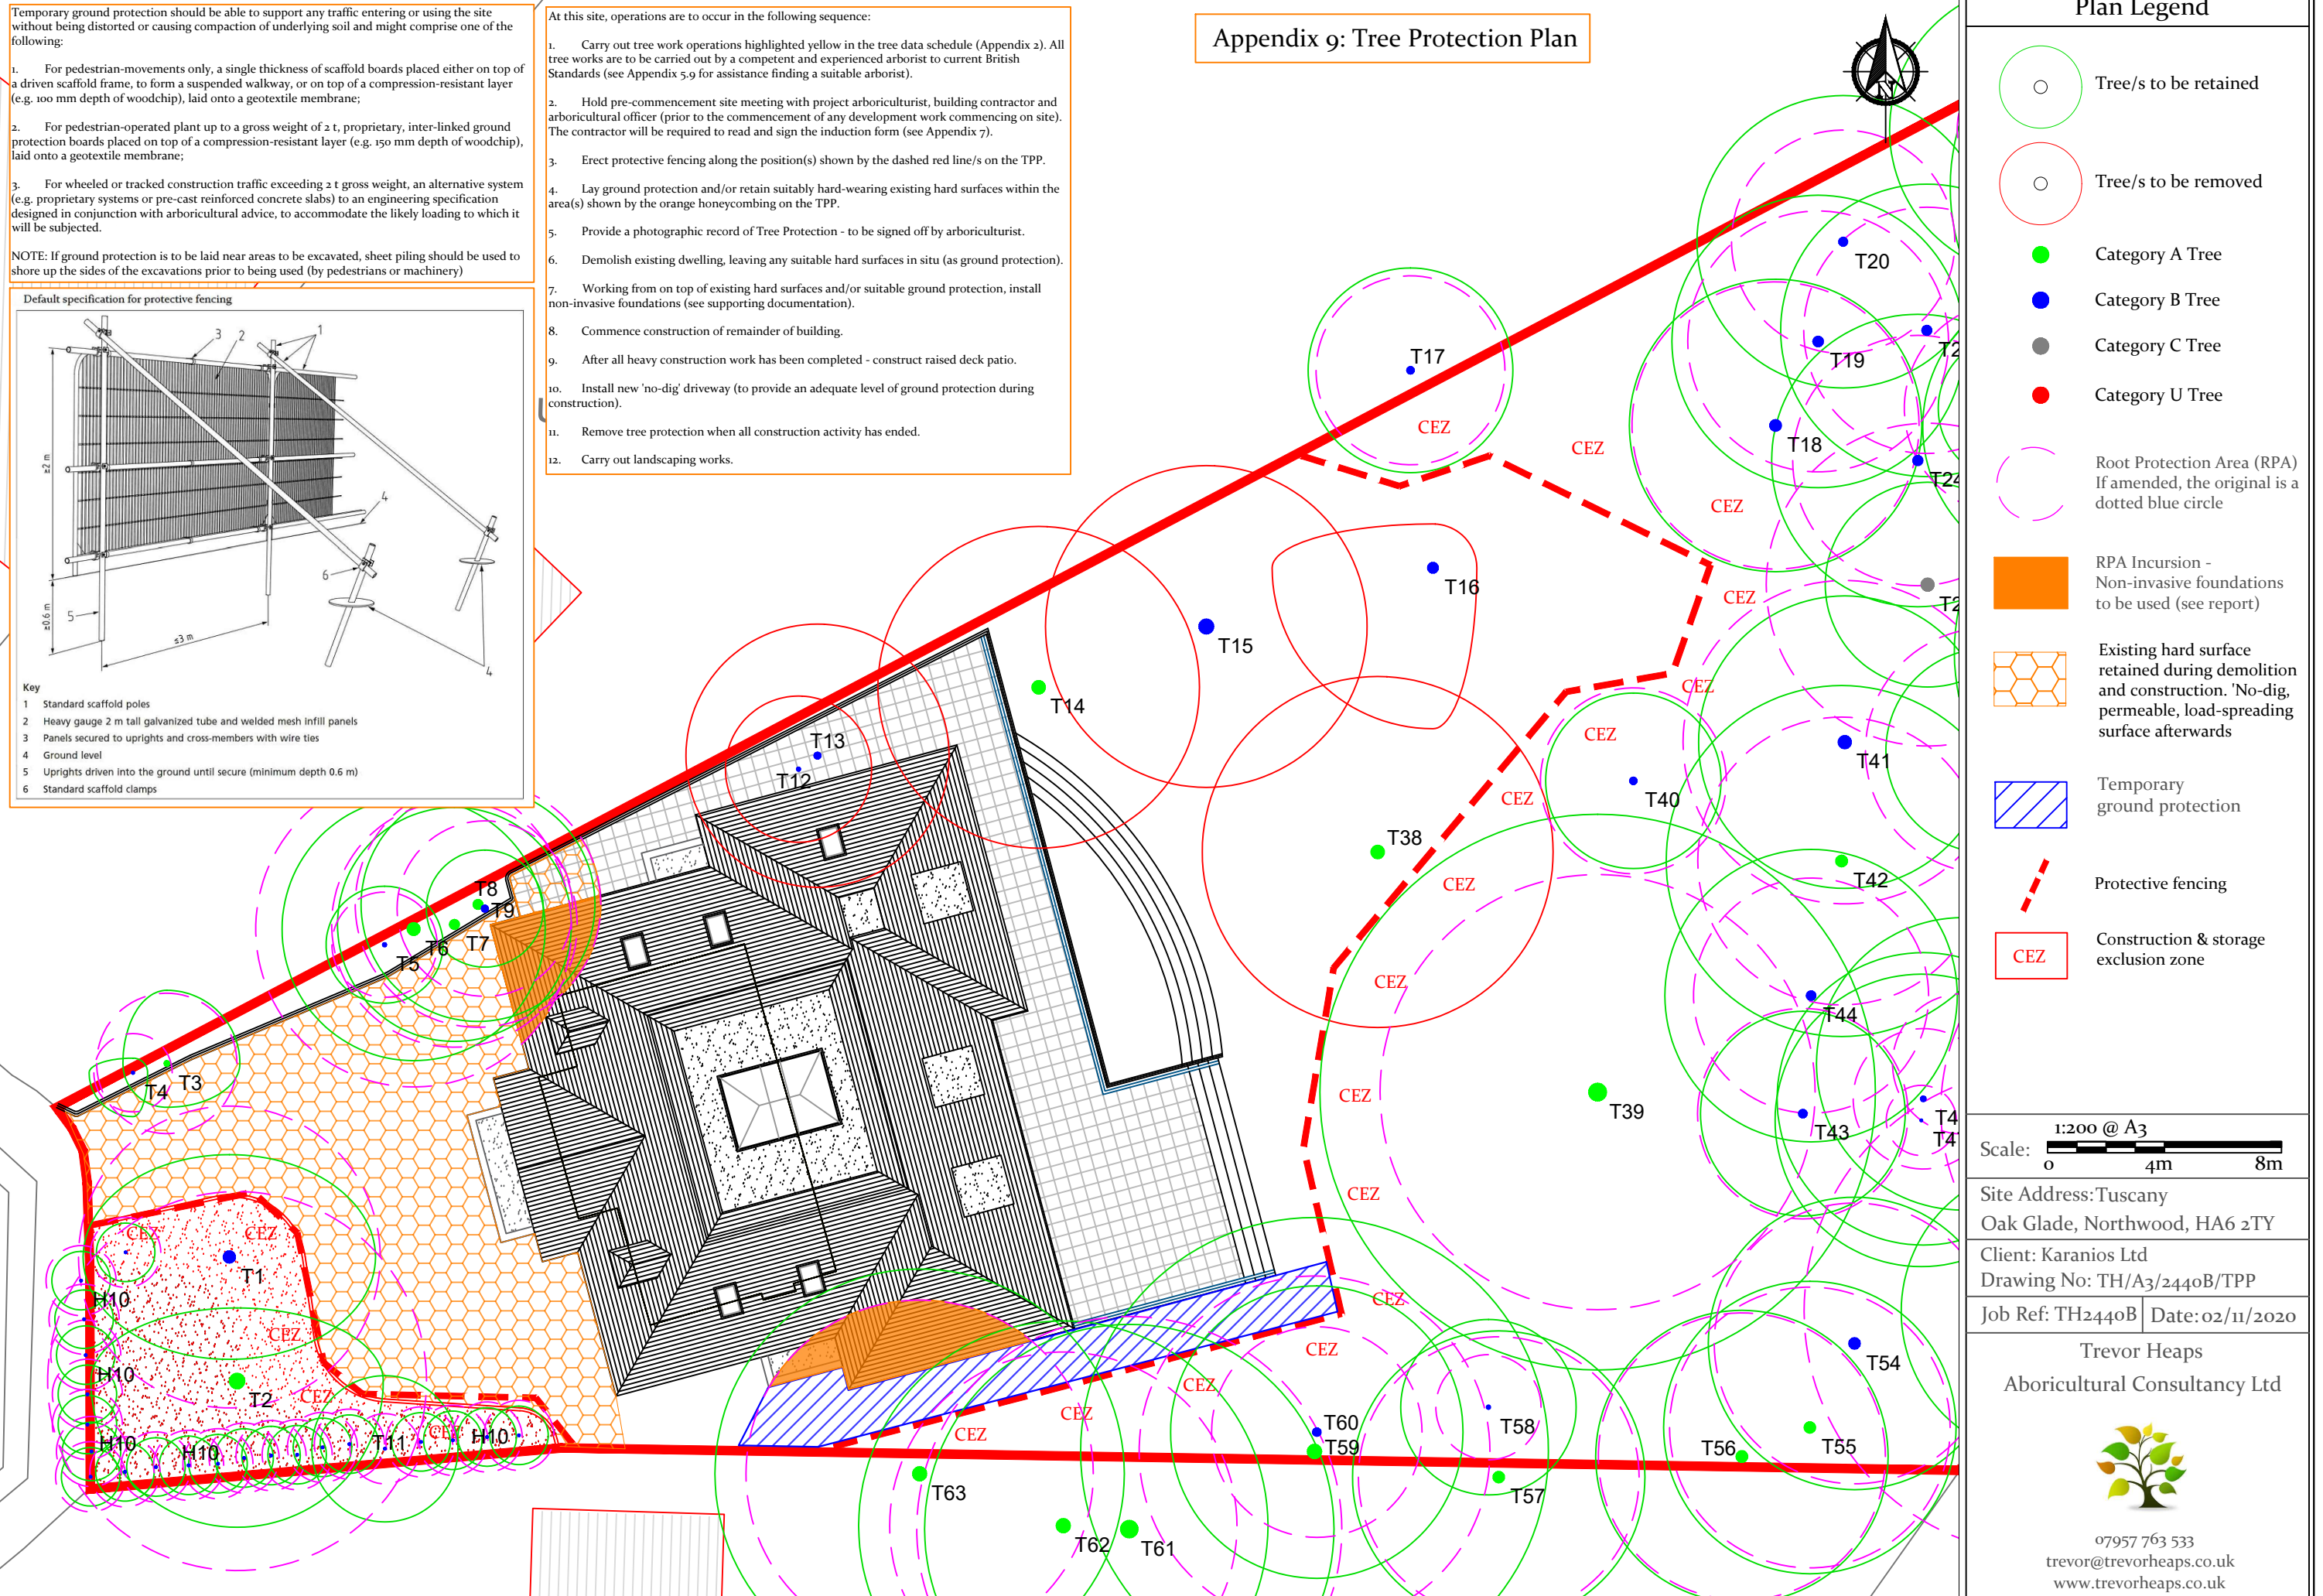
## Appendix 9: Tree Protection Plan

3. Erect protective fencing along the position(s) shown by the dashed red line/s on the TPP.
4. Lay ground protection and/or retain suitably hard-wearing existing hard surfaces within the area(s) shown by the orange honeycombing on the TPP.

11.3 This AMS should be read in conjunction with the supporting Tree Protection Plan (TPP), which is found in Appendix 9.

- Erect protective fencing along the position(s) shown by the dashed red line/s on the TPP.
- Lay ground protection and/or retain suitably hard-wearing existing hard surfaces within the area(s) shown by the orange honeycombing on the TPP.
