Arboricultural Impact Assessment Method Statement & Tree Protection Plan (to BS:5837 2012)

Former Yiewsley Swimming Pool
35 Otterfield Road, West Drayton, UB7 8PE

Prepared for L.B. Hillingdon

Ref: TH 1958

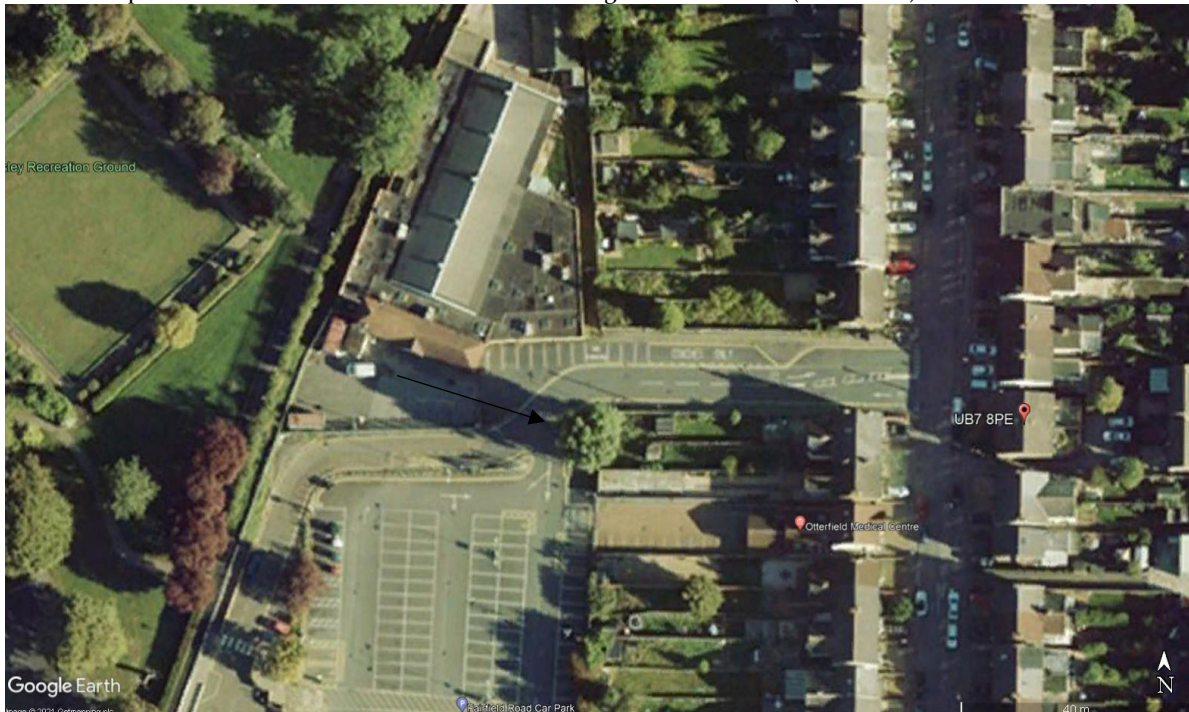
9.4.3 The existing hard surface of the access road and parking areas (see photo below) will provide ample protection for any roots of Poplar T1 growing beneath and so does not need reinforcing.

Photo 1. Poplar T1 is about centre. Note the hard surfacing around the tree (still in situ).

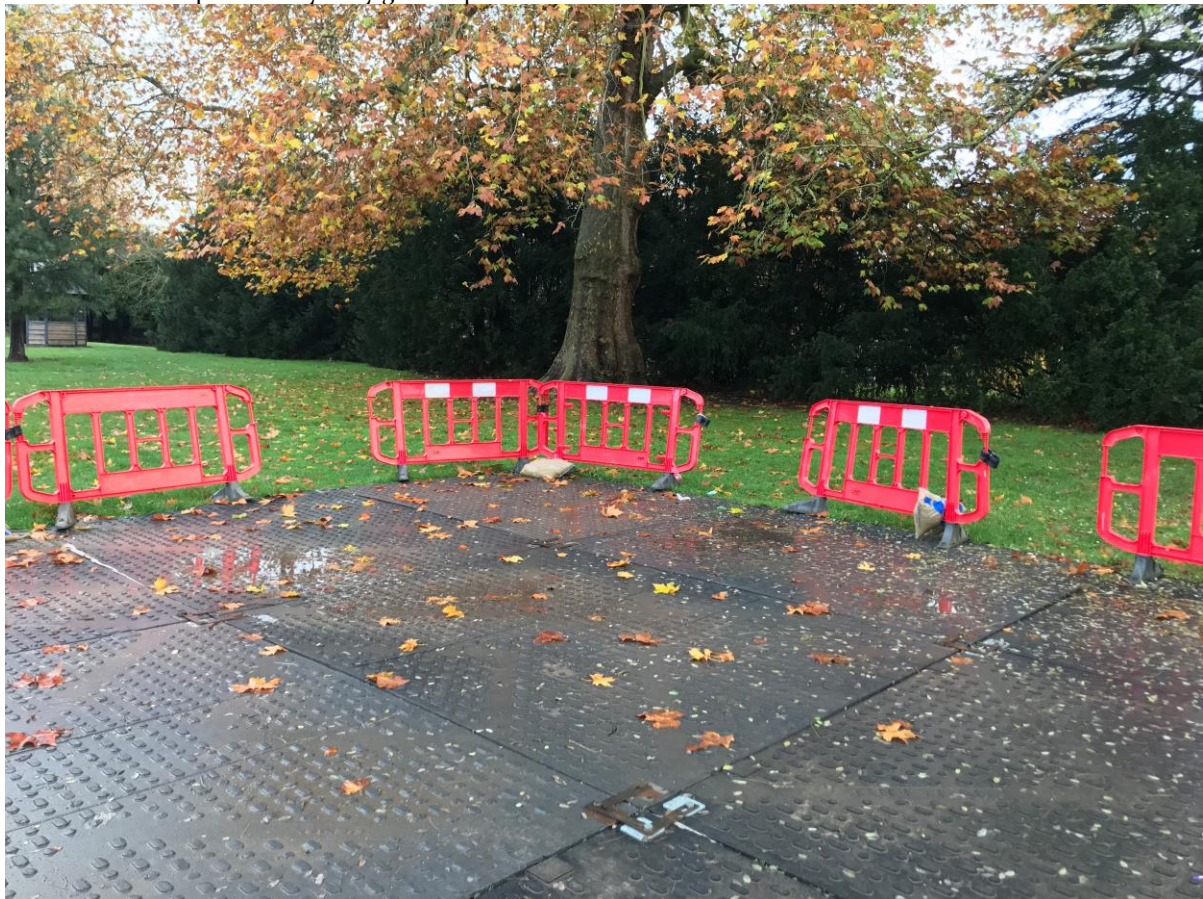
Photo 2. An example of heavy-duty ground protection.

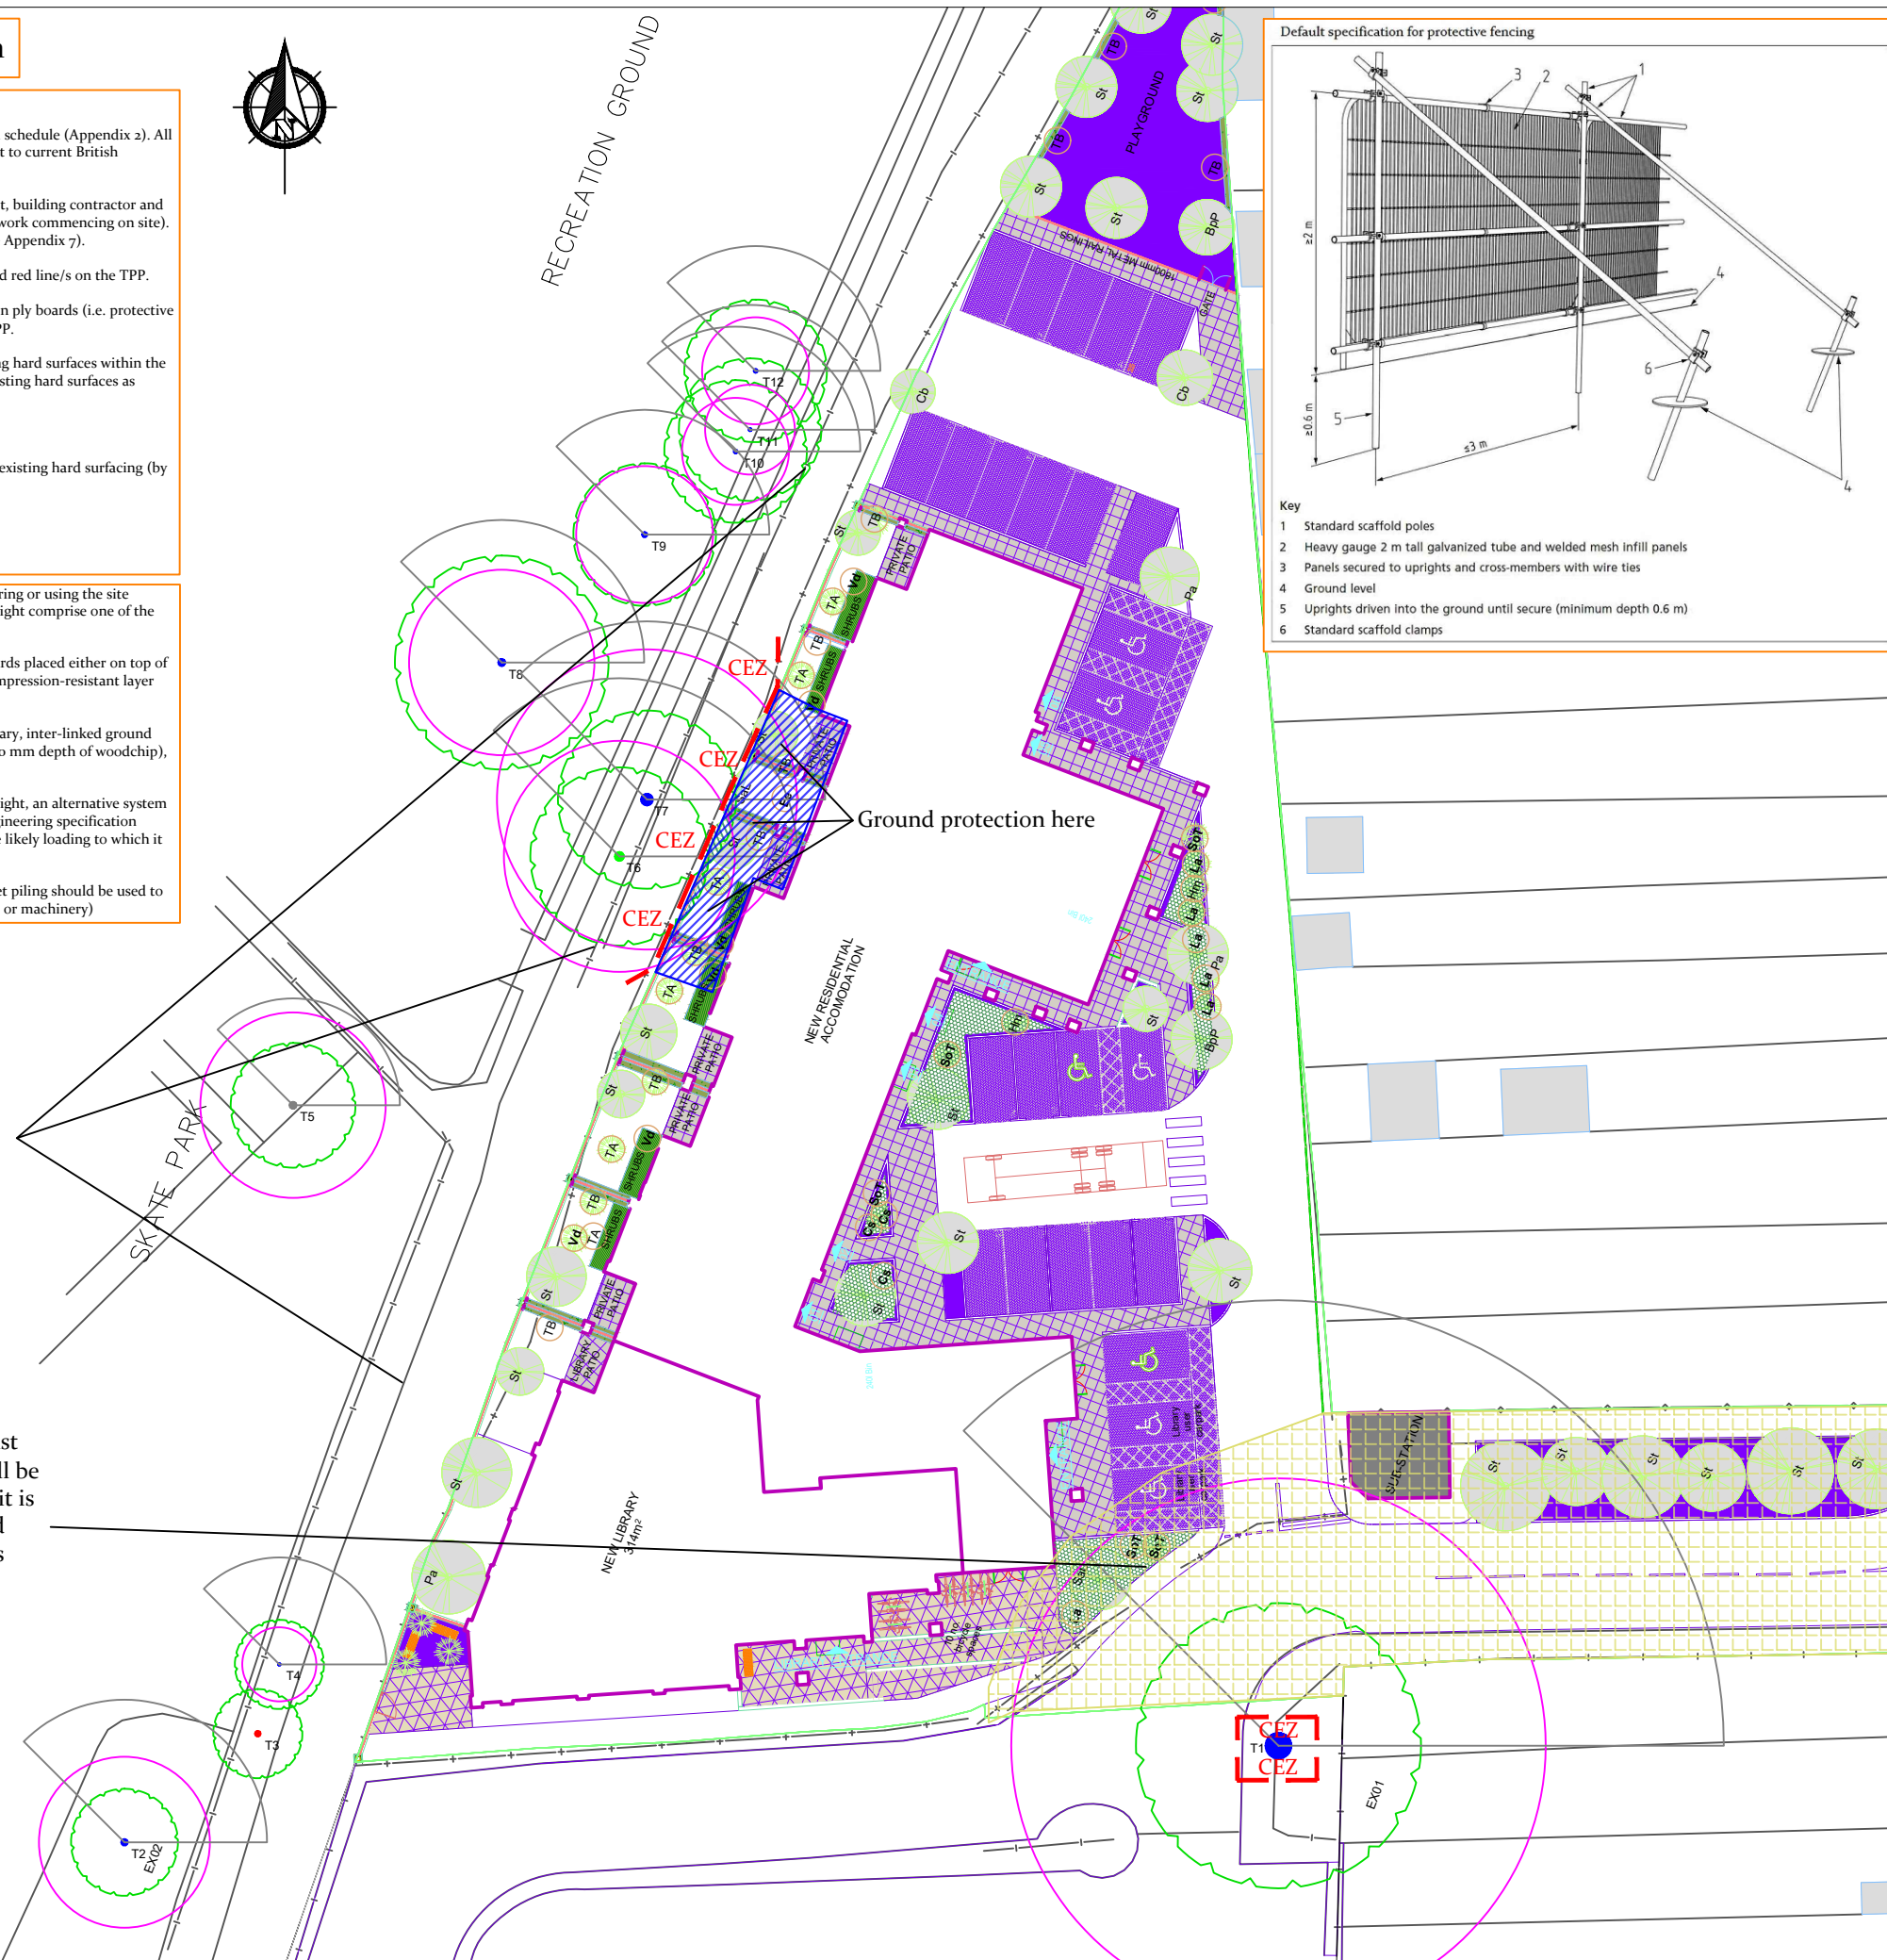
Either the existing fencing or (more likely) the new site hoarding will separate the off-site trees and hedges from the working areas

The existing hard surfaces (at least within the RPA of Poplar T1) shall be retained during construction. IF it is to be replaced, it will be removed using hand-held pneumatic drills and will be replaced with a permeable surface (with no new excavations beneath the existing sub-bases)

3. Erect protective fencing along the position(s) shown by the dashed red line/s on the TPP.
4. Protect stems of Poplar T1 from damage by boxing off with wooden ply boards (i.e. protective fencing). Location of boxing is shown by the dashed red line/s on the TPP.

5. Lay ground protection and/or retain suitably hard-wearing existing hard surfaces within the area(s) shown by the diagonal blue lines on the TPP. Retain all other existing hard surfaces as shown by the sandy coloured squares on the TPP.
