Car Park Site Selection Report

Assessment III Appendix

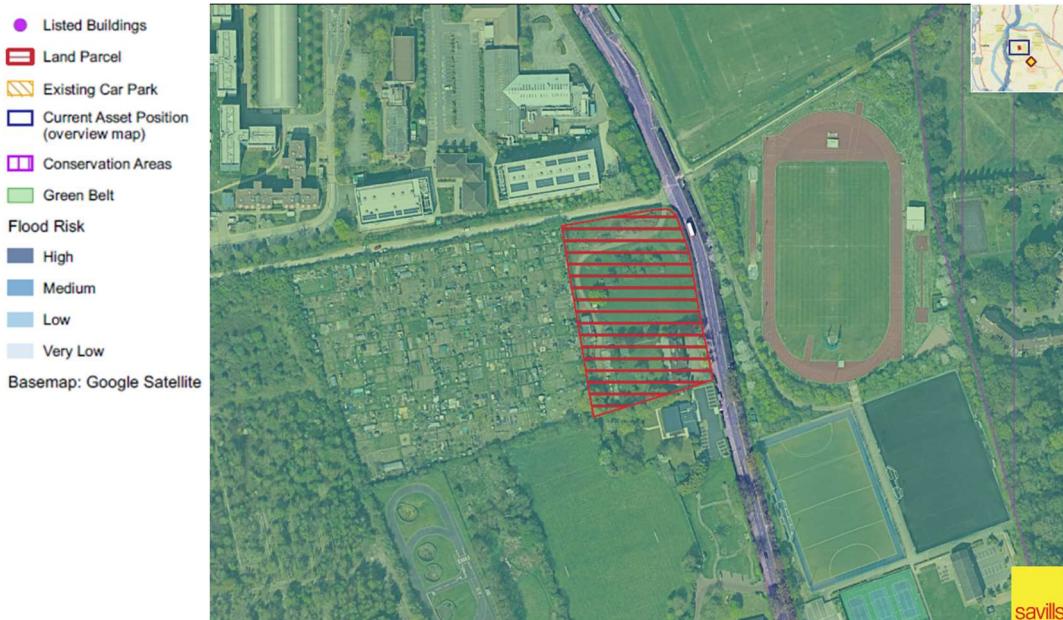
Above – Parcel of land opposite the Brunel University Running Track aerial view

- 1.2 This site is located on a parcel of land bordered by Kingston Lane and Nursery Lane, postcode UB8 3PQ.
- 1.3 It is owned by Brunel University London and sits opposite the Brunel University Running Track. Allotments are located to west of the site and a residential dwelling to the south.

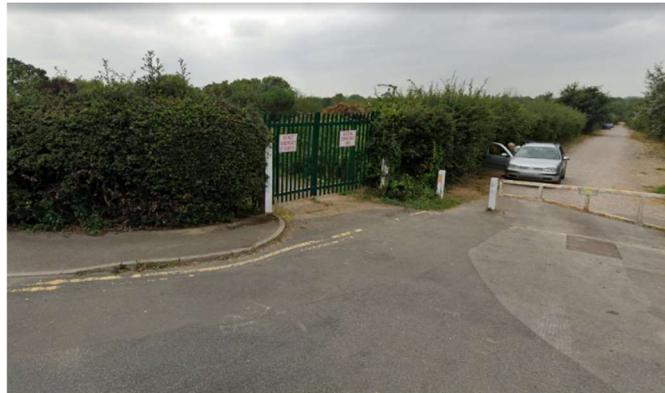
1.4 Access is available coming off the intersection of Nursery Lane and Kingston Lane.

Above – Access to Land Adjacent to Brunel Running Track

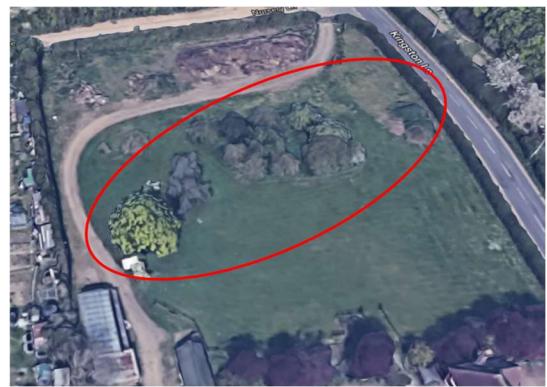
Above – Existing trees on Site 1

1.5 This site would have to be cleared for development which would include the removal of any trees/shrubs. It will require the construction of a surface car park with grasscrete and tarmac surface.

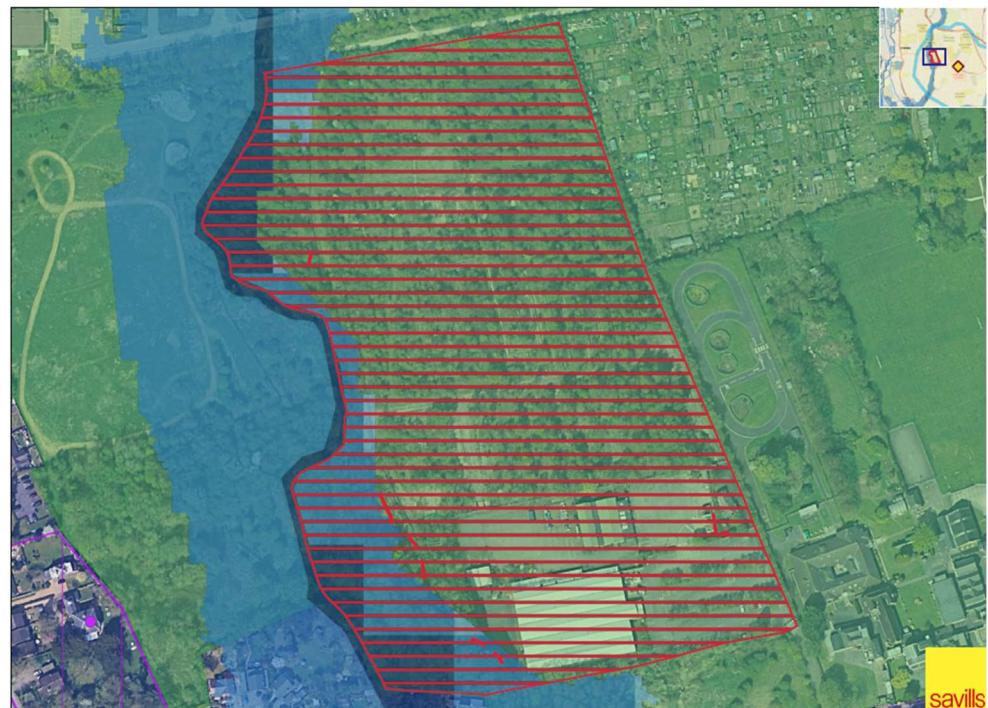
Above – Aerial view of former garden centre and surrounding land

1.10 The selected site is made up of the former garden centre building this includes a large single storey building along the southern end of the site and a number of smaller buildings. The site also contains an existing car park and to the north established woodland.

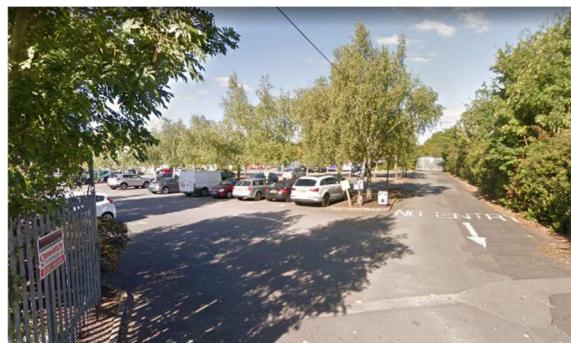
Above – Car park in use for the former garden centre

1.20 The temporary car park could not rely on the existing car park alone. Currently the main car park comprises of 142 spaces and a further 46 spaces located to the north. For all the parking to be located on one site, this would require either the removal of existing buildings and/or the removal of trees and shrub land to the north of the Garden Centre and Car Park.

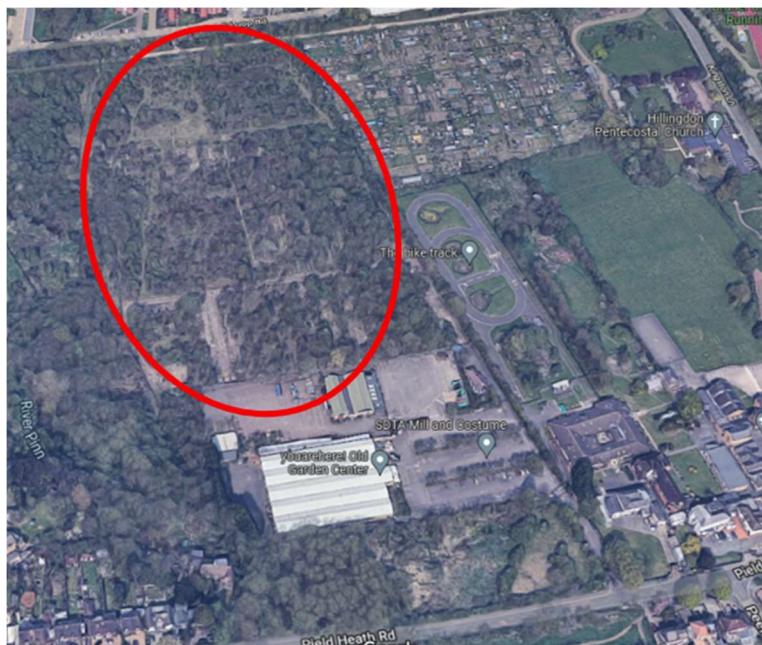
1.17 The surrounding vegetation greatly screens the site from being visible in the surrounding area, with deciduous woodland to the south that would be retained. There are traditional orchards on the north of the site, in order to accommodate enough parking, some of this forestry may have to be removed.

Above – Existing forestry to the north of the former garden centre

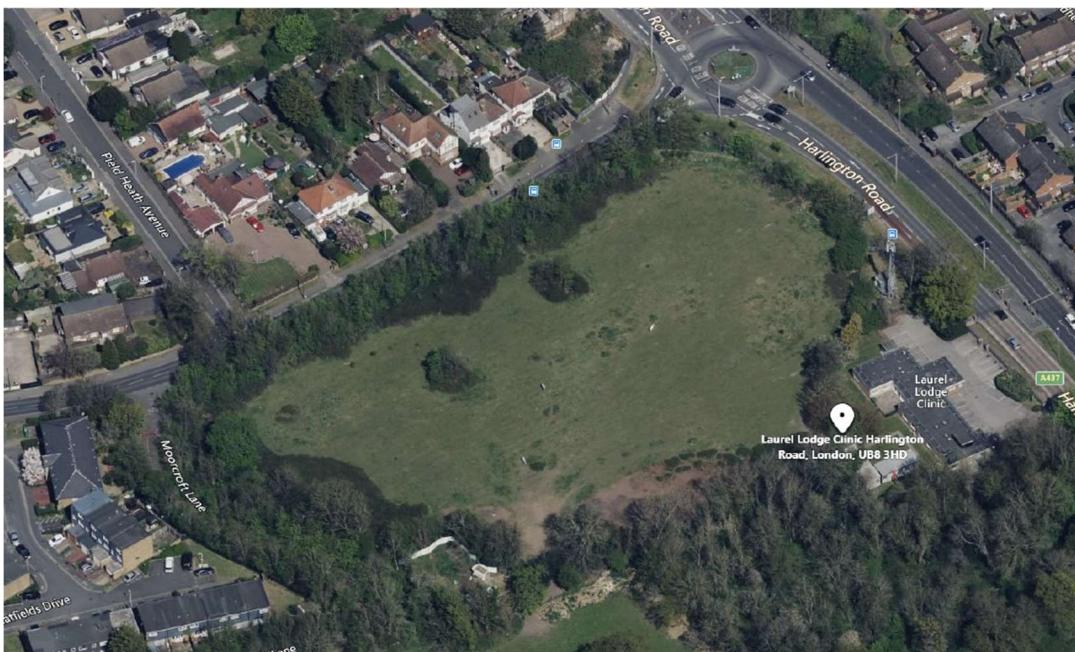
Above – Aerial view of Moorcroft Lane site

- 1.23 The Moorcroft Lane site is located approximately a 9 minute walk and a 2 minute drive from the hospital. The site is currently grassland that is used for grazing horses under an agricultural licence. It is generally flat with well-established tree belts around all of its borders. These screen the site and create a sense of enclosure.
- 1.24 To the north and east of the site is a highway (A437), and beyond this is mainly two storey dwellings. To the west is Moorcroft Lane which contains residential homes. The trees which are located along the borders of the site create screening, meaning views into the site are limited.
- 1.25 There is an existing entrance point to the site as shown in the image below. This would require some alterations to fully access the site, with the removal of some shrubs and trees potentially required.

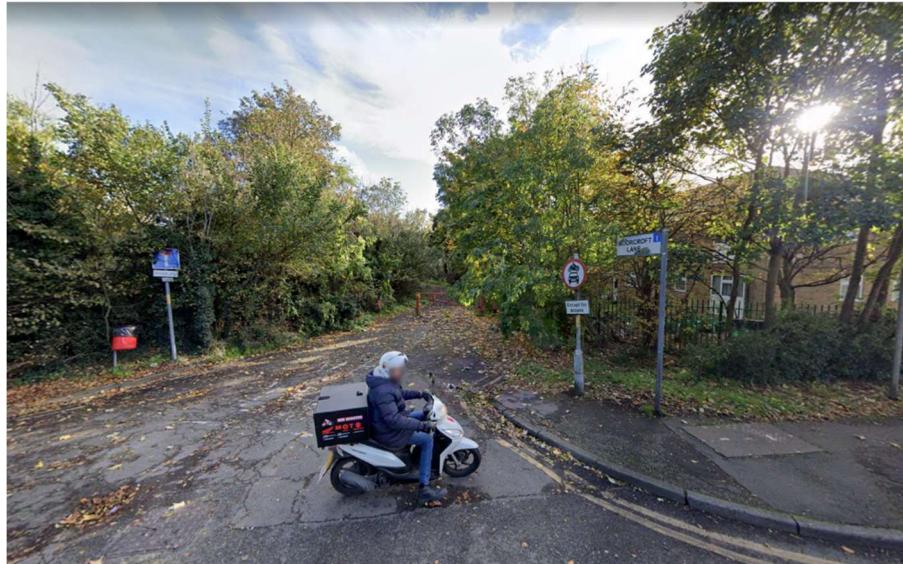
Above – Existing entrance to Moorcroft Lane site

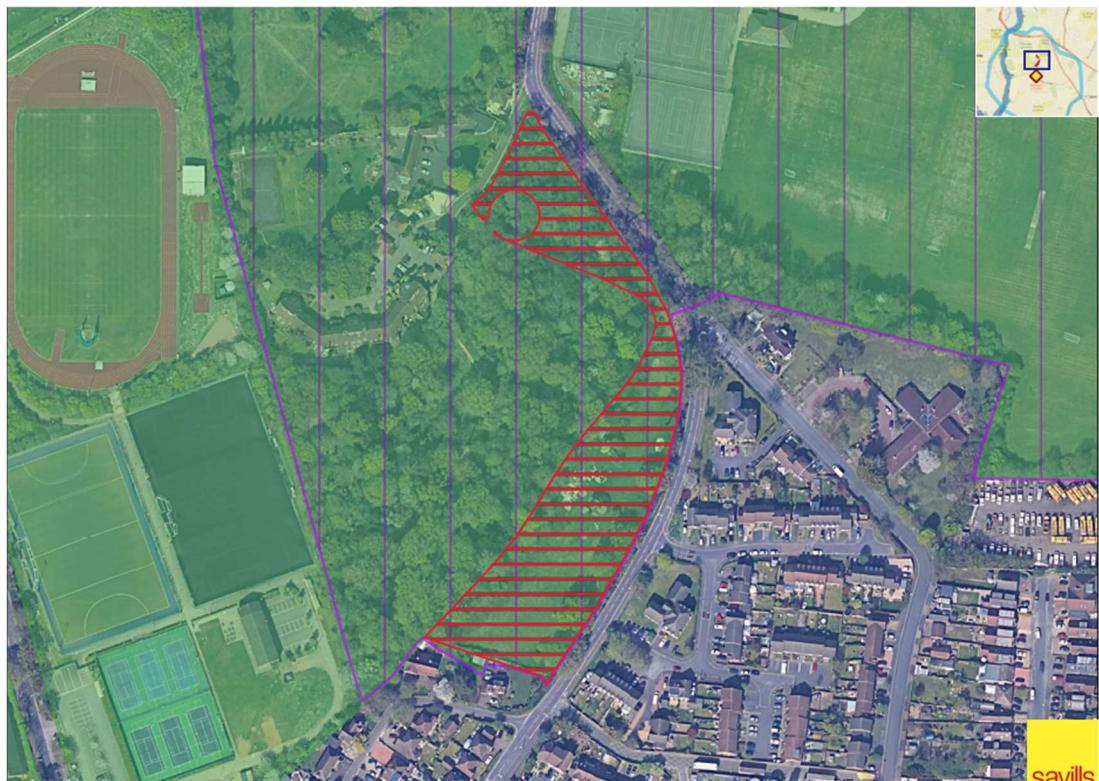
Above - Uxbridge Grove Nature Reserve aerial view

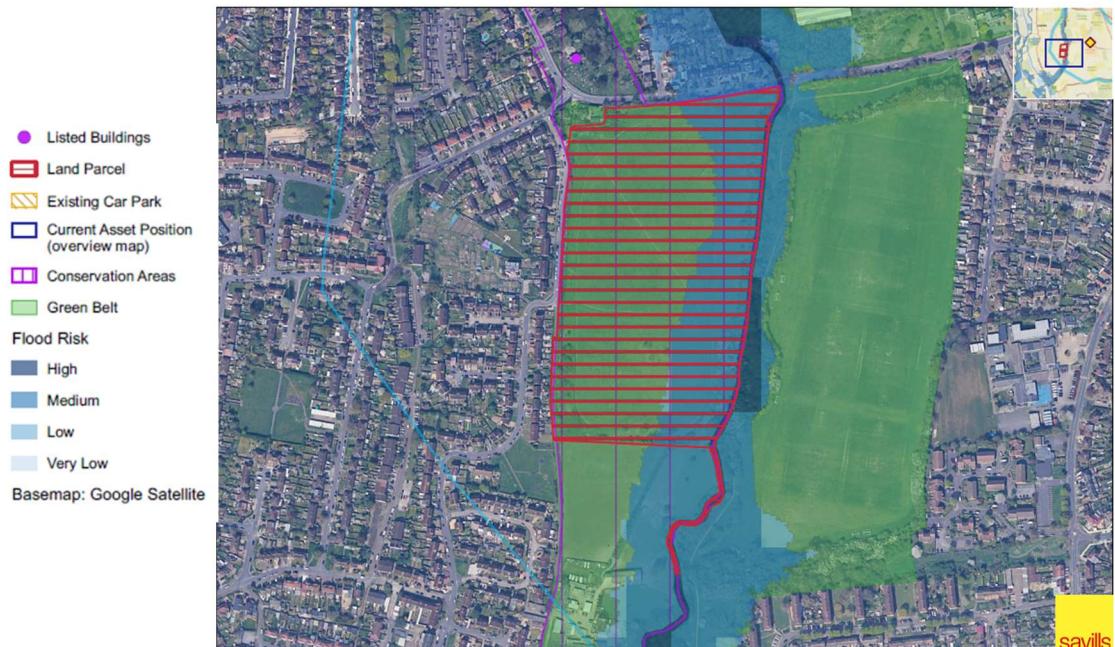
Above – Aerial view of land on the south side of Church Road, Uxbridge

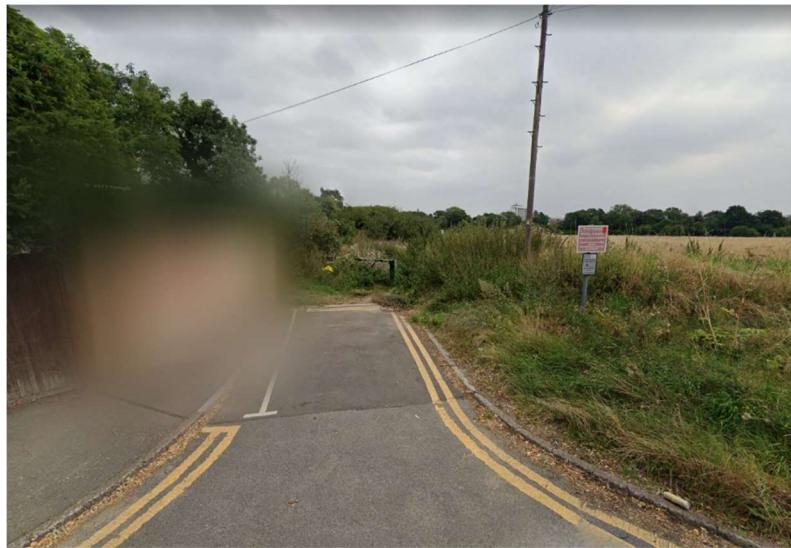
Above – Potential access point

Criteria	RAG Rating	Reasoning
Transport and Access	Red	There is no existing access. Above shows where an entrance point could be established. The site is a longer walk from the hospital of 13 minutes.
Trees and Ecology	Red	Trees are present on this site, however, they are located on the perimeter of the site, and due to the existing access tree removal is unlikely to be required. There are no ecological designations, however, as a green open space, the temporary use of a car park would likely bring harm to the local environment.
Heritage and Conservation Areas	Yellow	The site is covered by the Cowley Church (St. Laurence) Conservation Area, however, no listed buildings are present on this site.
Flooding risk	Red	A significant proportion of the site is classed as Flood Zone 3, which means that flooding is likely and this makes the site unsuitable for development.
Previously developed land/ Contamination	Green	As there is no previous development on this site, the risk of contamination is low.

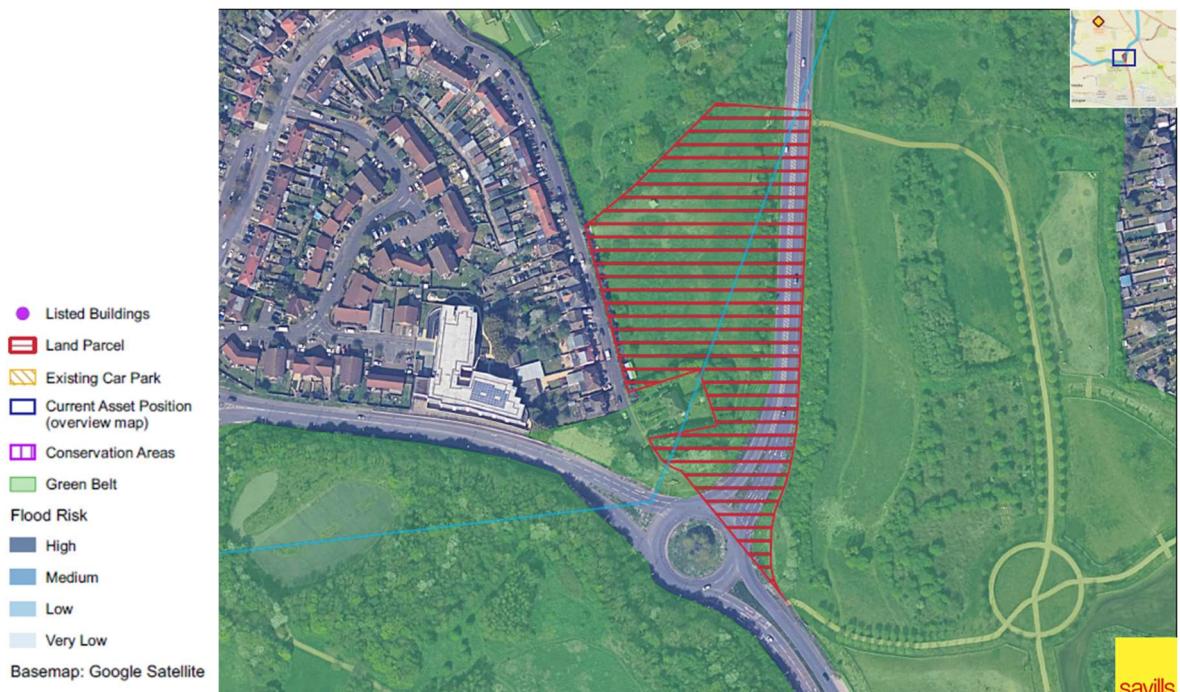
Above – Land to the east side of Chapel Lane

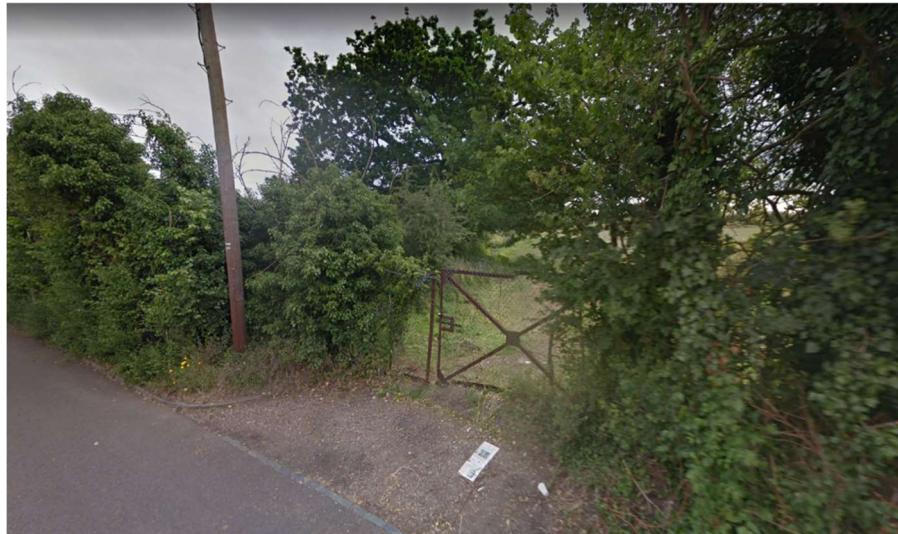
1.48 The site is a 15 minute walk from the hospital and approximately a 4 minute drive. There is currently no apparent road access to the site, and this would need to be created to accommodate the temporary car park. Creating access may be problematic, due to the high density of trees surrounds the sites perimeter. There is, however, an existing gate on Chapel Lane that could be expanded to accommodate vehicle access.

Above – Current access

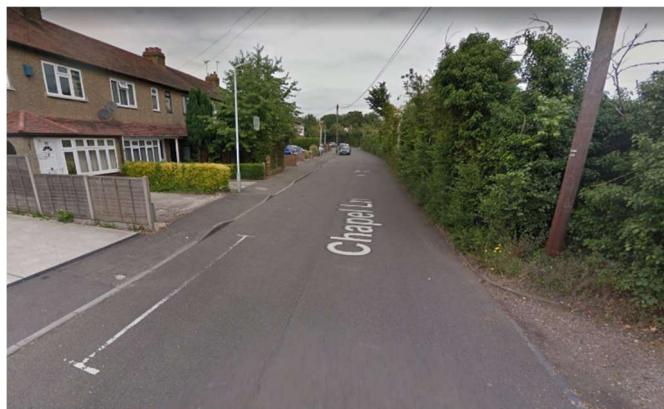
Above – Chapel Lane

1.49 Access onto Chapel Lane could lead to an increase in traffic which may be notable due to the limited width of the road. This is also a residential area, and the 24 hour use of the car park would create noise during unsociable hours. There are four driveways for existing dwellings on this road as shown in figure x, however, residents also use on street parking which could cause difficulties for vehicles accessing the car park and would mean increased traffic on the street.

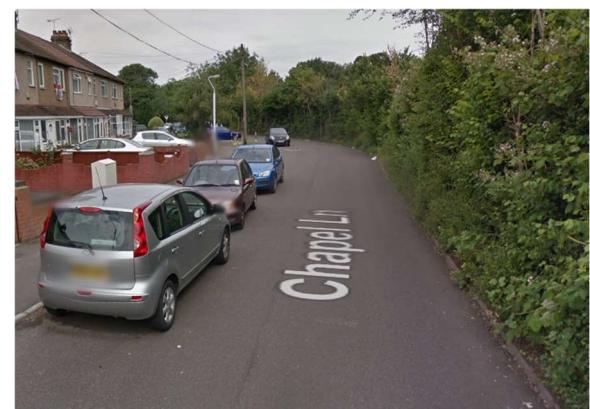
Above – On street parking reducing road width

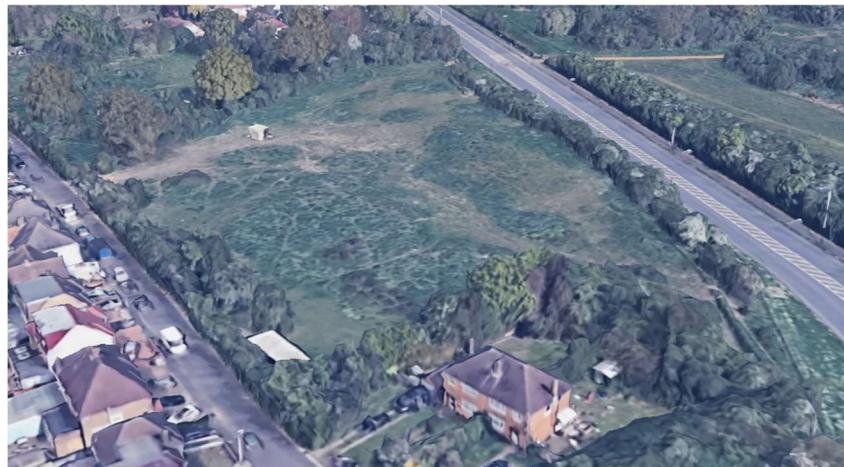
1.50 From Google Earth satellite view, it appears that the topography of the land would be challenging for the creation of a flat car park.

Above – View to the north east showing unlevel surface

1.51 This means that further remedial works would need to be implemented to level out the site, and this would increase cost and time. There would need to be efforts to level the land which would result in the loss of top soil. This could create challenges for re-growth which would be essential due to the Green Belt designation of this land.
