**London Borough of  
Hillingdon Council**

# **2<sup>nd</sup> Ickenham Scouts Group, Ickenham**

**Remediation Strategy and Verification Plan**

| ISSUE RECORD | | | | | |
|---|---|---|---|---|---|
| Report Reference: 2401020.001.01 | | | | | |

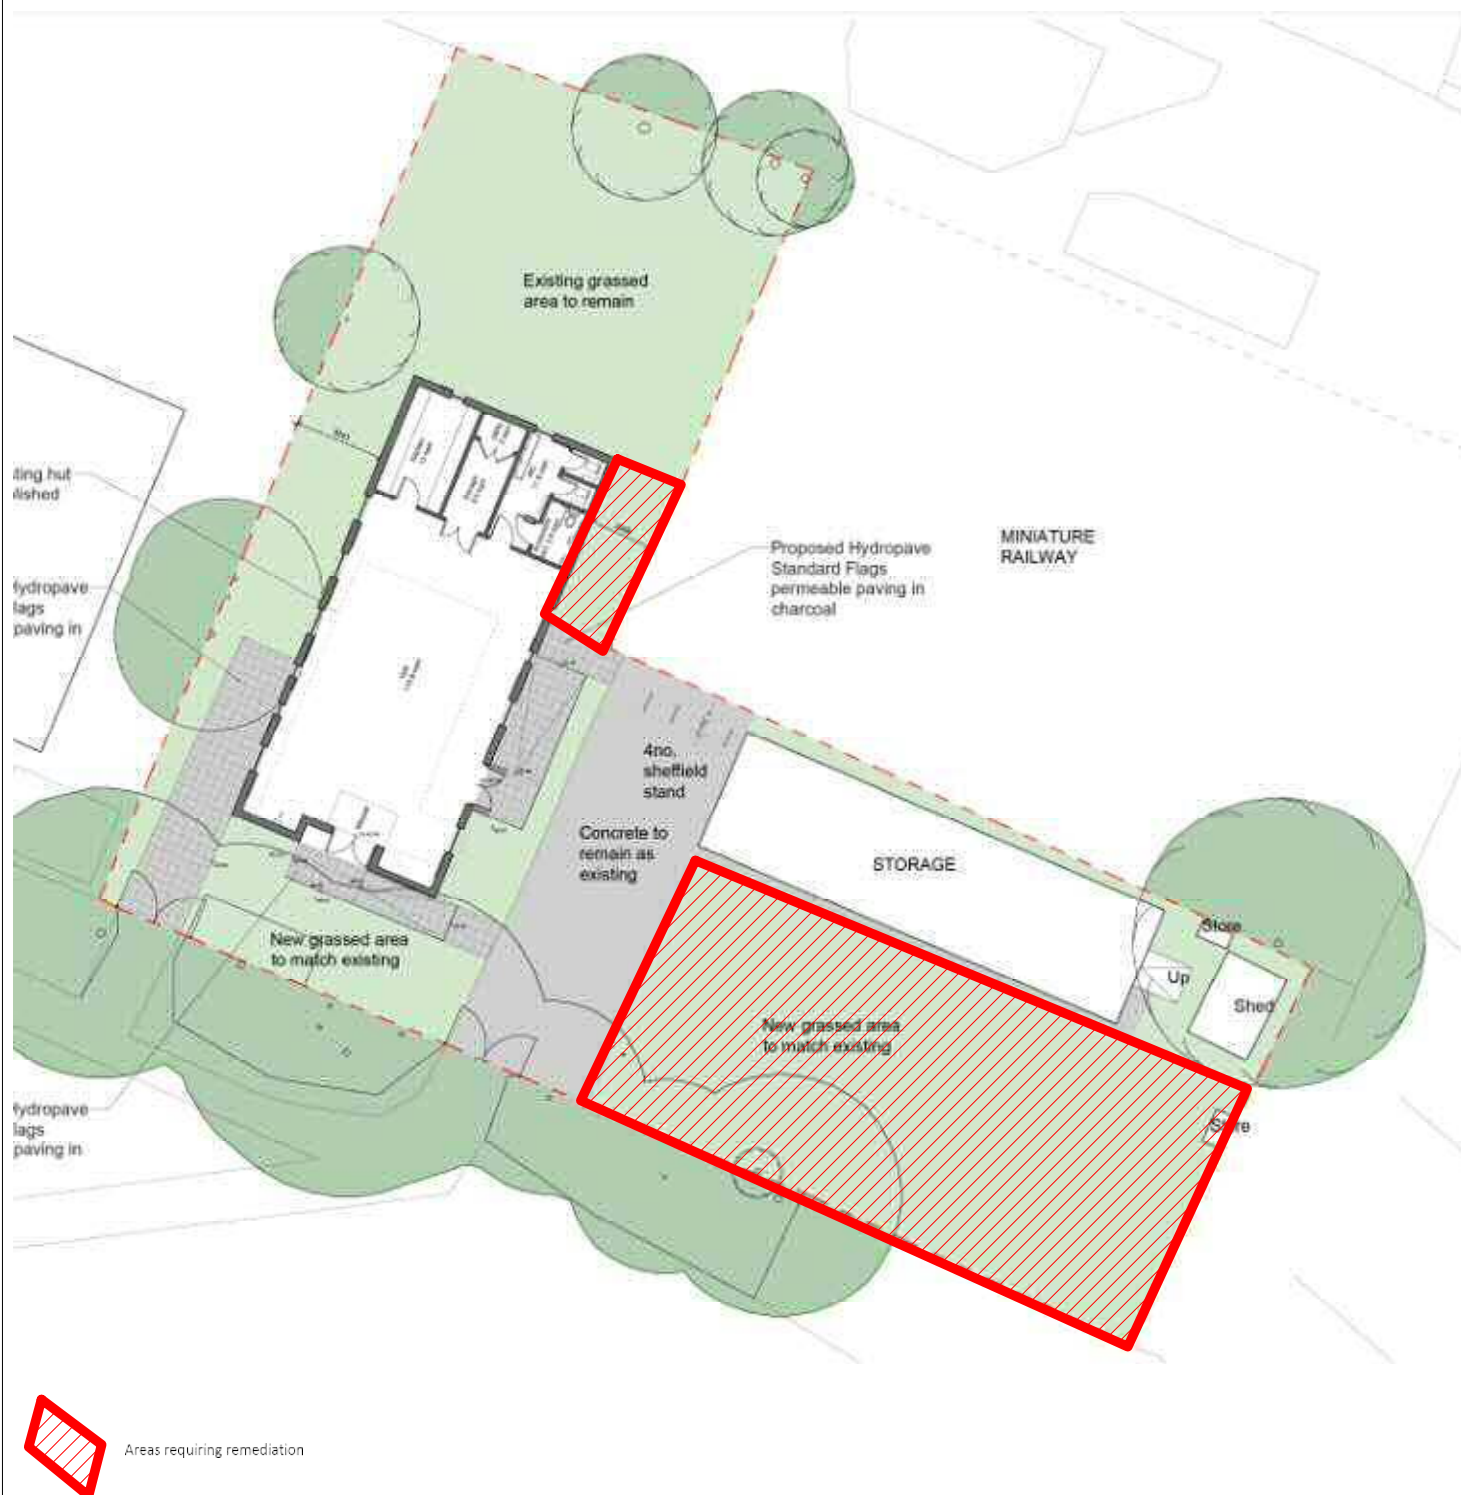
Extract of Inter Urban Studios '2nd Ickenham Scout Community Close - Proposed Site Plan'. Dwg No.: PL-03, 16.11.21.

1.2.3 The existing site plan presented within Figure 4 with the proposed development plan presented within Figure 2.

4.2.4 The proposed development layout is presented within Figure 2.

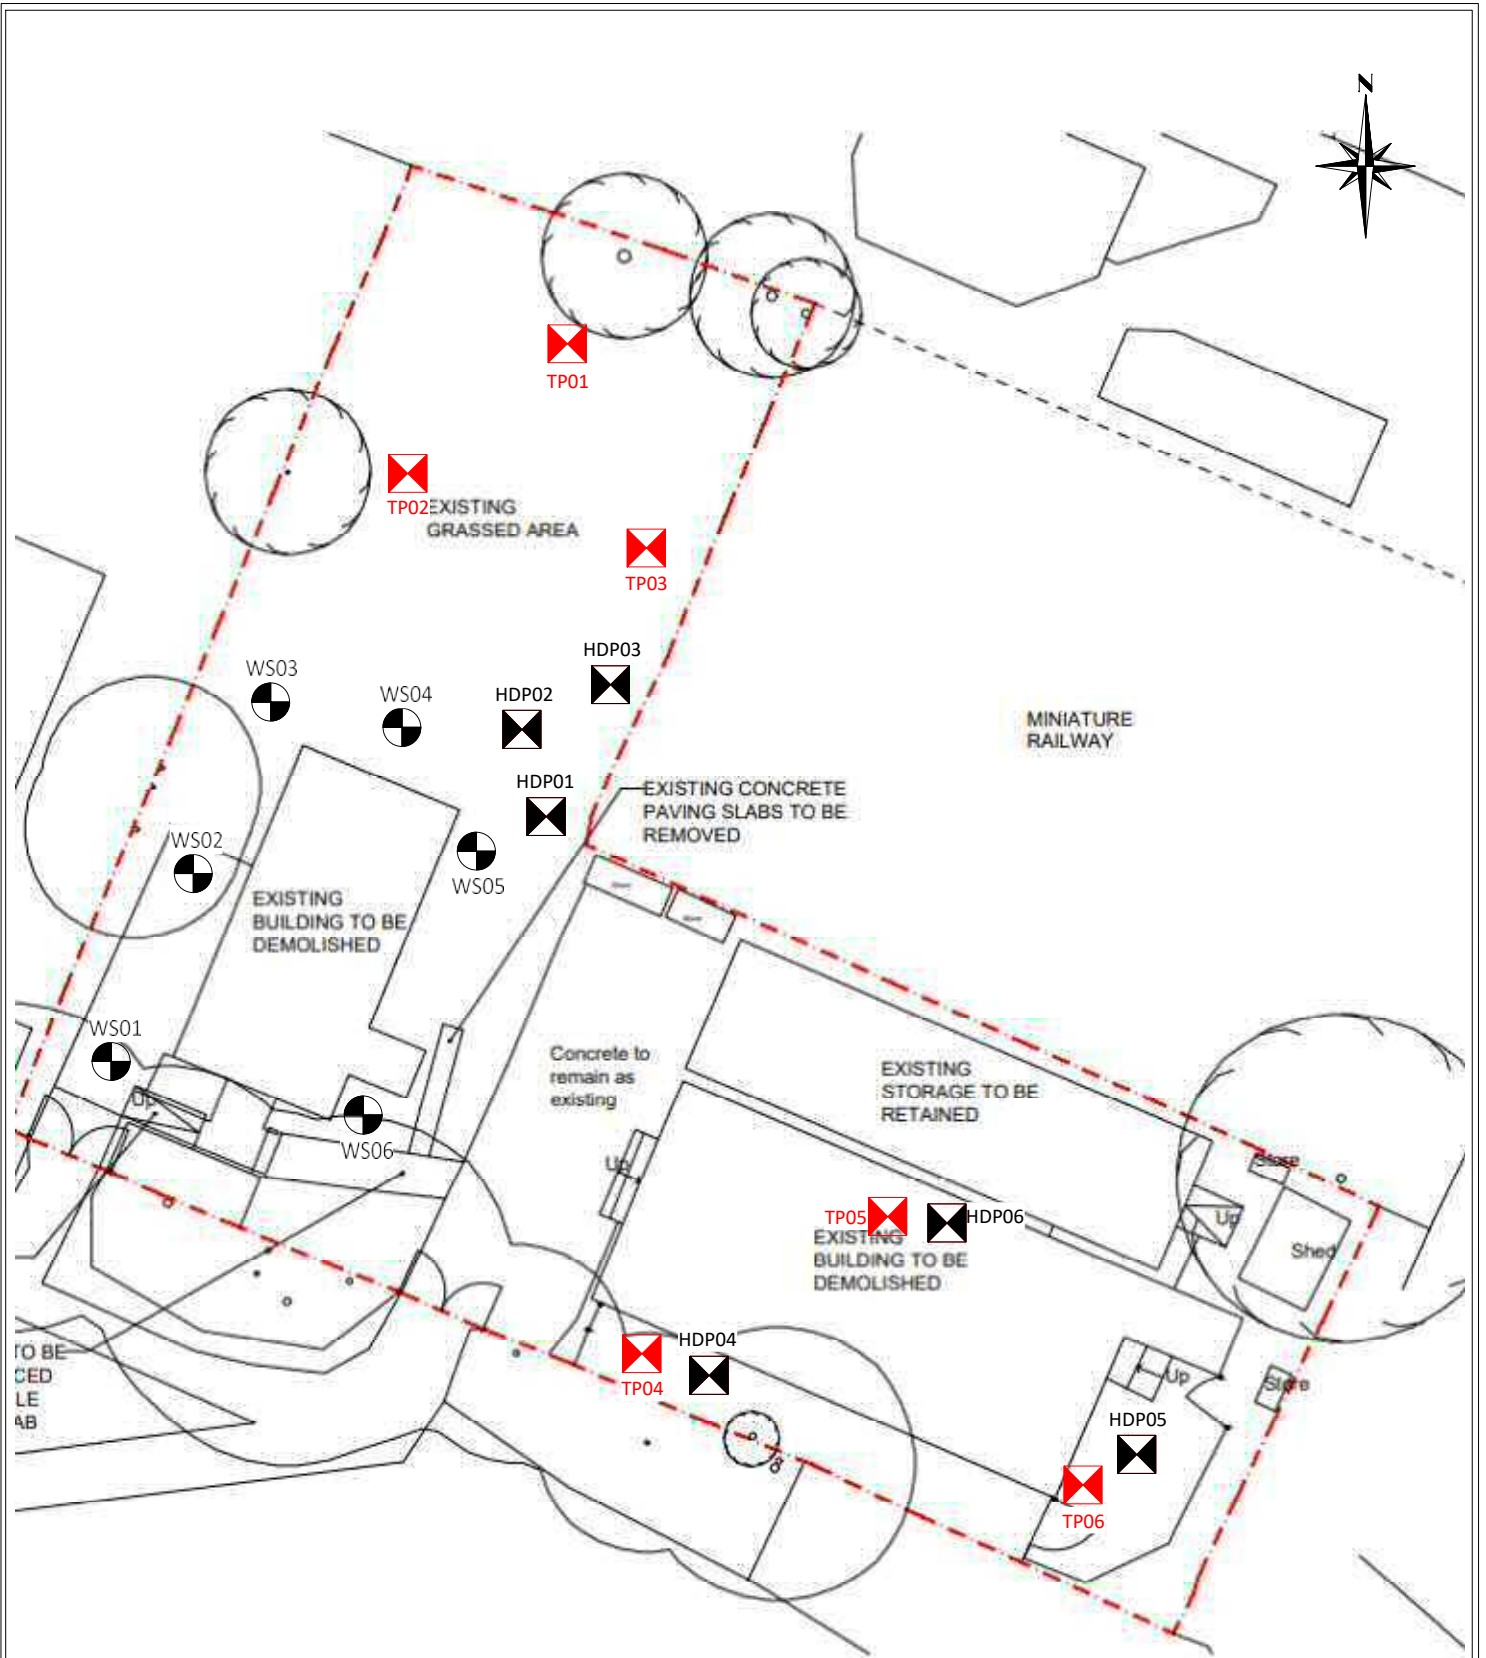
Extract of Inter Urban Studios '2nd Ickenham Scout Community Close - Existing Site Plan'. Dwg No.: TEN-03 Rev A, 21.04.22.

| <b>Methodology</b> | <p>Additional ground investigation works were undertaken on 13<sup>th</sup> June 2024.</p> <p>3No. trial pits (TP01 to TP03) were located in the north of the site within the proposed area of soft landscaping not previously sampled, and 3No. trial pits (TP04 to TP06) were located in the eastern portion of the site (within the proposed soft landscaped area which had previously been sampled in April 2024).</p> <p>The locations of all of the trial pits from the three phases of investigation are provided on Figure 4.</p> |

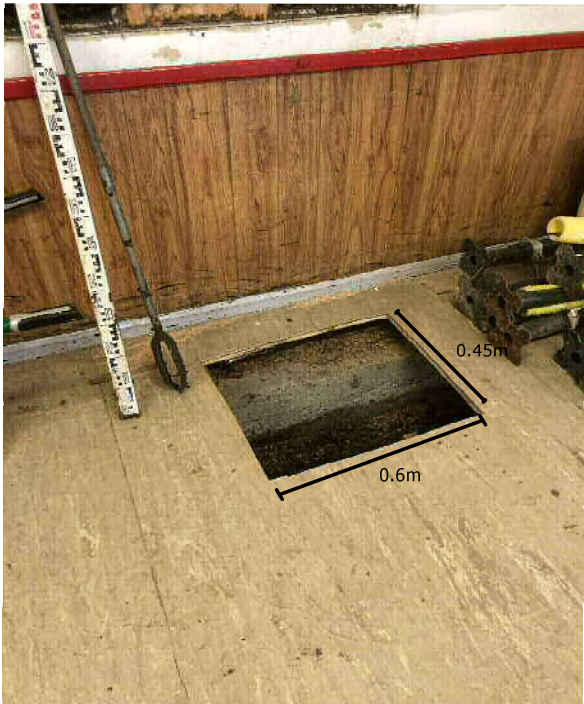
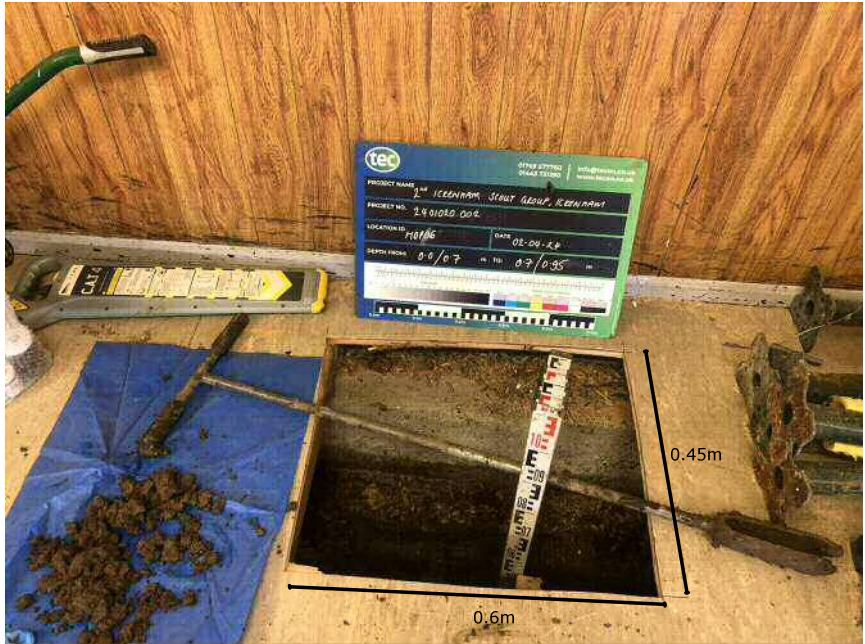
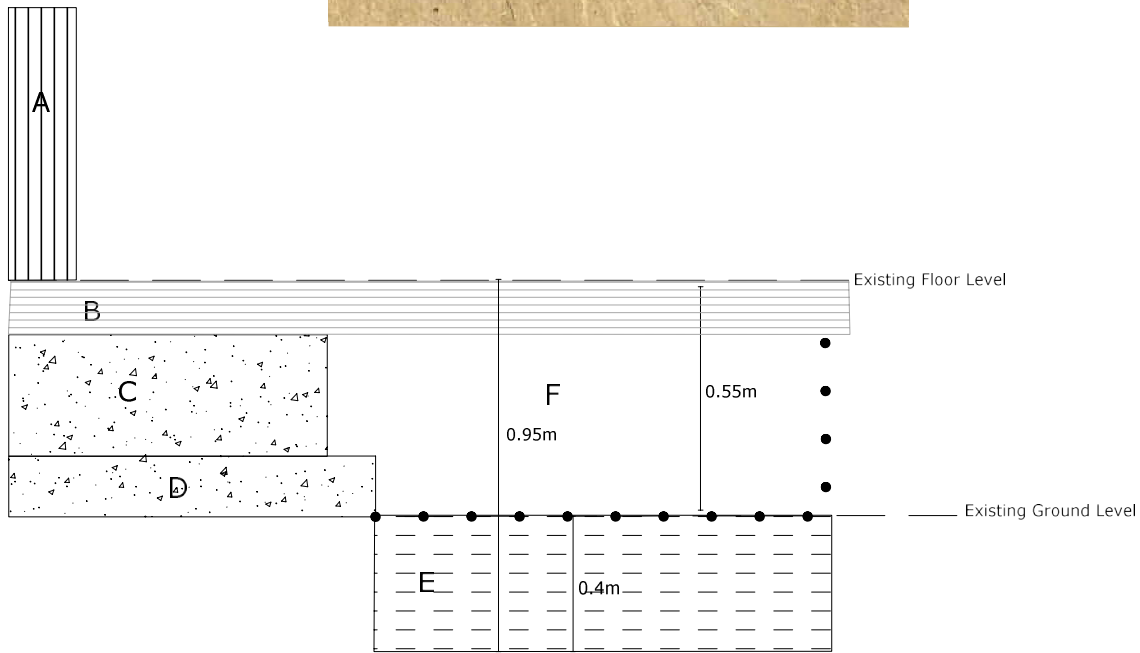
Hand Dug Pit HDP06 Section

A - Existing Wall

B - Timber Frame Floor Structure

D - Concrete Foundation

| <b>Methodology</b> | <p>Additional ground investigation works were undertaken on 2<sup>nd</sup> April 2024.</p> <p>3No. additional hand dug verification pits (HDP01 to HDP03) were excavated in proximity to WS05 from the 2021 investigation, to assist in refining the remedial requirements potentially required in this area.</p> <p>3No. additional shallow hand excavated pits (HDP04 to HDP06) were also excavated in the area of proposed soft landscaping to the east. This included 2No hand excavated pits outside of the footprint of the existing scout hut, which was still present, and a third hand excavated pit (HDP06) through the floor of the existing scout hut to provide suitable coverage of the proposed area of soft landscaping. The locations of the hand verification pits are provided on Figure 4 and a section and photos of HDP06 are provide on Figure 5.</p> |
