Arboricultural Impact Assessment 2

Squirrels
Estate,
Viveash Close,
West Drayton

September
2022

Ref: 21-8770

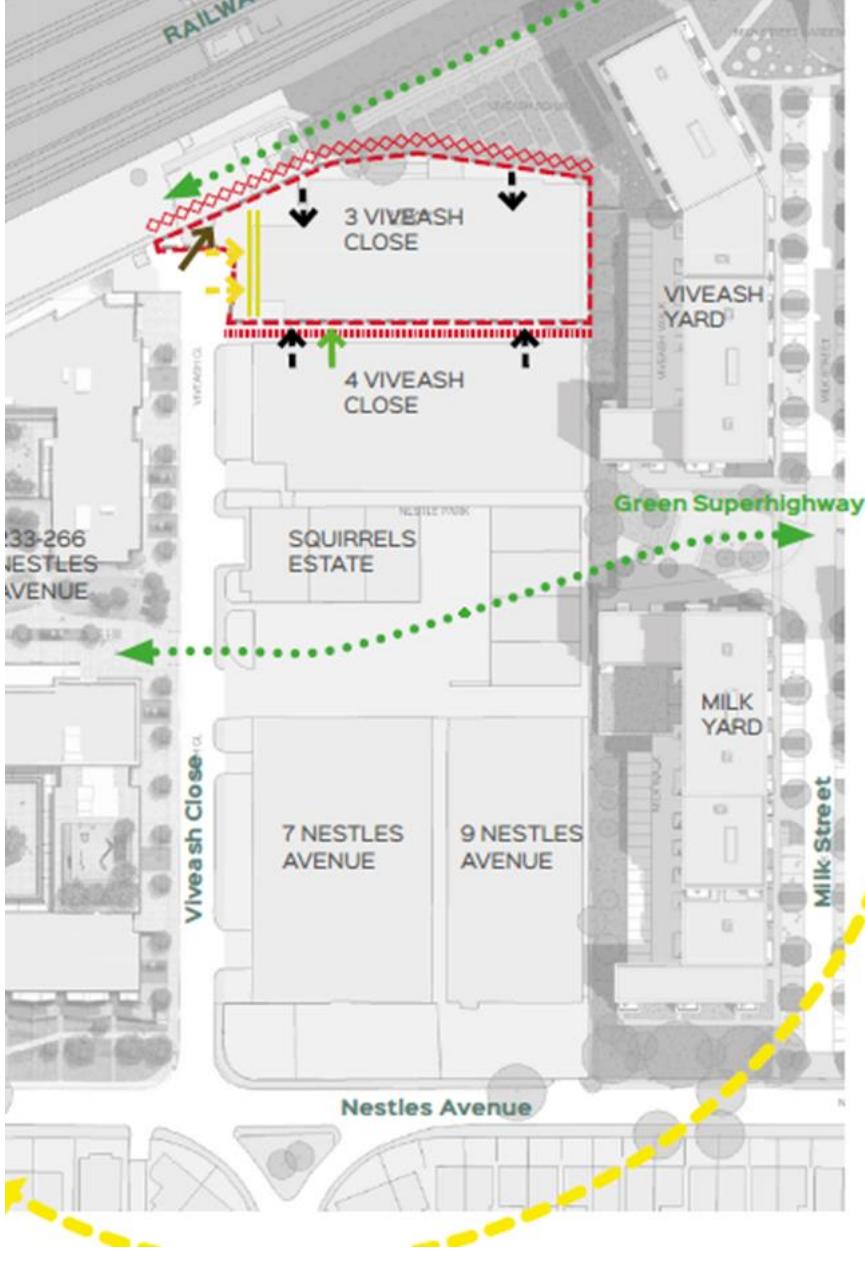
The site consists of a trading estate situated on Viveash Close.

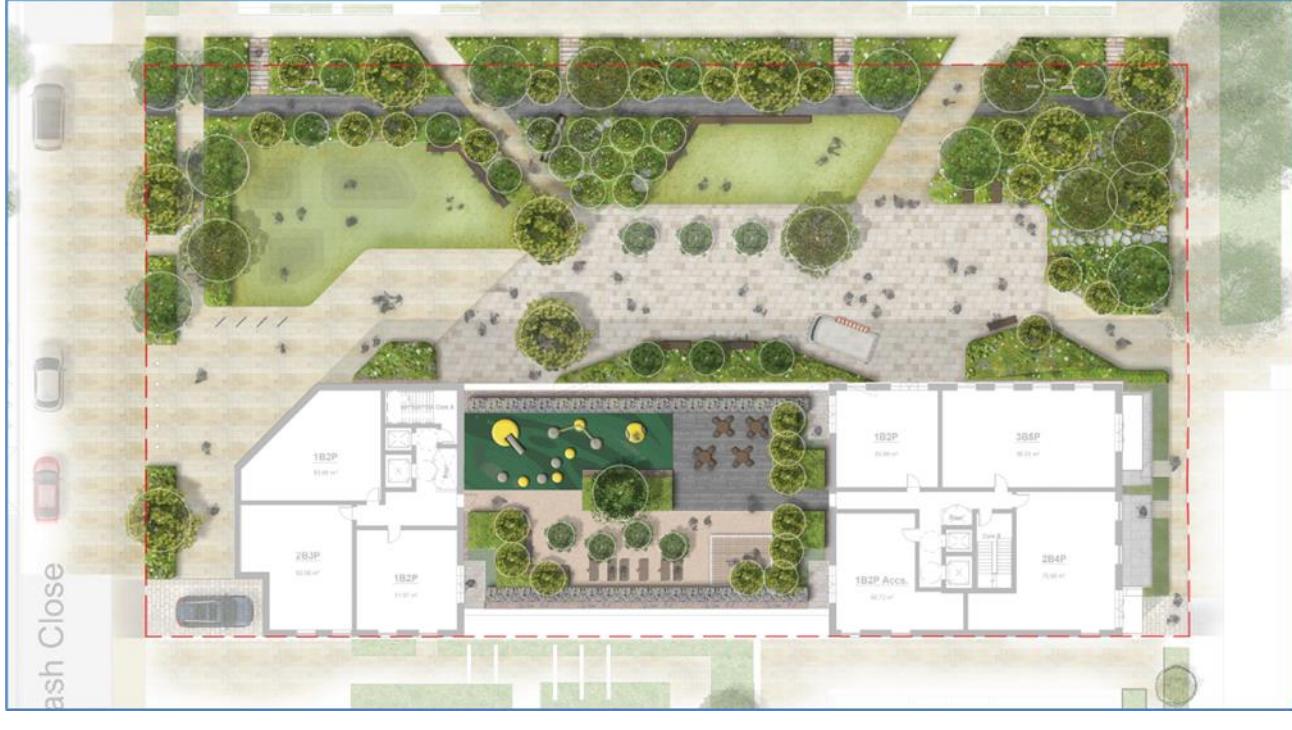
It is proposed to demolish the existing buildings and build new units with landscaping as illustrated below.

The location and detail of the proposed development and the positioning and numbering of the trees can be found plotted on the AIA plan at Appendix 2 and separate document Ref : AIA/20765. NB The original of this plan was produced in colour – a monochrome copy should not be relied upon.

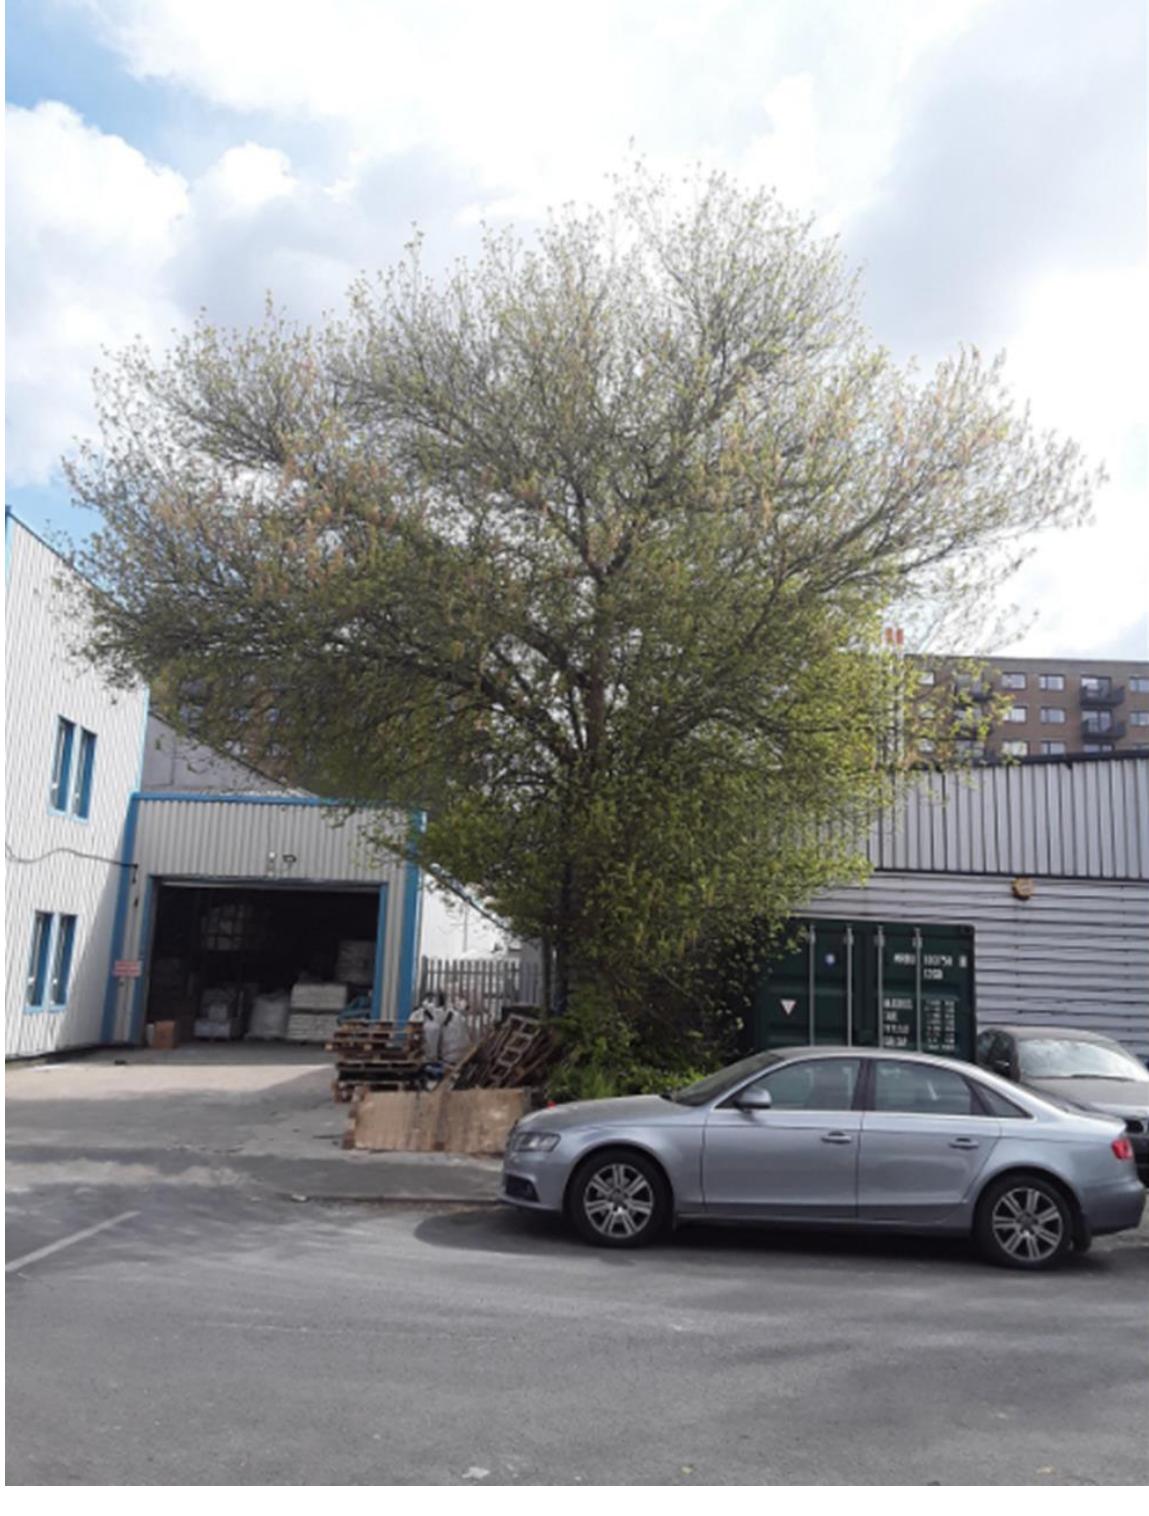
T01 is a maple

Ref.	Species	Measurements	General Observations	Retention Category	RPA	Physiological Cond	Structural Cond	Recommendations
T01	Box Elder Maple (<i>Acer negundo</i>)	Height (m): 12 Stem Diam (mm): 360 Spread (m): 4N, 4E, 4S, Crown Clearance (m): 2 Life Stage: Mature Rem. Contrib.: 10+ Years	This mature tree is growing in a raised planter	C	Radius: 4.3m. Area: 58 sq m.	Good	Good	Remove for development
T02	Birch (<i>Betula sp.</i>)	Height (m): 12 Stem Diam (mm): 220 Spread (m): 2N, 2E, 2S, 2W Crown Clearance (m): 2 Life Stage: Mature Rem. Contrib.: 10+ Years	This mature tree is growing in a raised planter	C	Radius: 2.6m. Area: 21 sq m.	Good	Good	Remove for development

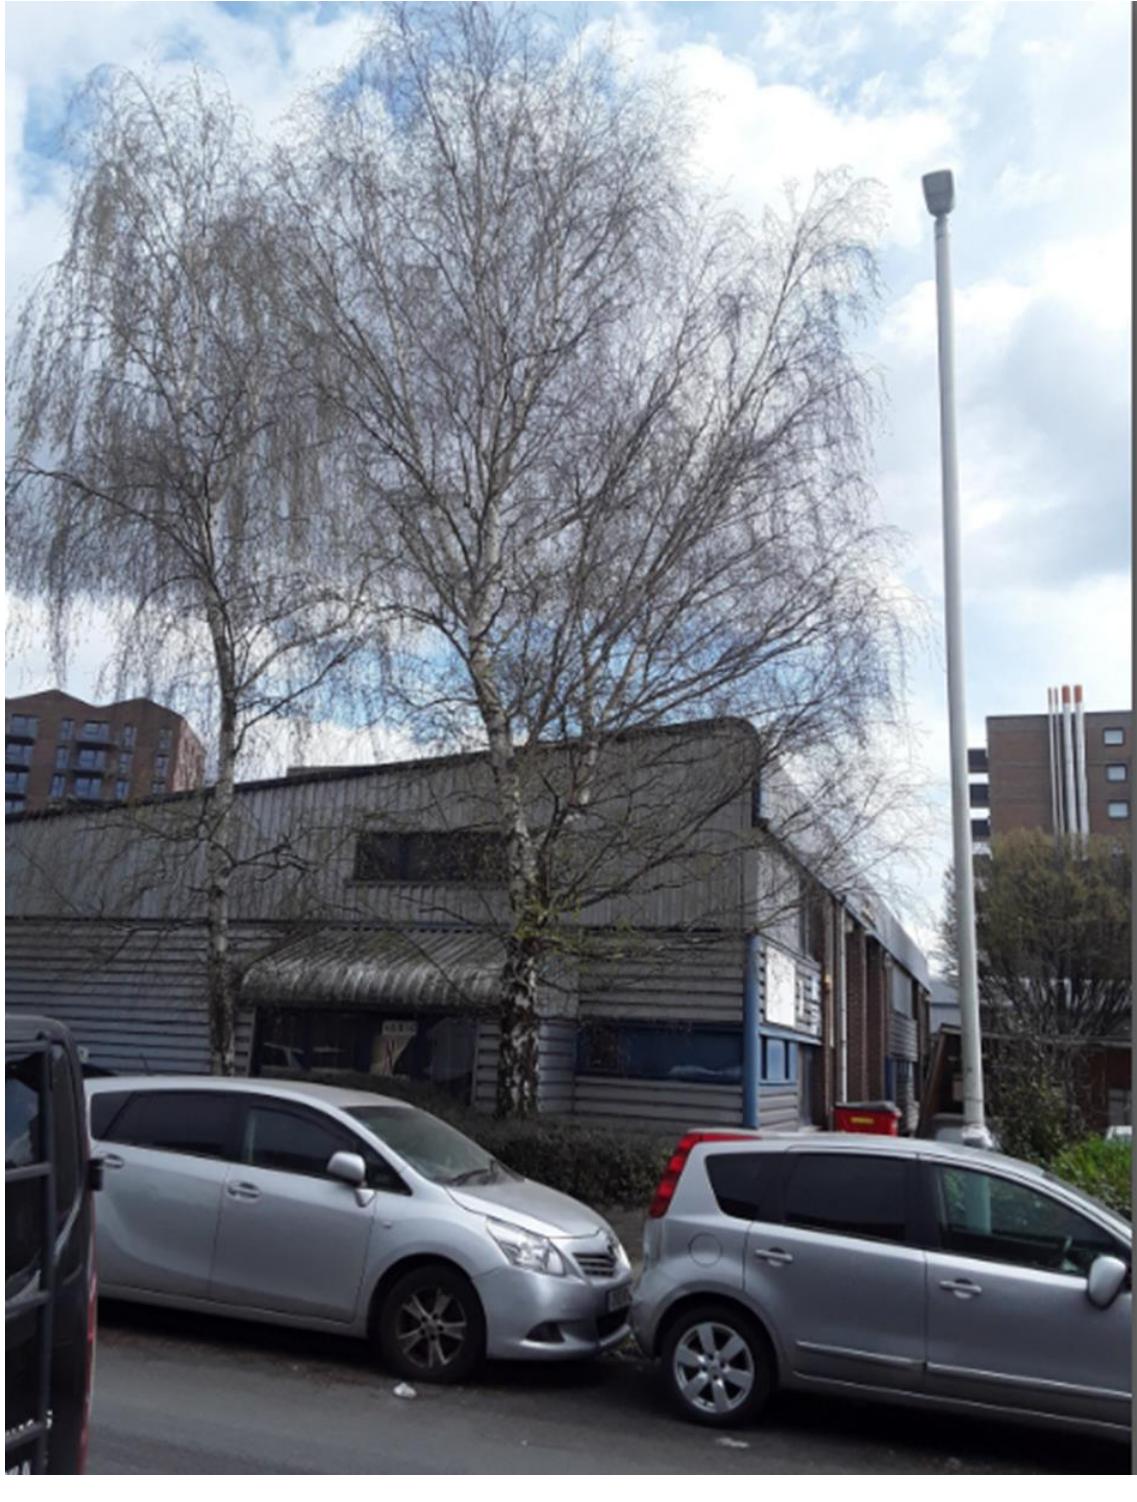
Trees T3 and T4 are mature birch

Ref.	Species	Measurements	General Observations	Retention Category	RPA	Physiological Cond	Structural Cond	Recommendations
T03	Birch (<i>Betula sp.</i>)	Height (m): 12 Stem Diam (mm): 300 Spread (m): 3N, 3E, 3S, 3W Crown Clearance (m): 2 Life Stage: Mature Rem. Contrib.: 10+ Years	This mature tree is growing in a raised planter	C	Radius: 3.6m. Area: 41 sq m.	Good	Good	Remove for development
T04	Hornbeam (<i>Carpinus betulus</i>)	Height (m): 12 Stem Diam (mm): 240 Spread (m): 3N, 3E, 3S, 3W Crown Clearance (m): 4 Life Stage: Mature Rem. Contrib.: 10+ Years		C	Radius: 2.9m. Area: 26 sq m.	Good	Good	Remove for development

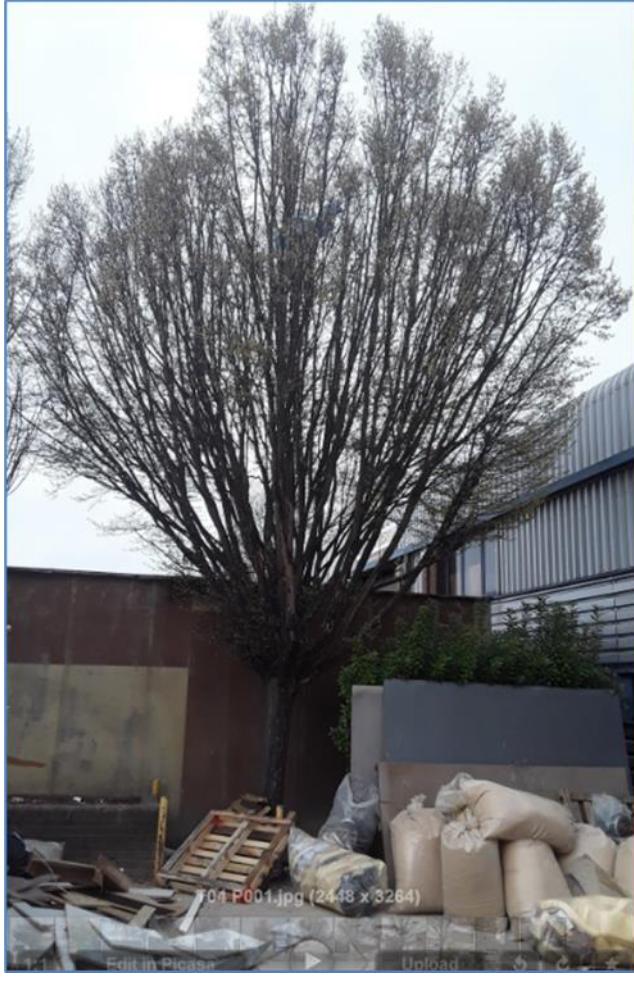
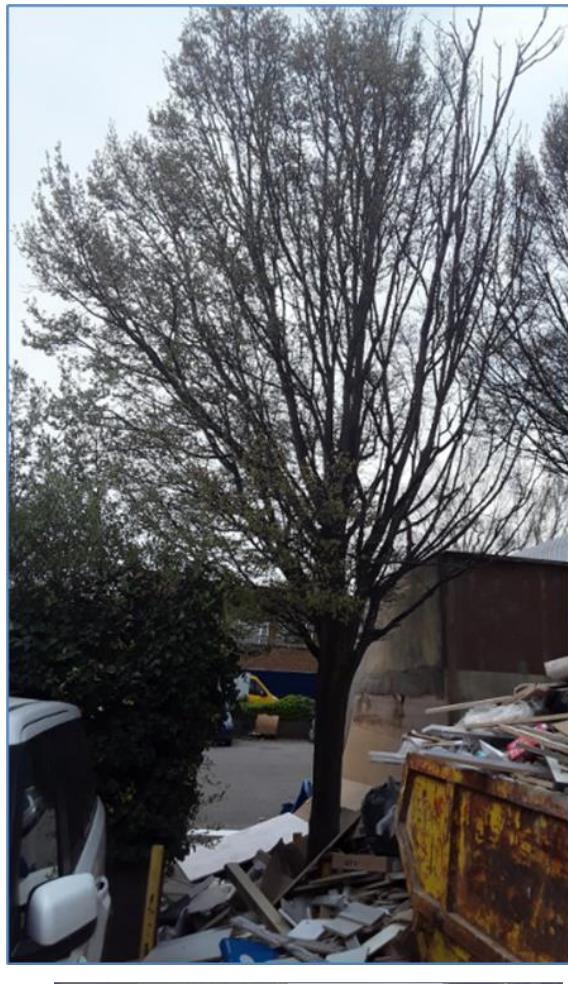
Tree T04 and T05 are hornbeams

Ref.	Species	Measurements	General Observations	Retention Category	RPA	Physiological Cond	Structural Cond	Recommendations
T05	Hornbeam (<i>Carpinus betulus</i>)	Height (m): 10 Stem Diam (mm): 200 Spread (m): 2N, 2E, 2S, 2W Crown Clearance (m): 3 Life Stage: Mature Rem. Contrib.: <10 years	This tree has suffered vehicle damage and has died back as a result	U	None - due to Retention Category of U.	Poor	Fair	Remove for management reasons
T06	Dead tree	Height (m): 9 Stem Diam (mm): 200 Spread (m): 1N, 1E, 1S, 1W Life Stage: Dead		U	None - due to Retention Category of U.	Dead		Remove for management reasons
T07	Sycamore (<i>Acer pseudoplatanus</i>)	Height (m): 10 2 stems, diam(mm): 200, 150 Spread (m): 3N, 1E, 3S, 2W Life Stage: Mature Rem. Contrib.: <10 years	Self sown tree on rear boundary in decline	C	Radius: 3.0m. Area: 28 sq m.	Fair	Fair	Remove for management reasons

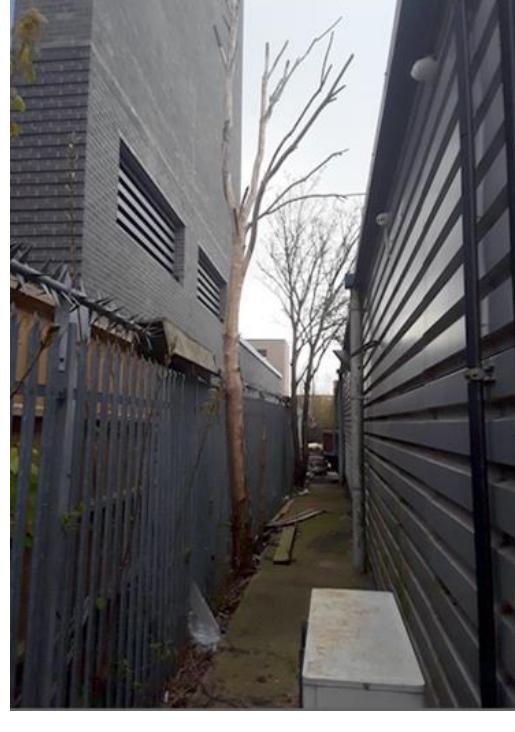
At the rear of the site are 2 self sown sycamore trees, one of which has died

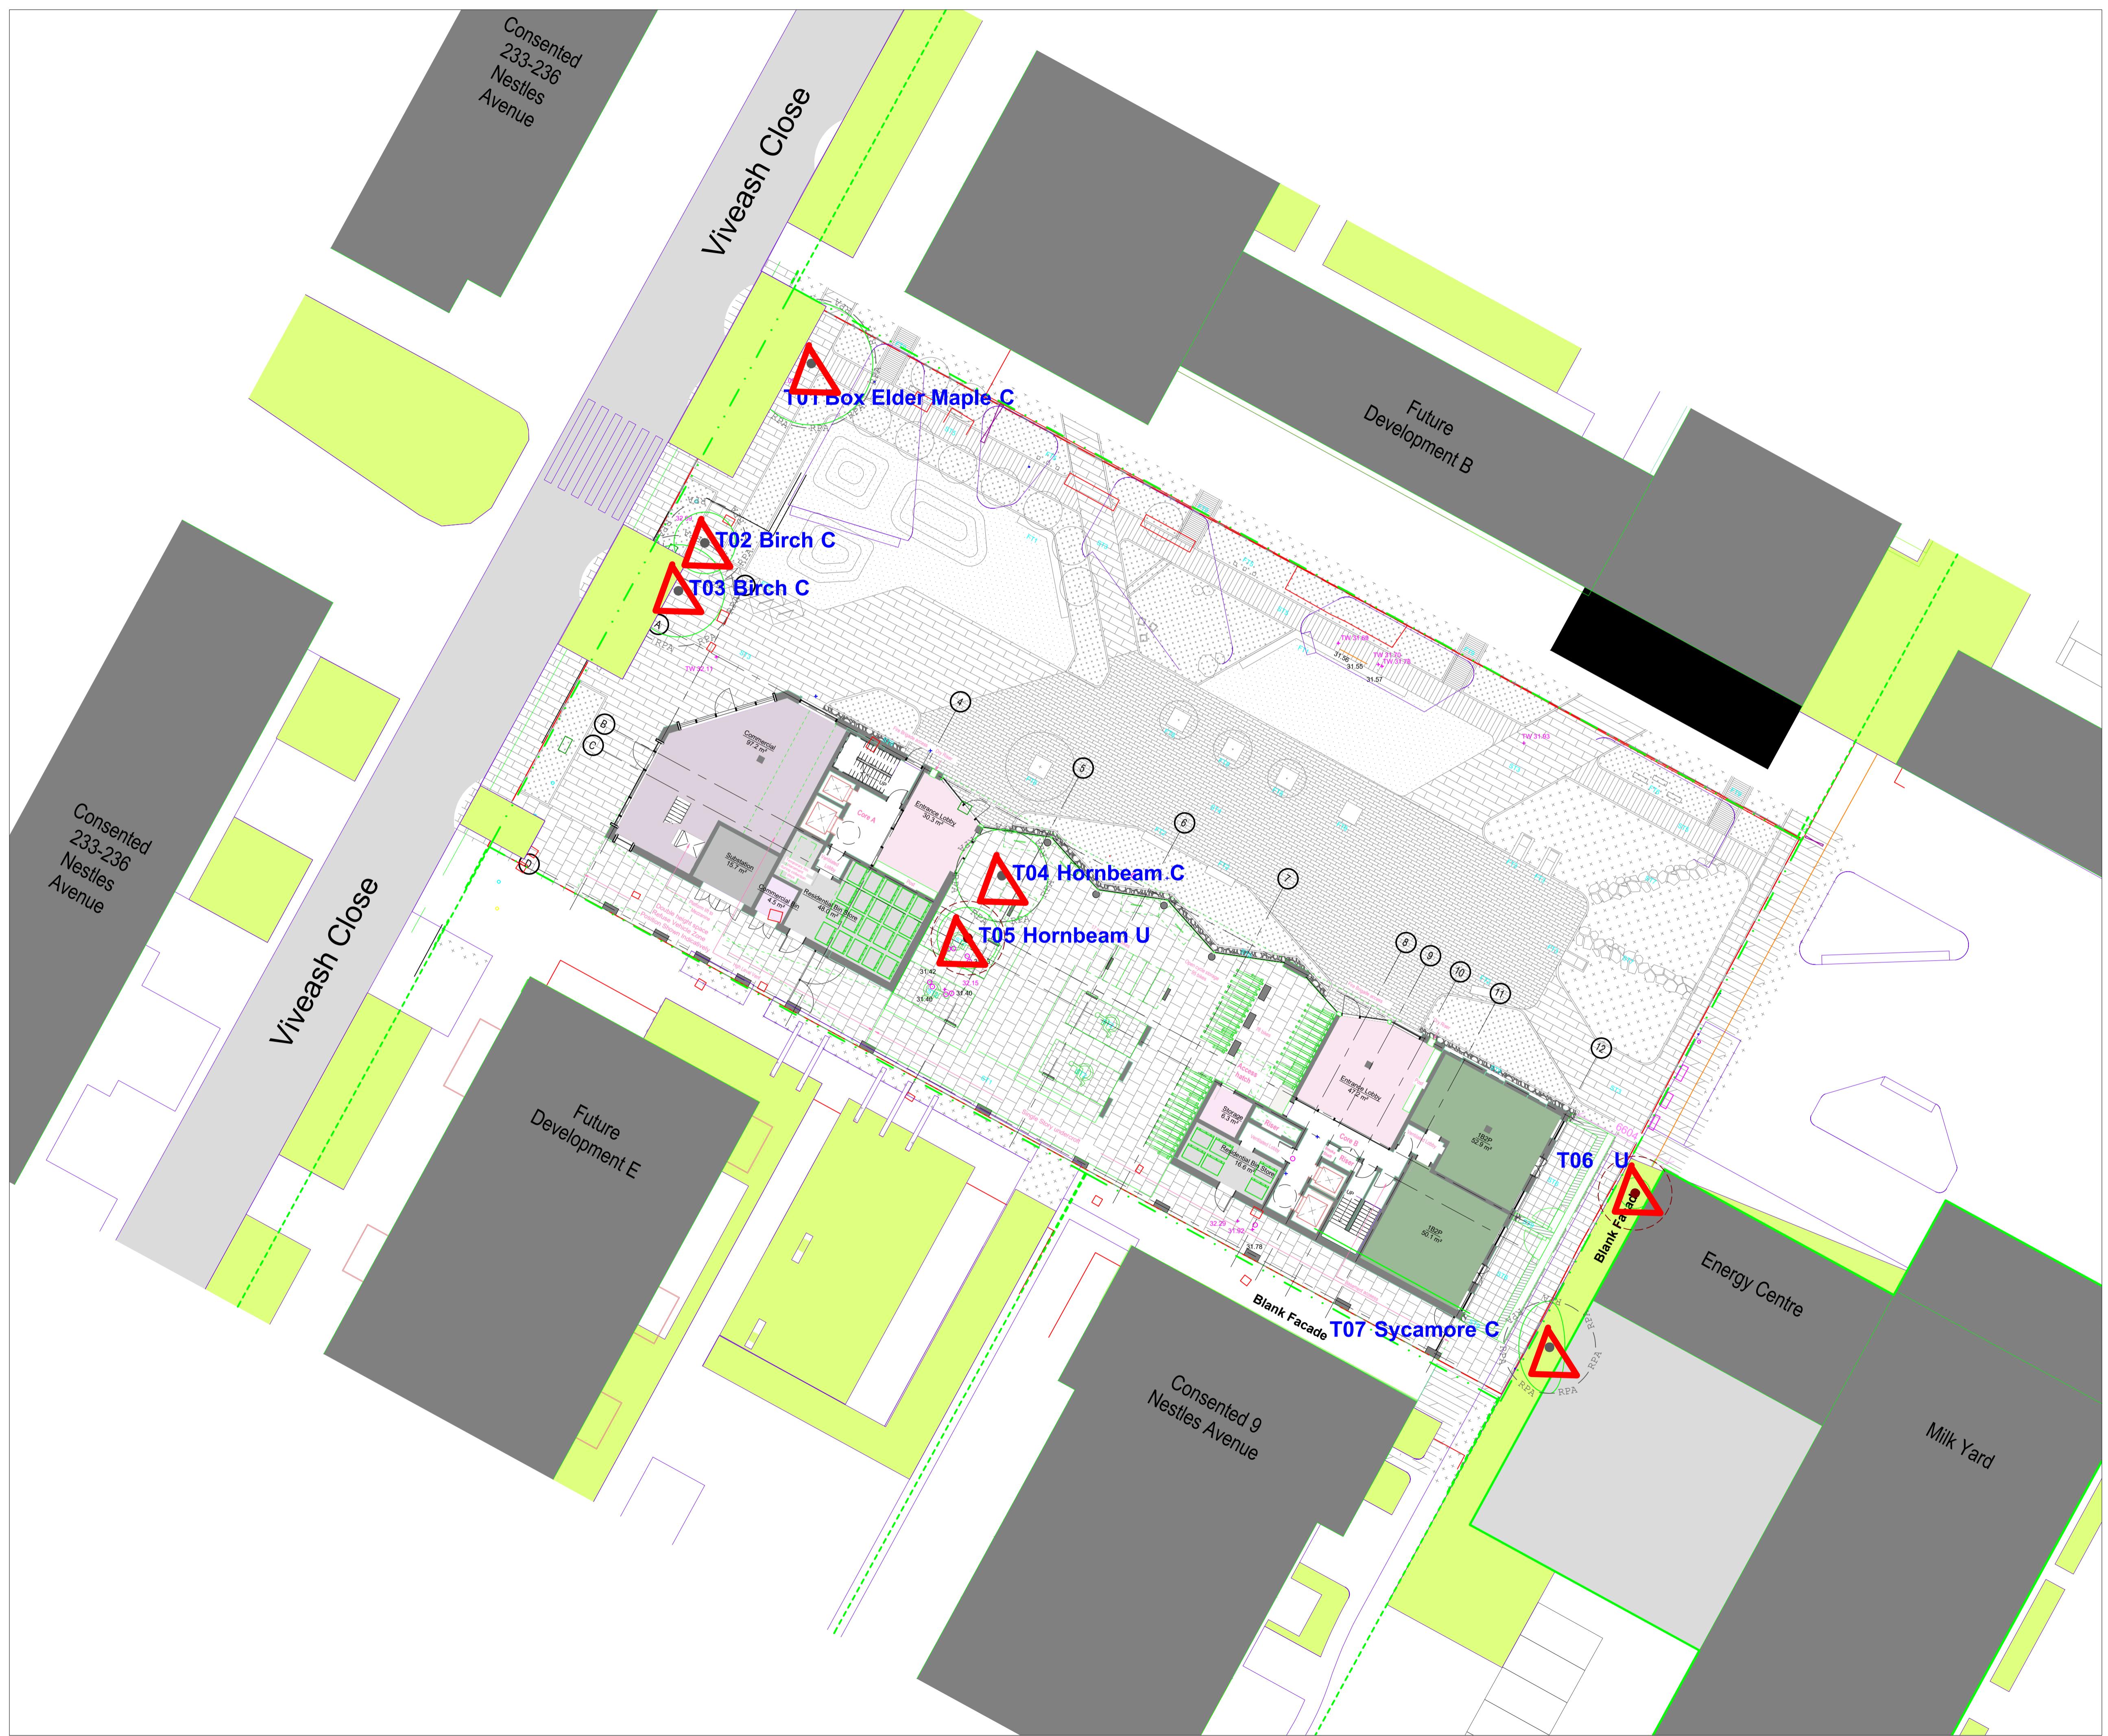
Arboricultural Impact Assessment plan

Drawing Number 20792			
	Tree canopy		
	RPA cat C		
	Cat U		
	Tree to remove		
Rev	Date	Description	Checked
			<input type="checkbox"/>
			<input type="checkbox"/>
			<input type="checkbox"/>
Client	Syntegra		
Project	Squirrels Trading Estate, Hayes		
Title	AIA		
Drawing No.	20792		
Scale	1:200 @ A1	Date	14/09/22
Drawn	PP	Checked	PP
Approved	PP	Approved	PP

It is proposed to remove all trees for this development
