KEARNS

Topographical Survey

37 Midhurst Gardebs  
Hillington  
UB10 9DN

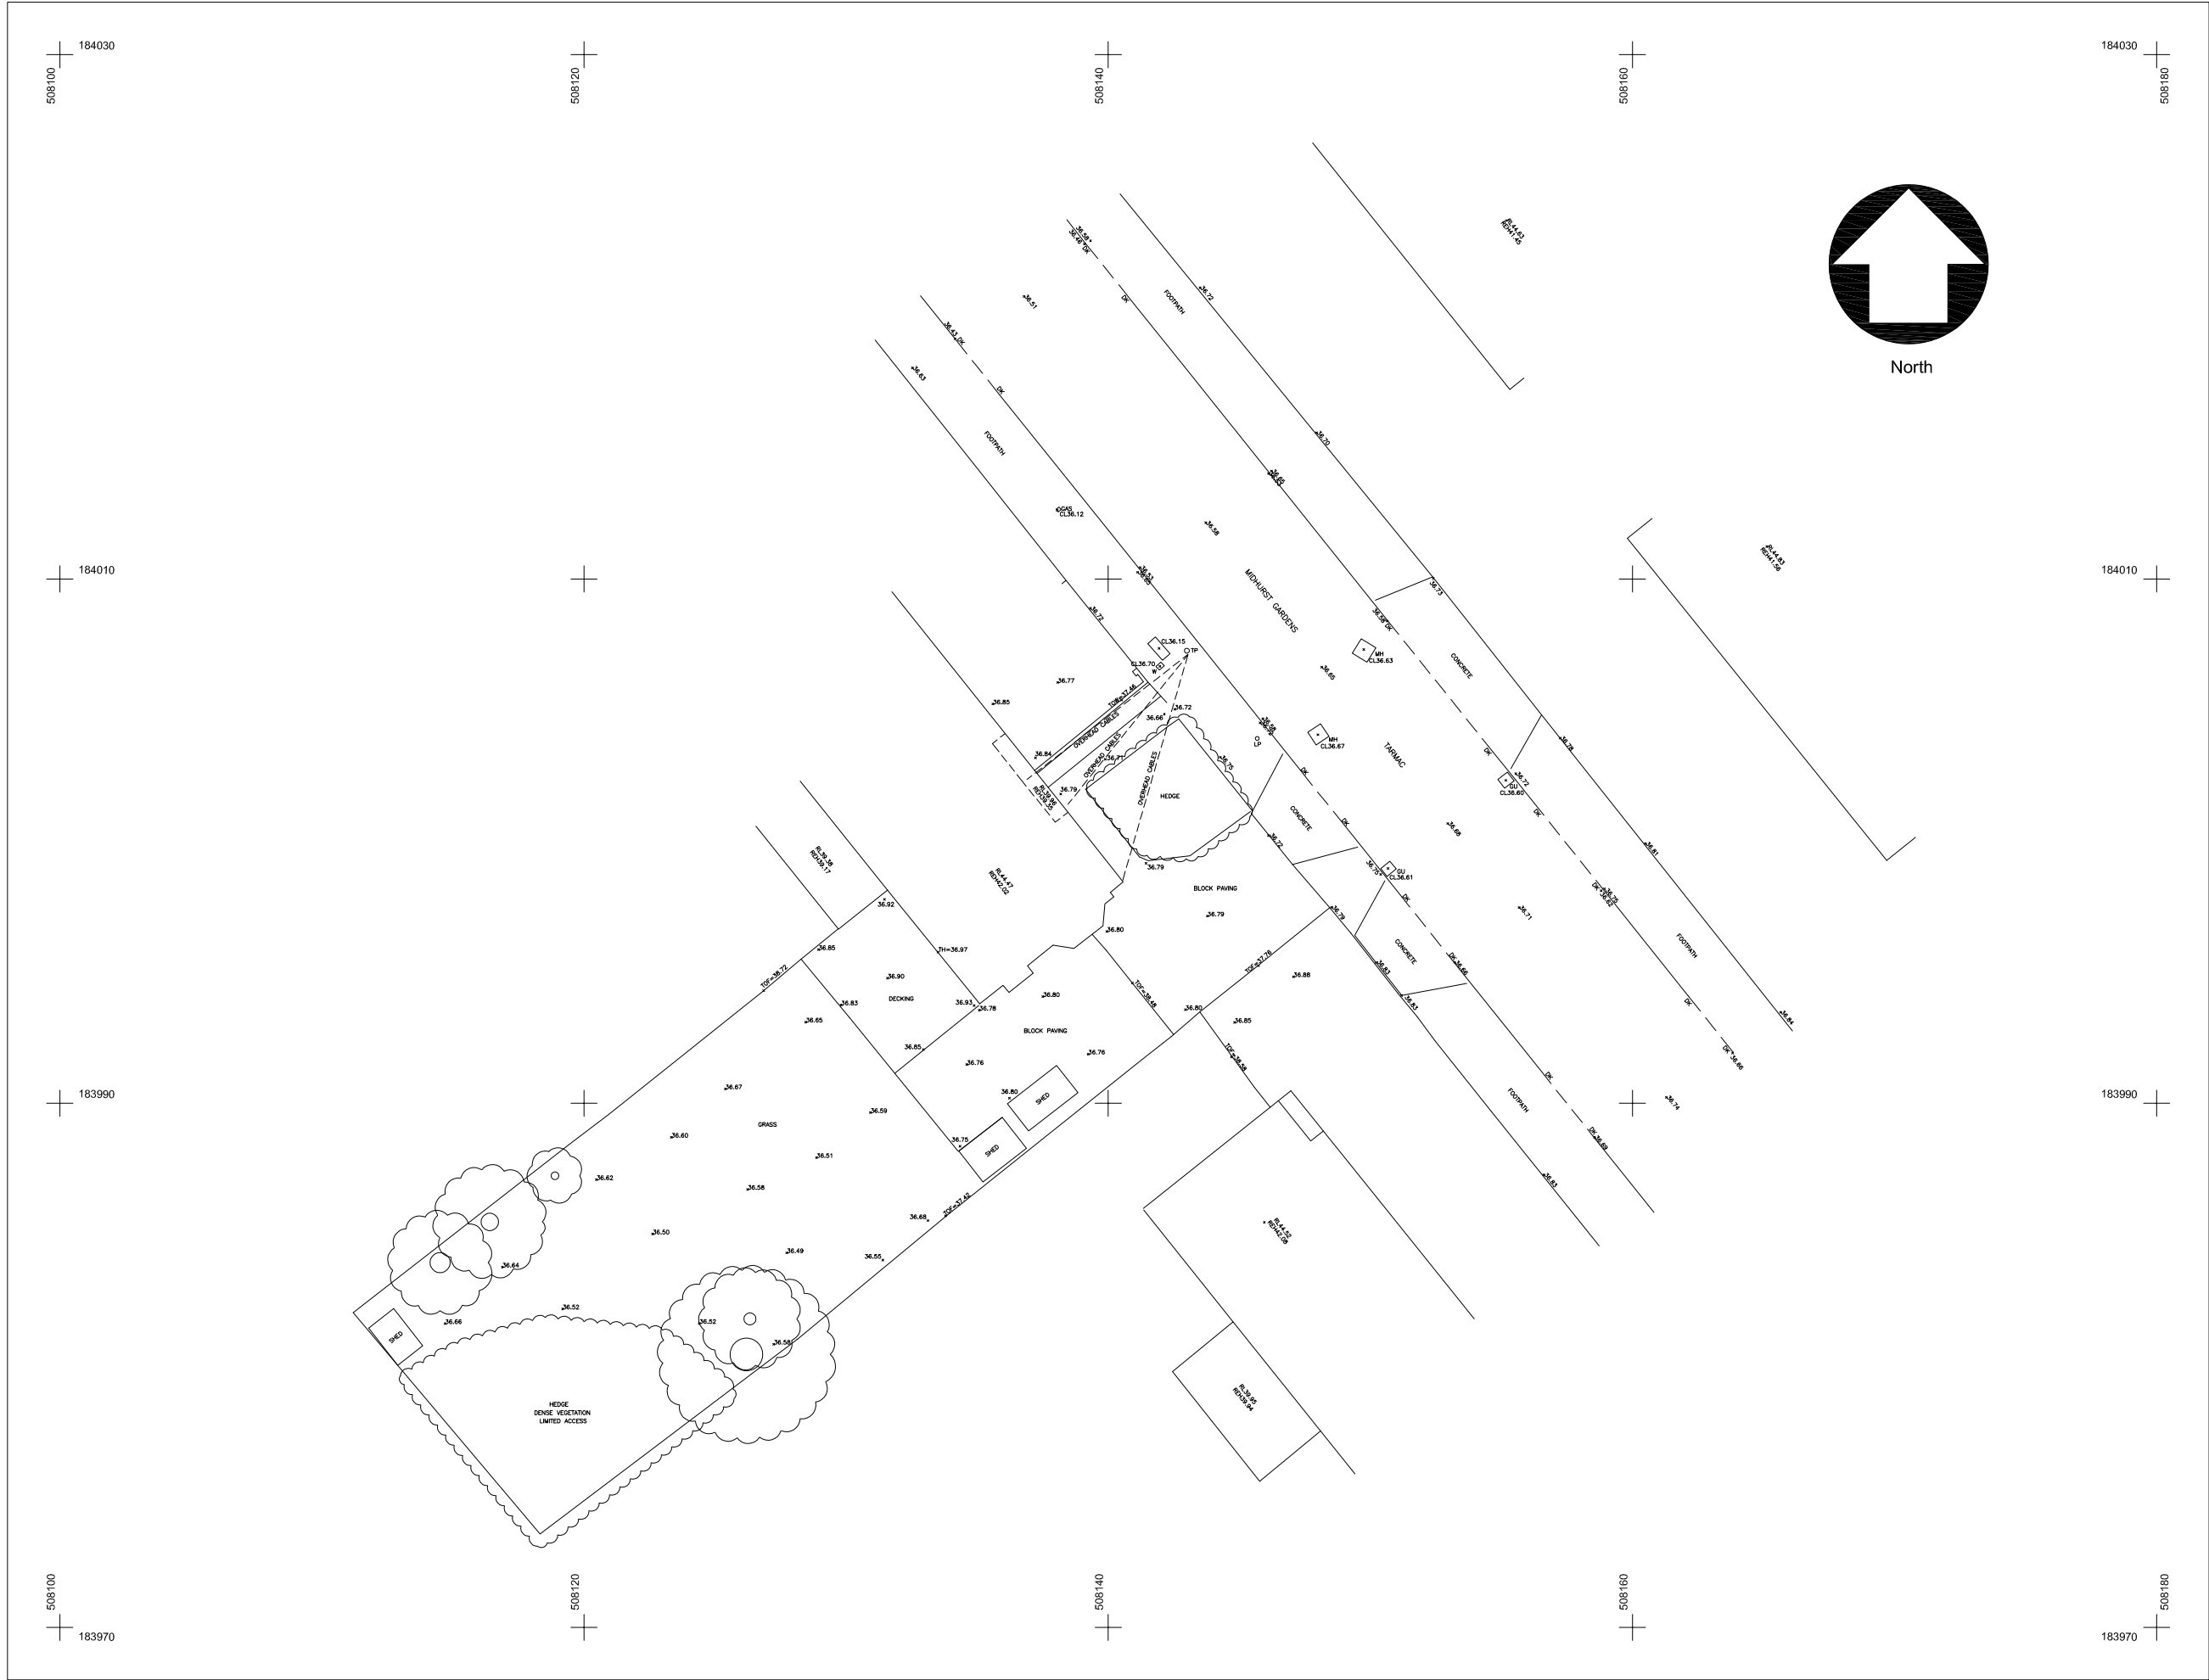
All ground features that were visible at the time of the survey have been located, however there may have been items obscured. Pipe sizes and flow direction have been visually assessed from the surface and should be considered as approximate only.

The survey grid has been established using GPS related to National Grid and orientated to grid north.
