## **Arboricultural Impact Assessment**

**Mariam Radi**  
**43 The Avenue**  
**Ickenham**  
**Uxbridge**  
**UB10 8NR**

Date: November 2024

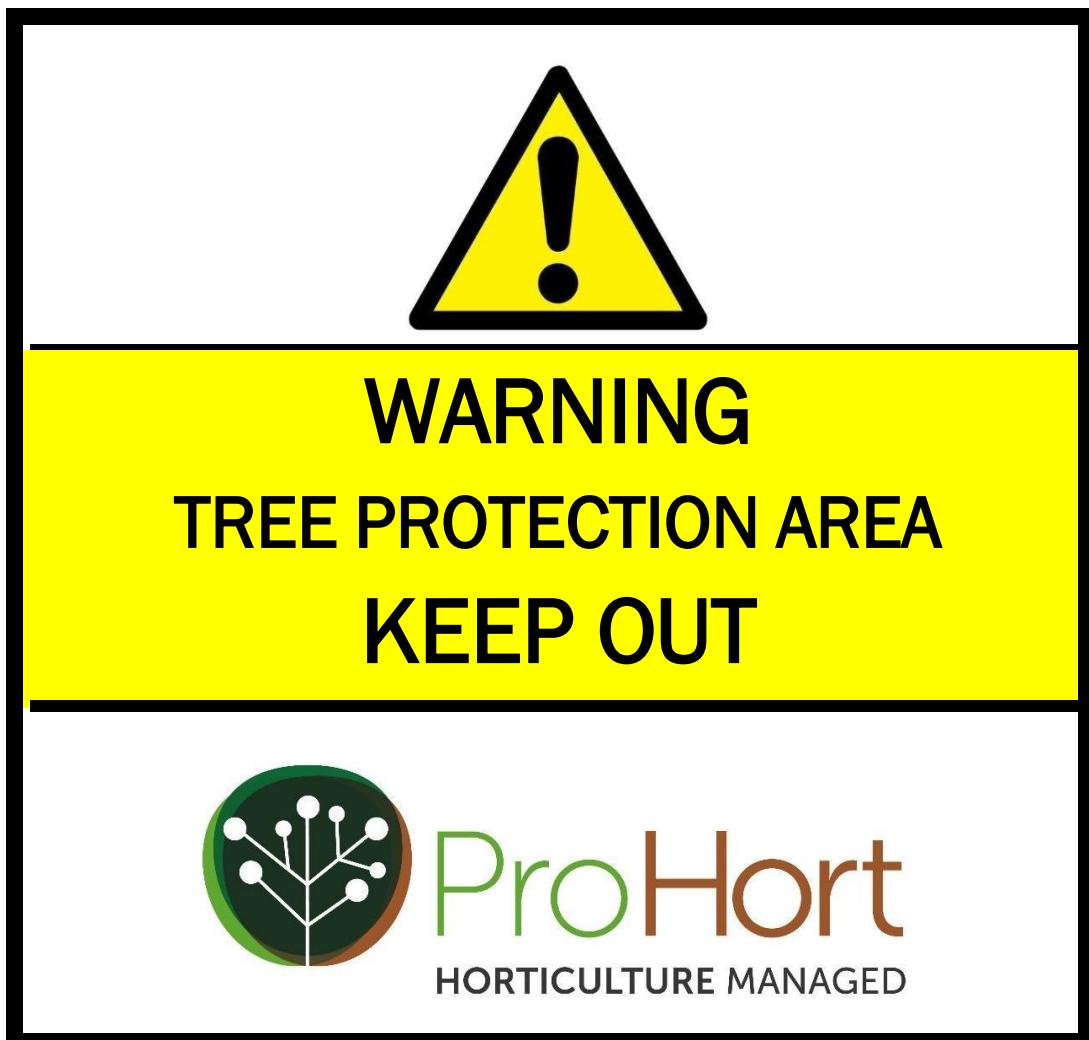
Construction Exclusion Zone – Keep Out” sign

*This sign must be minimum A4 size and at 1.5 metres above ground level.*
