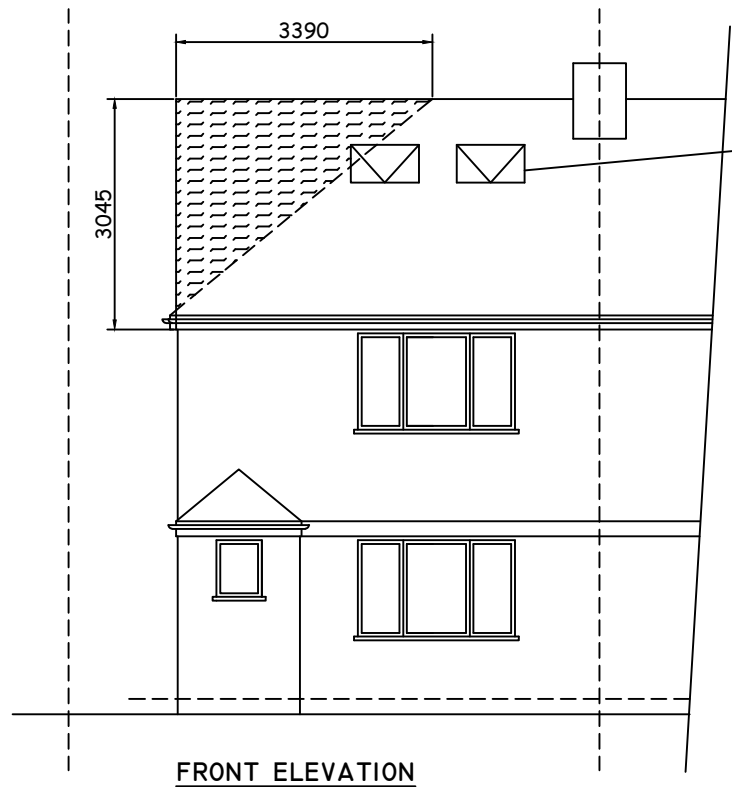
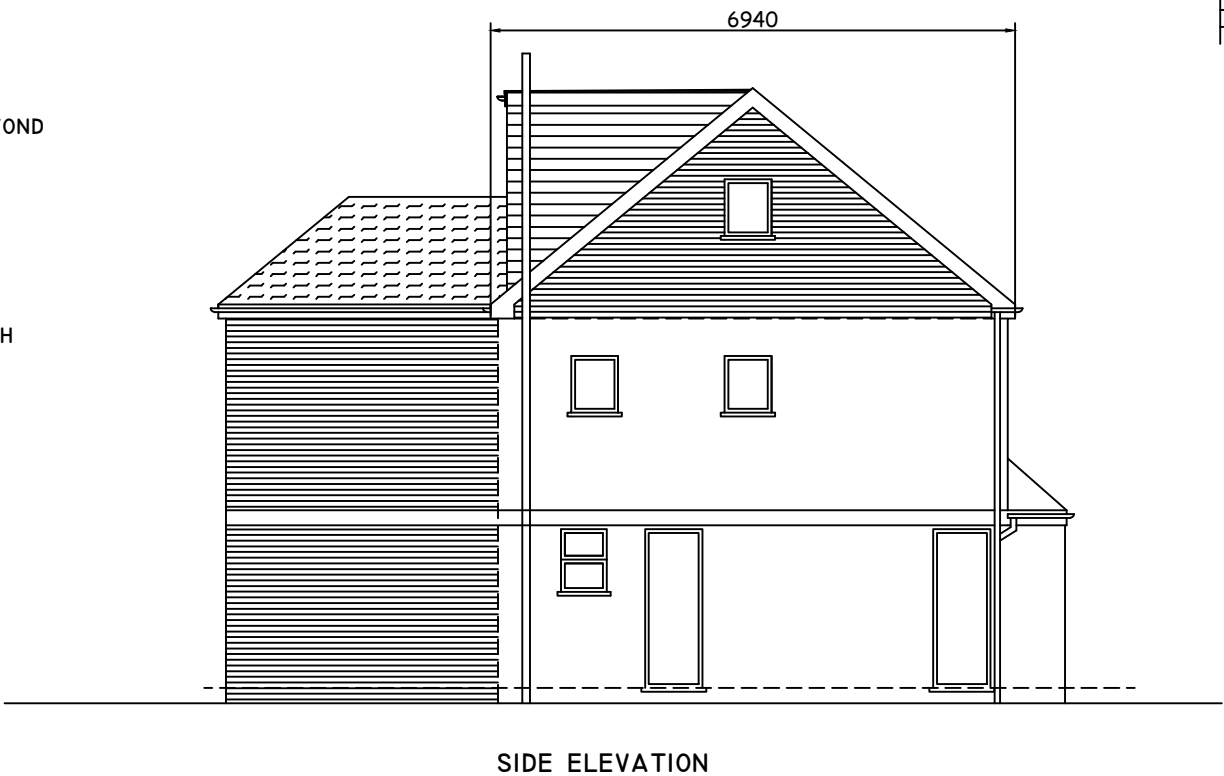
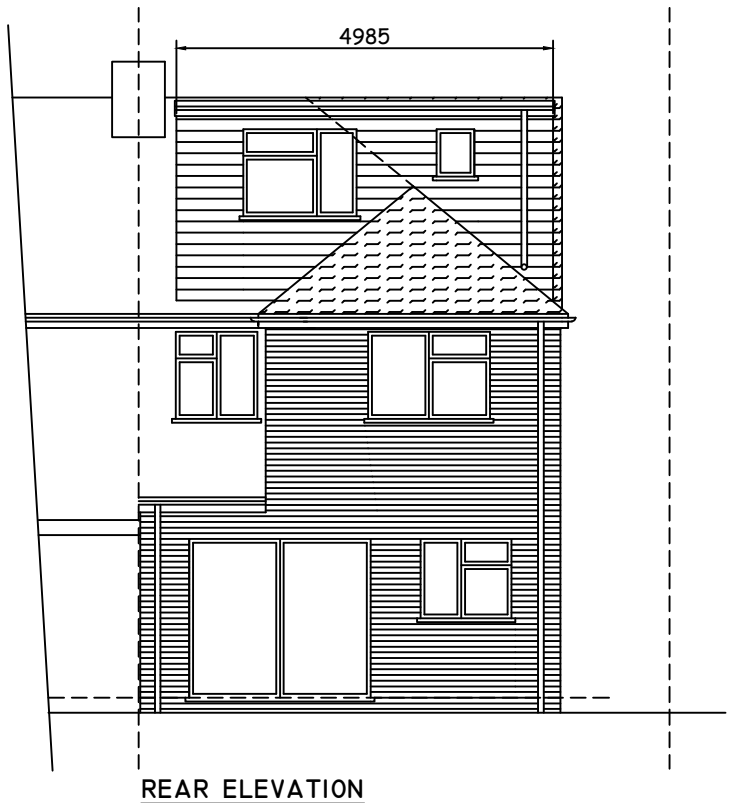
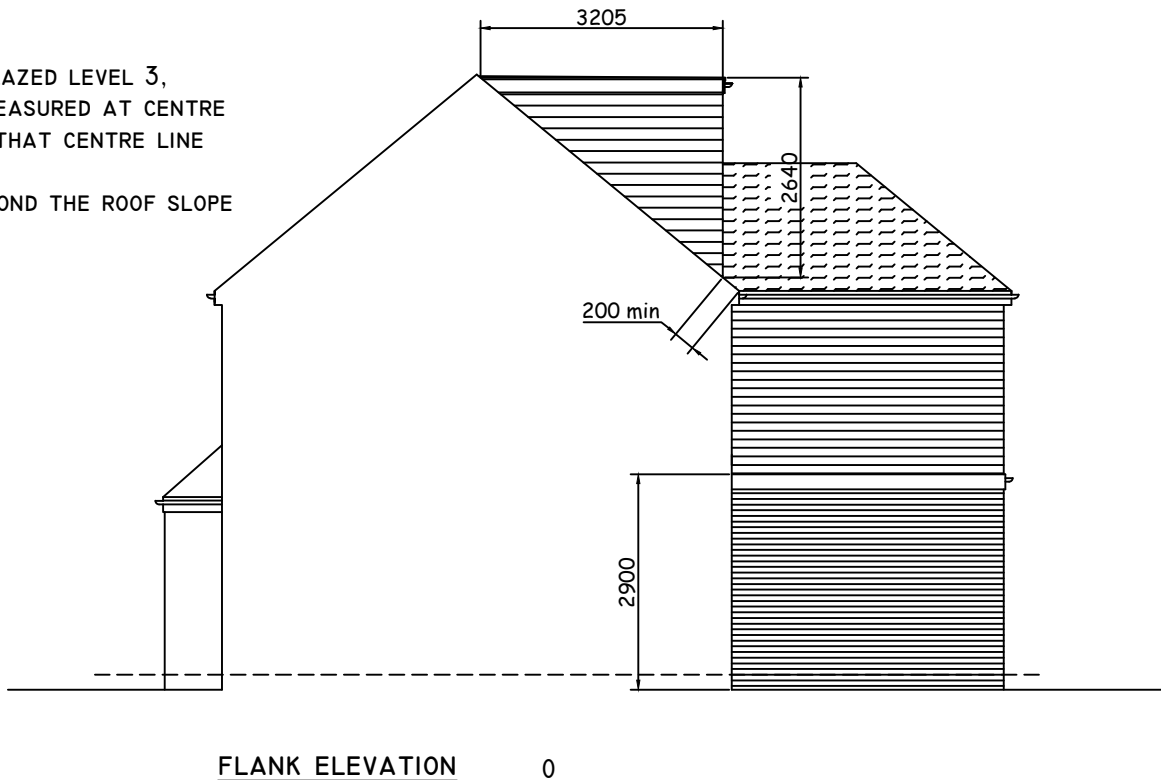
ROOF LIGHT NOT TO  
PROTRUDE 150MM BEYOND  
THE ROOF SLOPE

TILES TO MATCH  
EXISTING

BRICK WORK TO MATCH  
EXISTING
