Preliminary Basement Impact Assessment

10453 - 560 Sipson Road, West Drayton
Middlesex

P&S Hoteliers

SRW-PPC-00-XX-RP-G-0012

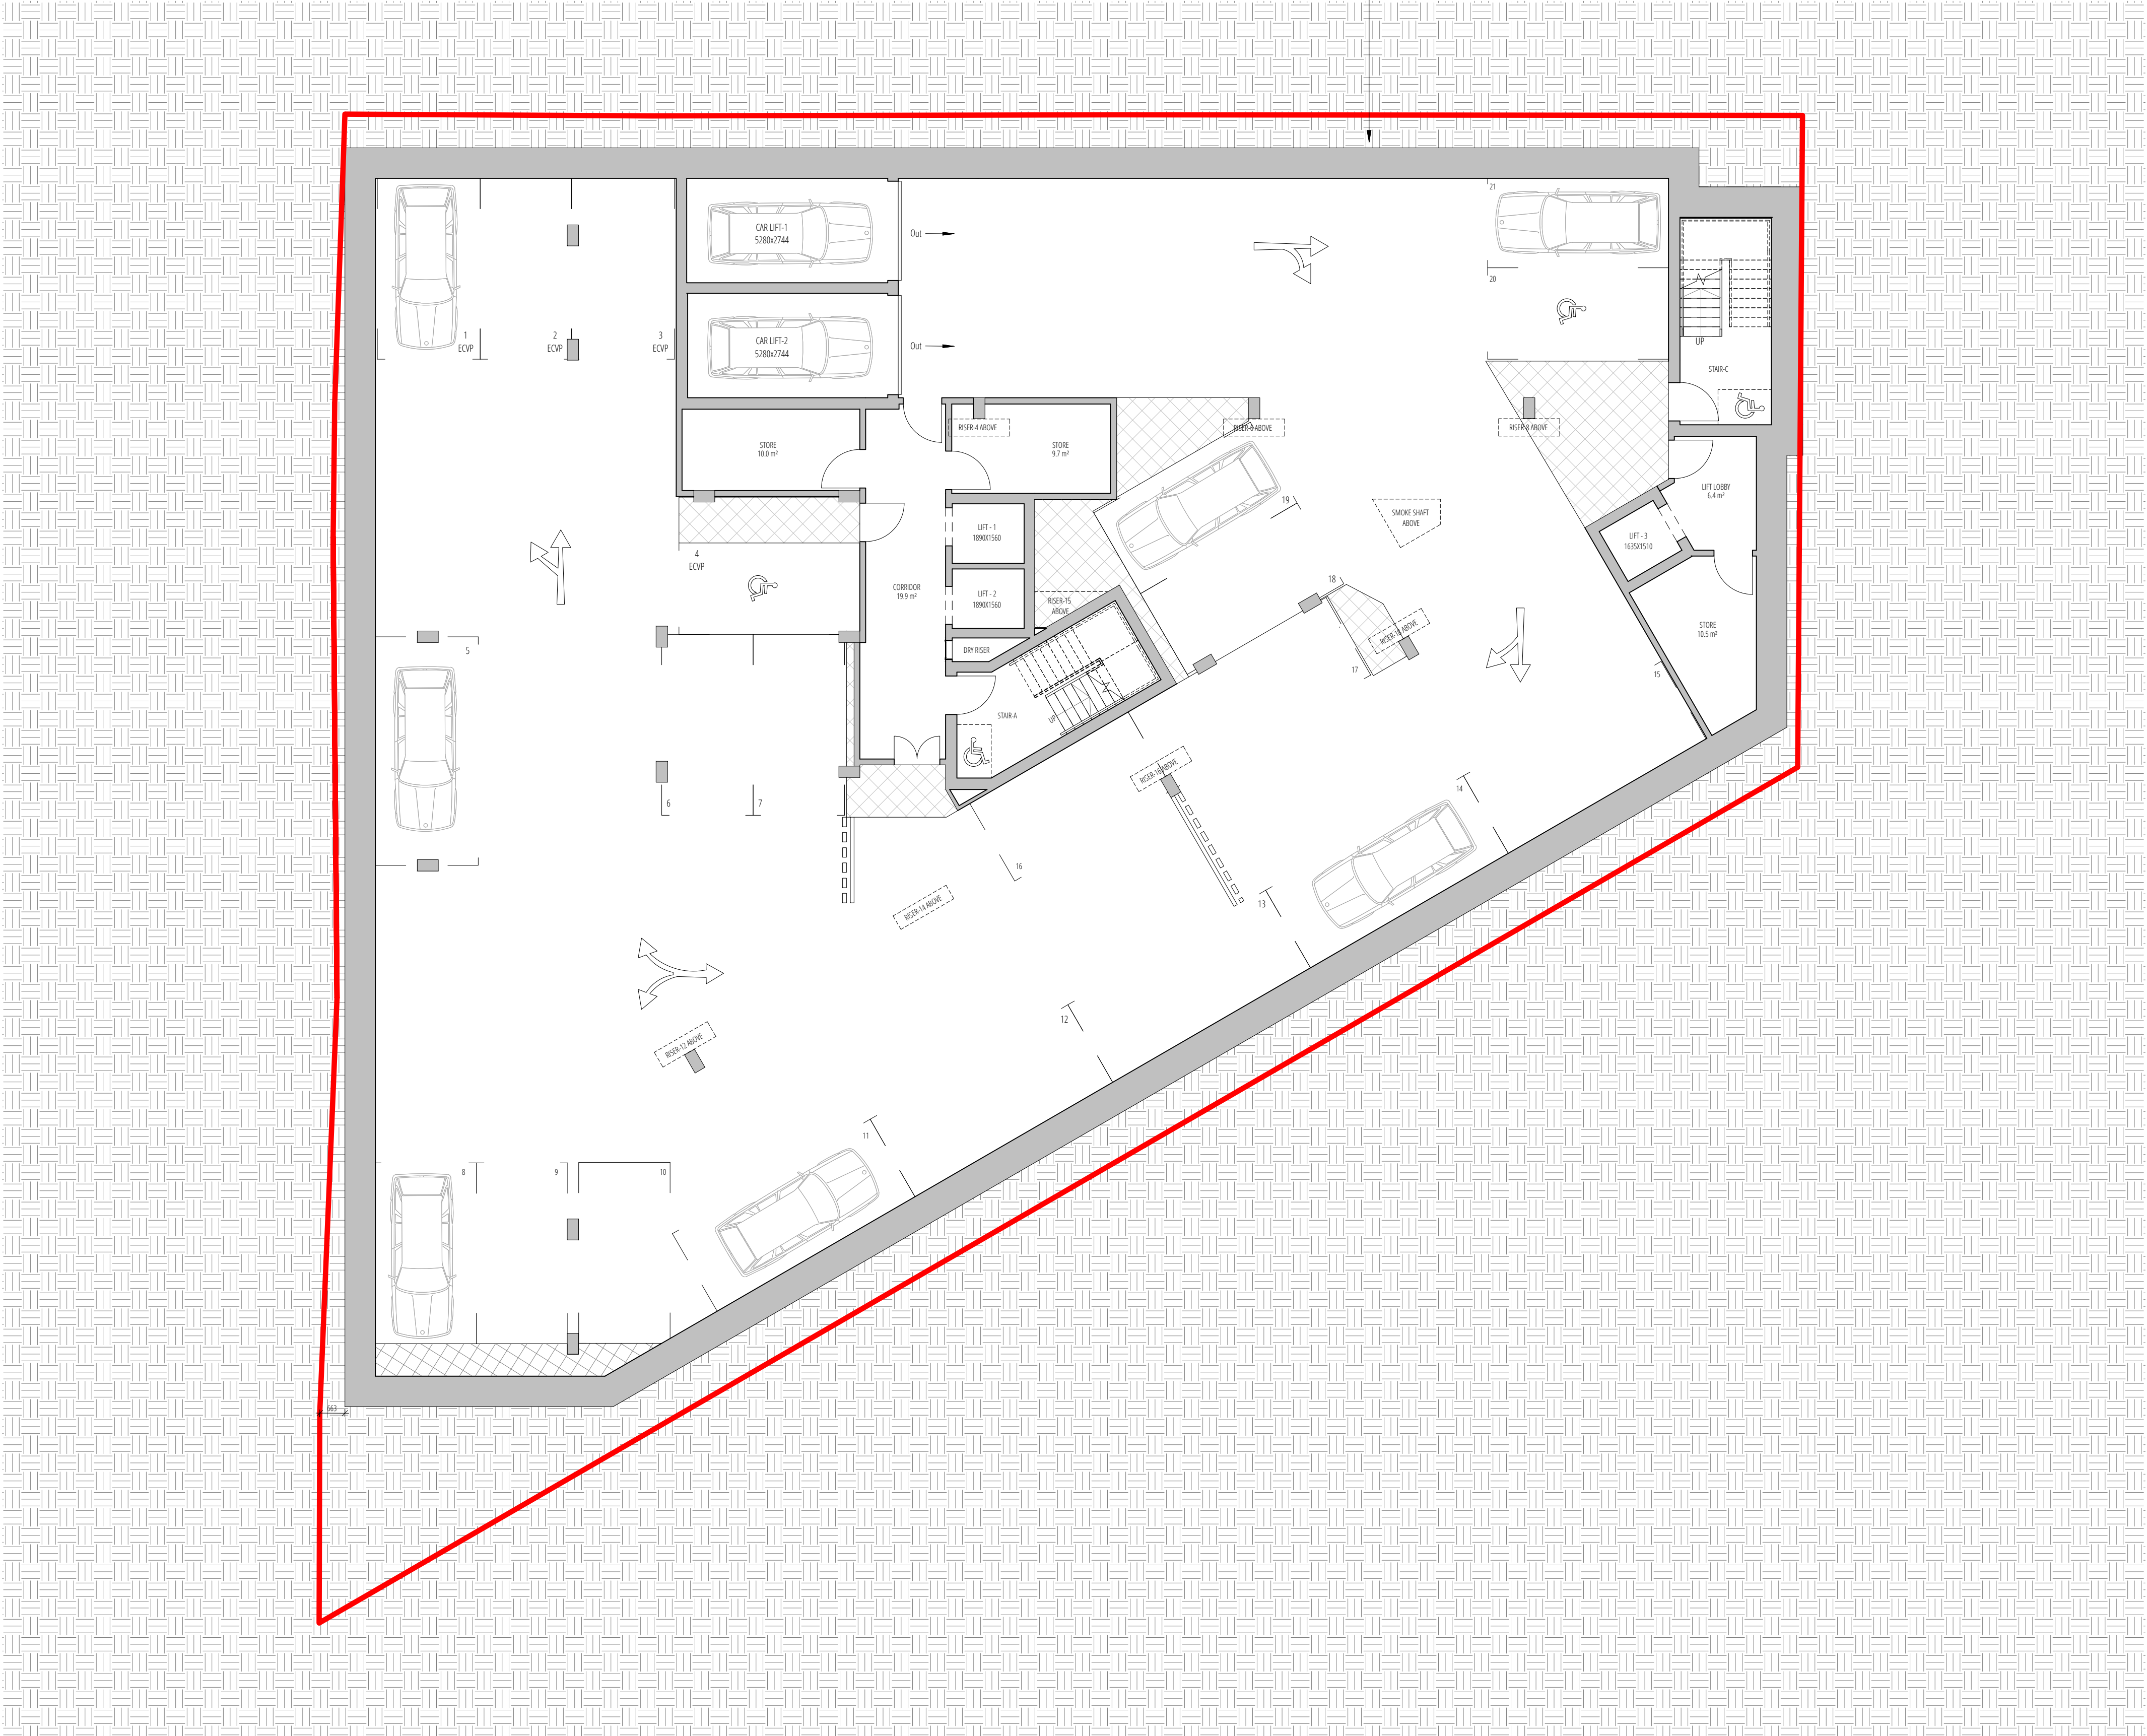
1 Proposed Basement GA Plan
1:100

BASEMENT TO BE VENTILATED VIA VENTS, SEE DRAWING 2103.
