### **Arboricultural Impact Assessment Method Statement & Tree Protection Plan (to BS:5837 2012)**

**Land at 188 Bury Street, Ruislip**

Ref: TH 2550/B

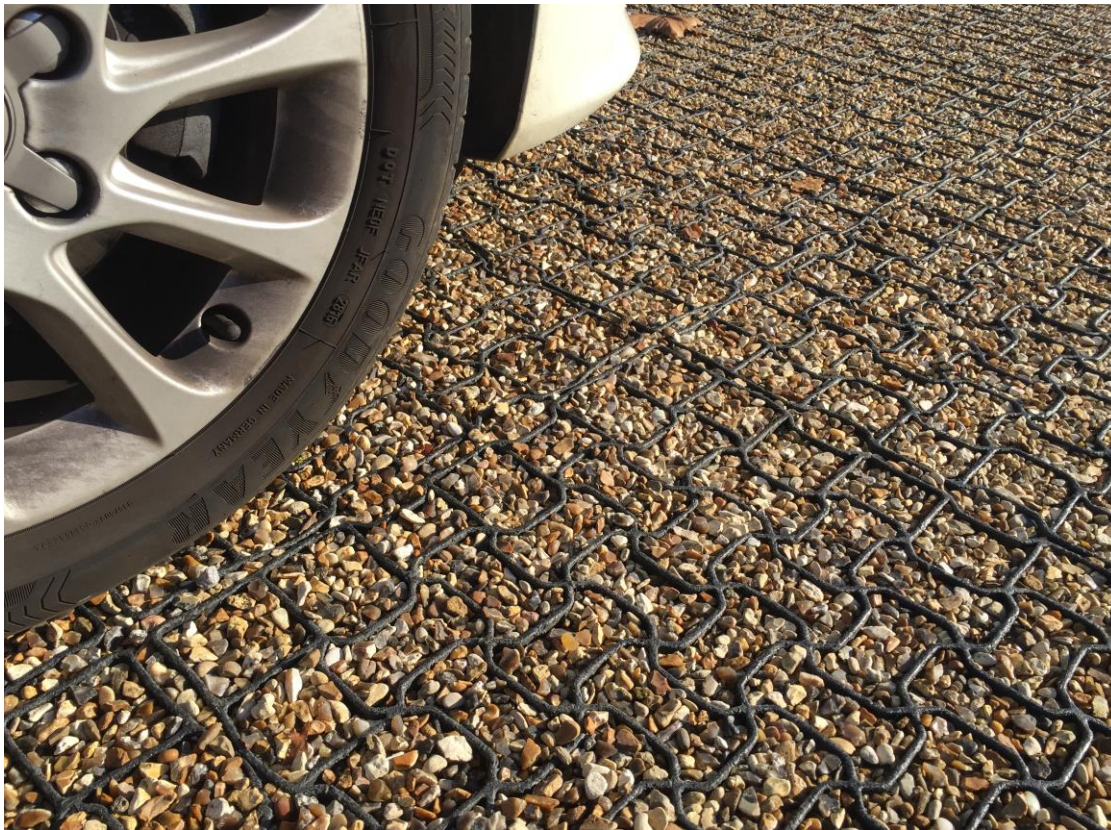
**Photo 4:** An example of a finished Gravel Grid system

Conventional kerb edges (set in concrete-filled trenches) is likely to result in damage to roots and should be avoided. Edge retention in RPAs must be designed to avoid any significant excavation into existing soil levels (BS 5837, 7.4.3) and there are several approaches that are fit for this purpose: Railway sleepers pinned in place or wooden boards are two options, depending on the expected loading of the surfacing. A permeable soil fill can then be used to batter the grade back down to the existing soil level.

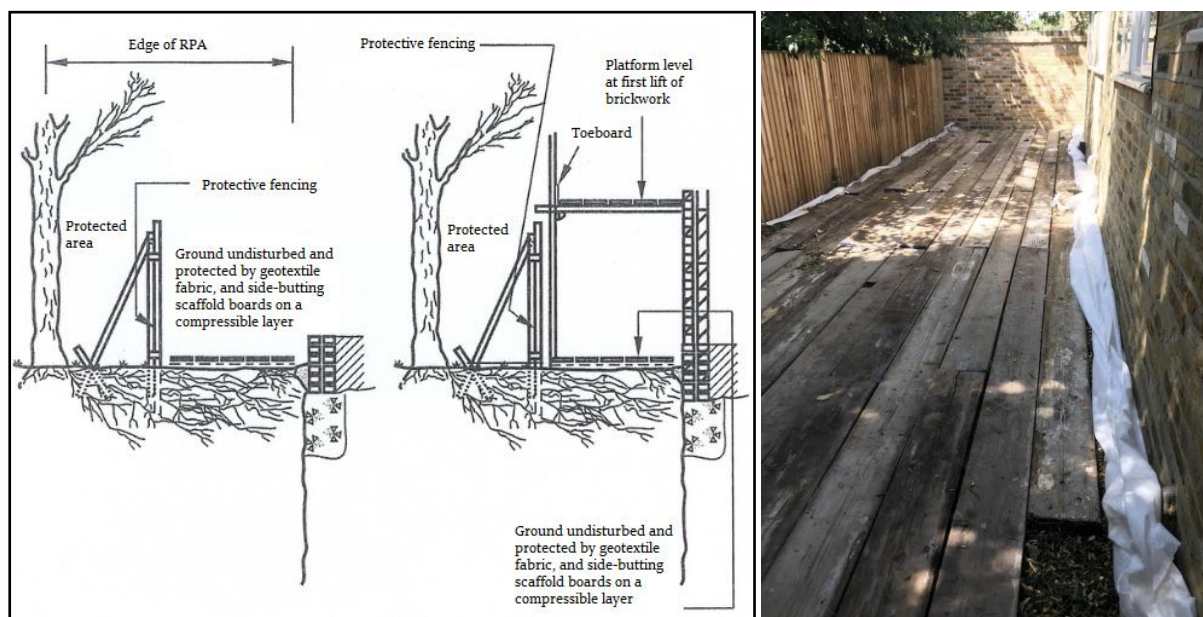
**Figure 1:** An example of ground protection on work areas within a RPA (BS 5837:2005).

In all cases, the objective should be to avoid compaction of the soil, which can arise from the single passage of a heavy vehicle, especially in wet conditions, so that tree root functions remain unimpaired.

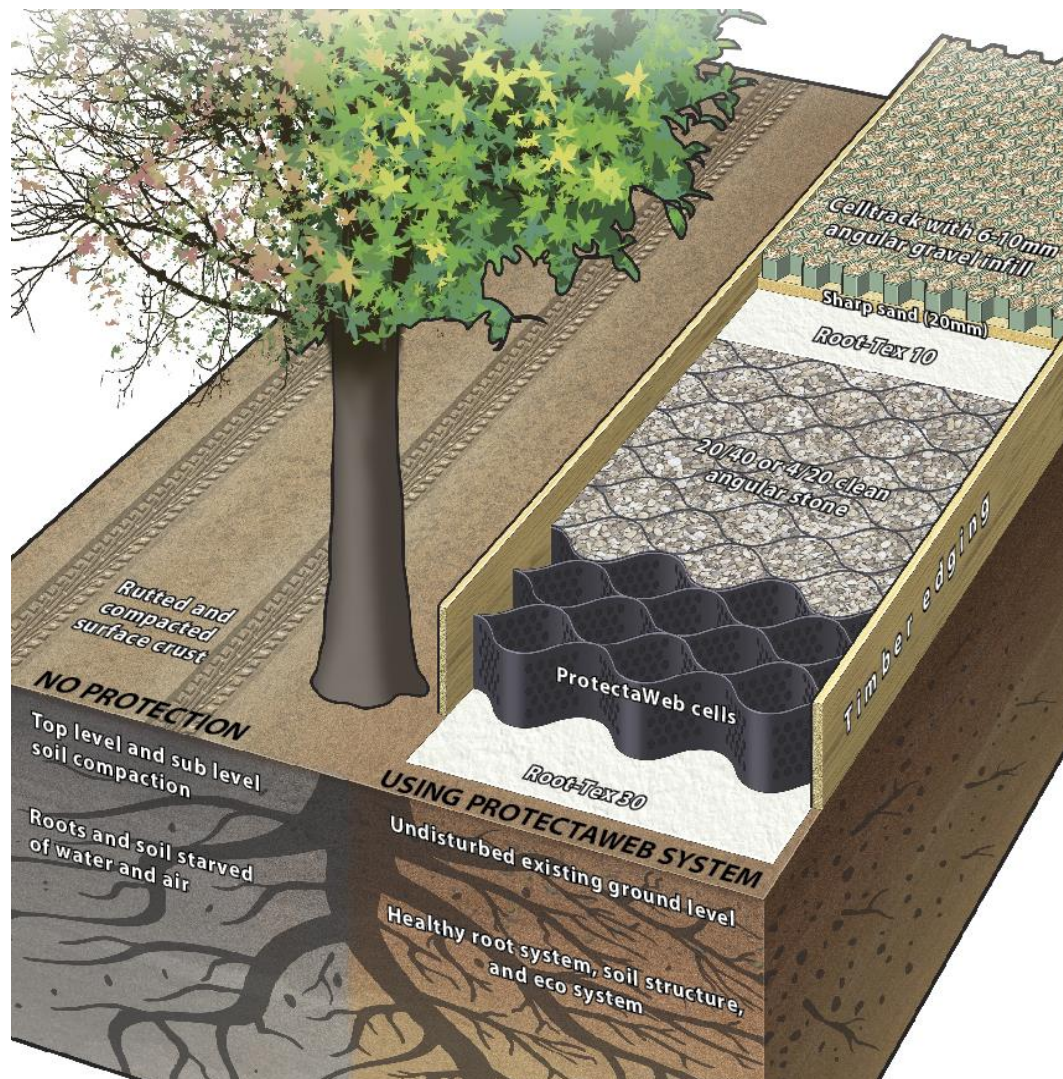
**Figure 4:** A good example of the principles of a no-dig surface.

The no-dig construction principles are outlined below and the areas to which they apply are shown on the TPP (shaded with orange honeycomb). A useful example diagram (by Protectoweb) is shown below (Figure 4).

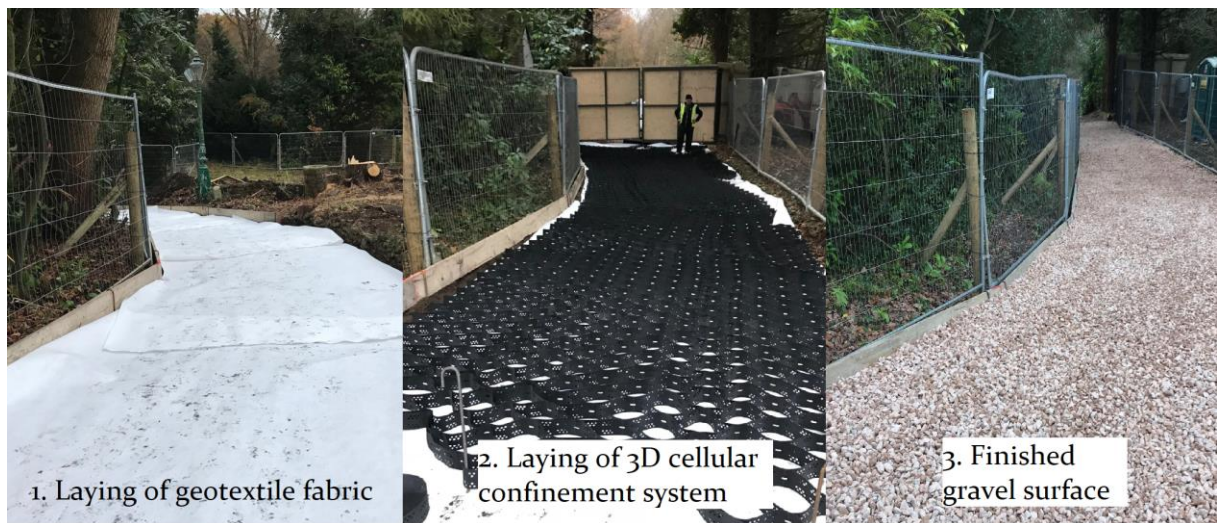
**Photo 3:** Three stages of a 'no-dig' driveway under construction.

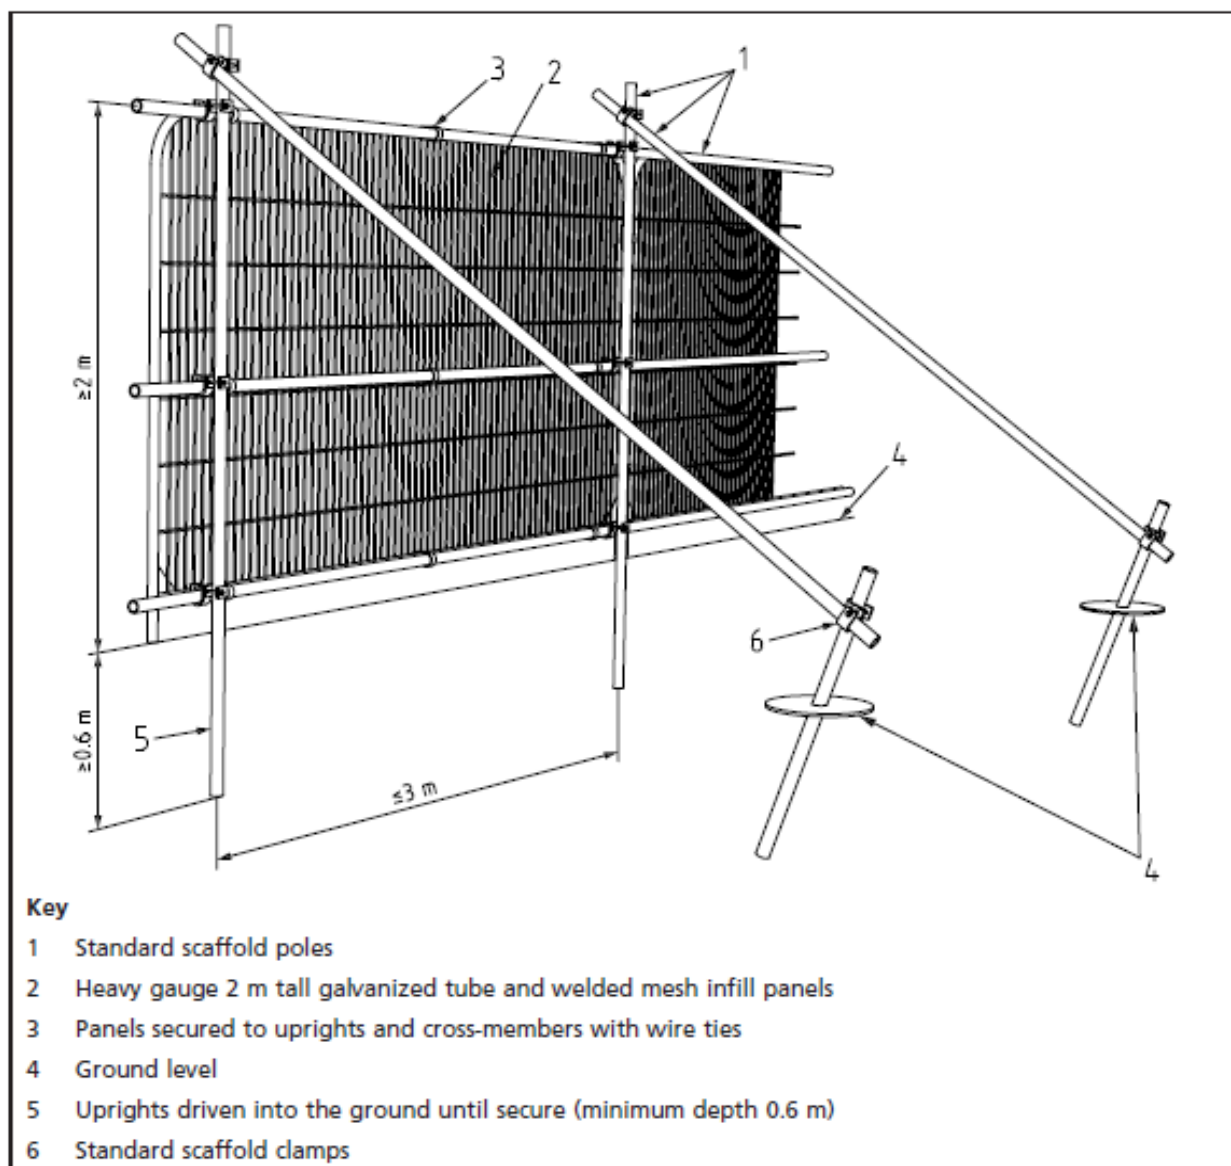
**Figure 2:** Default specification for protective barrier (BS 5837:2012)

The framework support (shown in Figure 2 and photo 1) is the usual method of support for 'Heras' fencing. Some variations are possible if site conditions are appropriate; i.e. support by wooden posts (75mm x 75mm x 2.75m) dug or concreted into the ground (dry mix concrete contained within a plastic bag), or if there is no pressure for access, a lighter form of netting on stakes.

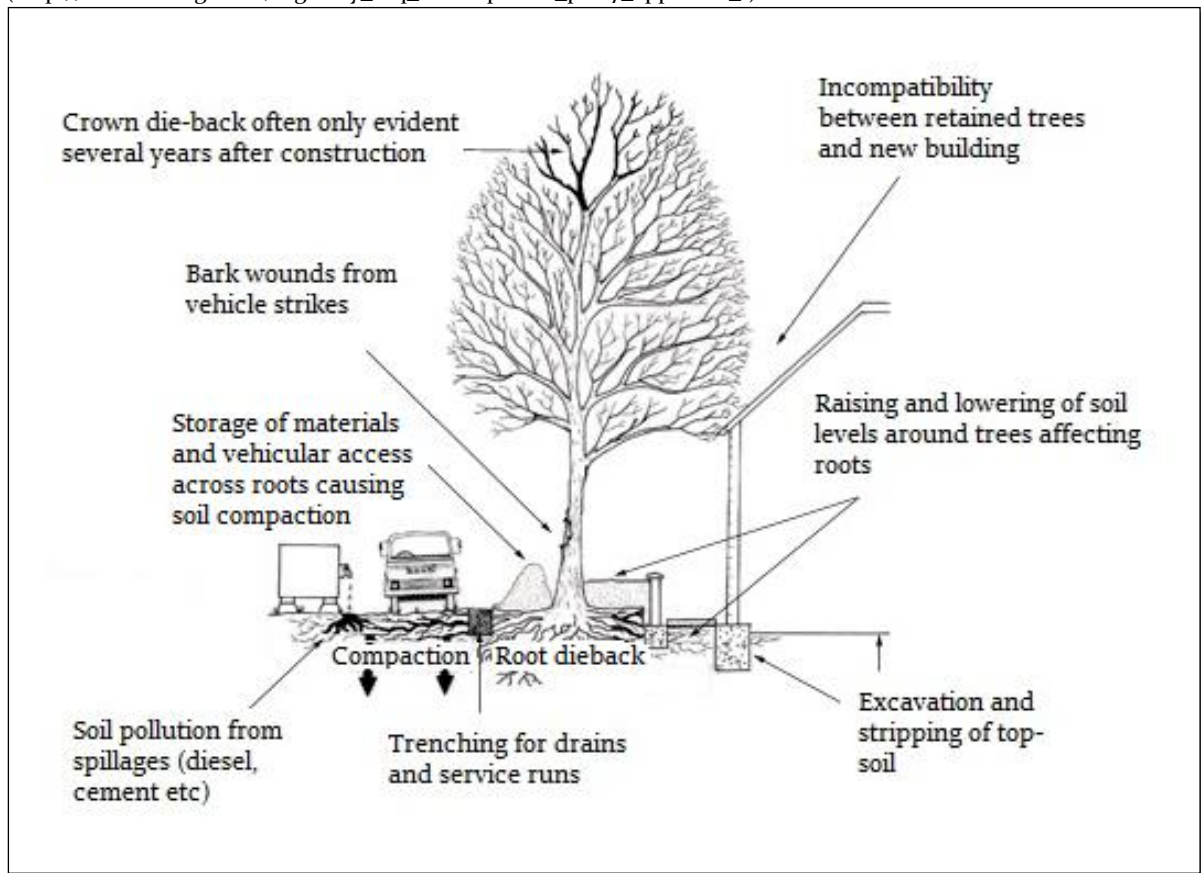
**Figure 4:** Common problems for trees on development sites  
([http://www.leics.gov.uk/highway\\_req\\_development\\_part7\\_appendix\\_f](http://www.leics.gov.uk/highway_req_development_part7_appendix_f))
