Project: **Haydon School Pinner**

Title: **Tree Constraints Plan**

Document Number: **5477-RPS-XX-XX-DR-AR-91001**
 Project Code - Originator - Zone - Level - Type - Role - Drawing Number
 RPS Project Number: **794-PLN-LAN-5477** Subtitle: **S03** Revision: **P01**
 rpsgroup.com

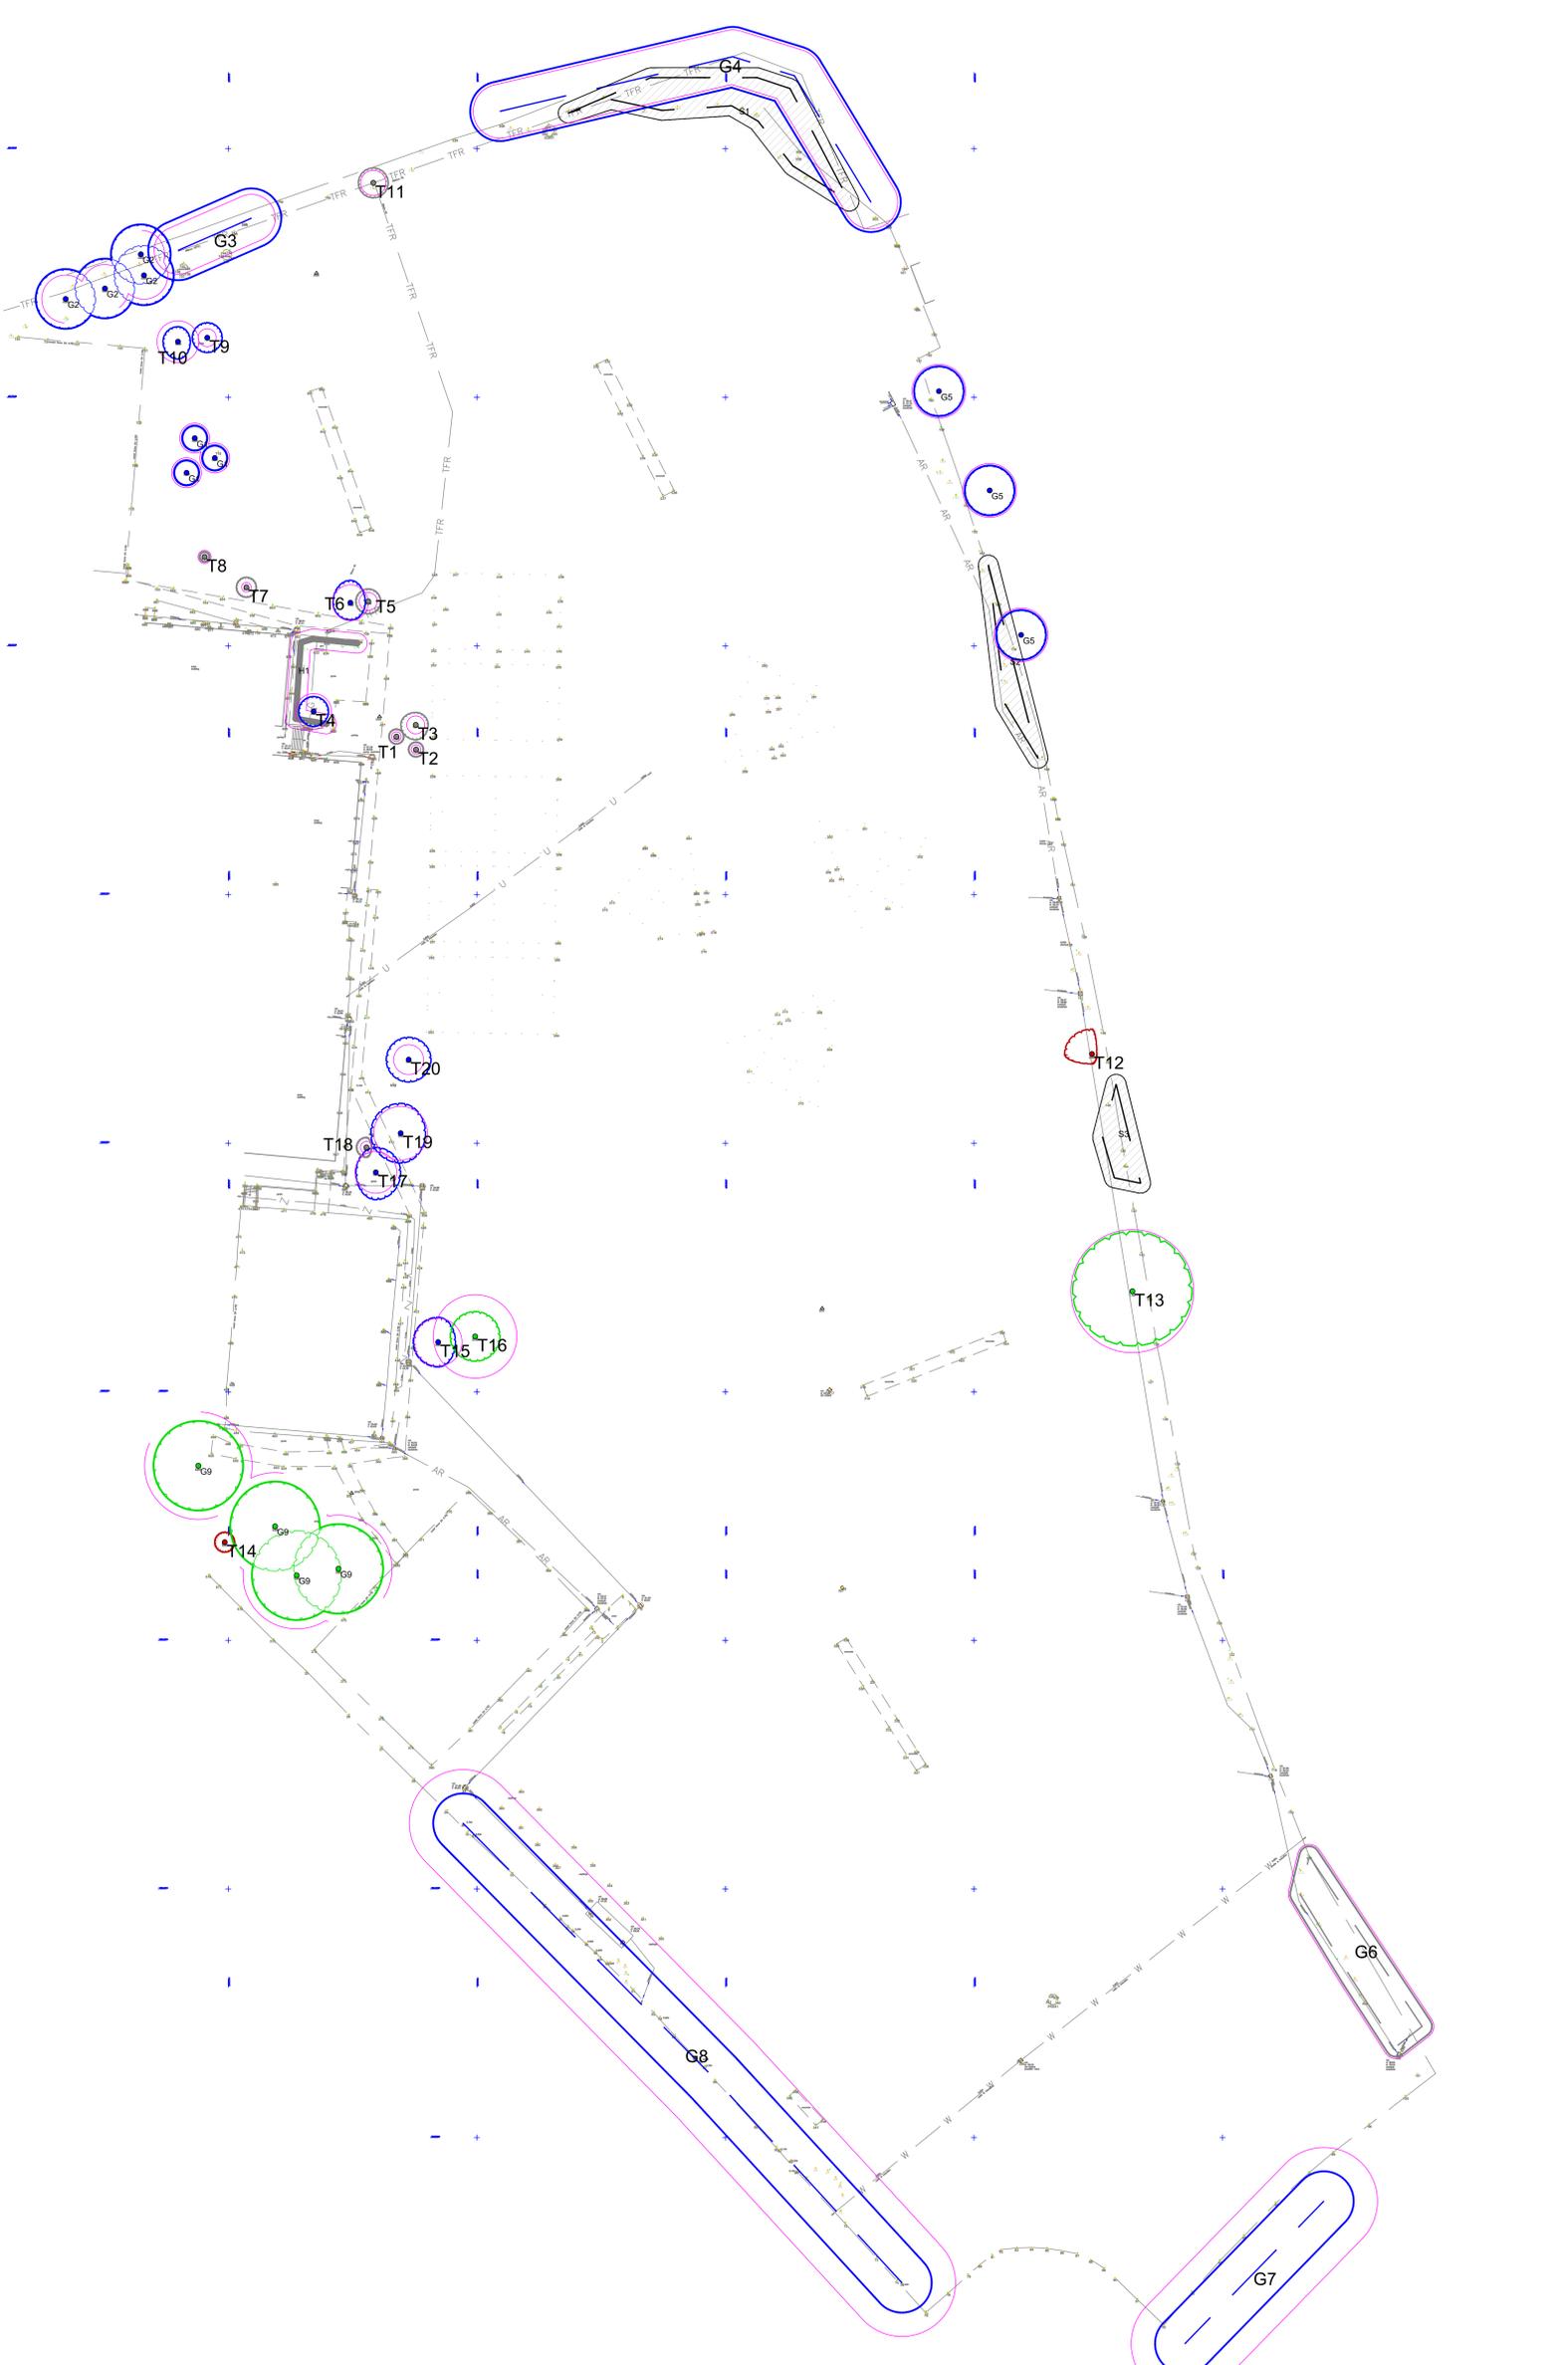
- Refer to RPS Tree Survey Report & Schedule for further details.
- Survey based on a visual inspection from the ground and is not intended as a full arboricultural inspection.
- Plans produced in accordance with recommendations set out in BS 5837:2012 - 'Trees in Relation to Design, Demolition and Construction'.
- Due to the tight protection afforded to breeding birds vegetation removal should not take place during the bird nesting period, generally, although not restricted to March - August inclusive.
- Survey based upon topographic survey RPS1617 - Haydon School
