**SUBJECT**  
**Response to Drainage Planning questions –**  
**Warrender Primary School**

**CLIENT**  
 London Borough of Hillingdon

**DATE**  
 01 February 2017

**PROJECT NUMBER**  
 35311100

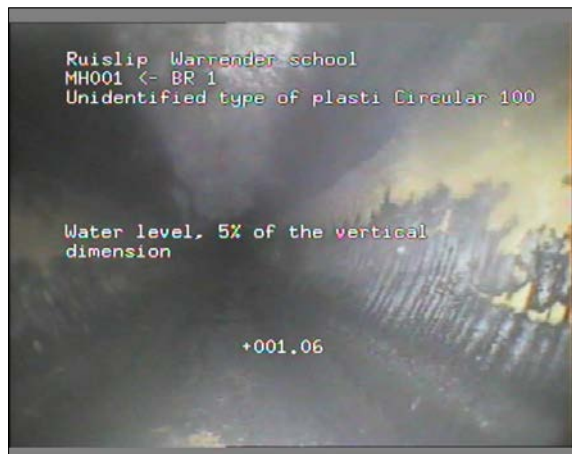
Photo: 6\_6\_23\_A.JPG  
 1.06m, Water level, 5% of the vertical dimension

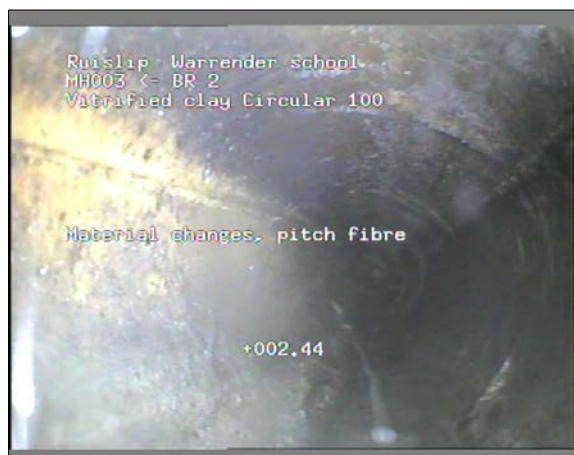
Photo: 8\_8\_32\_A.JPG  
 2.44m, Material changes, pitch fibre

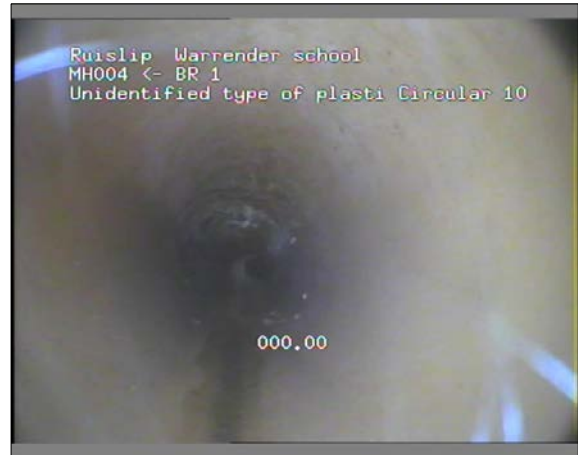
Photo: 10\_10\_40\_A.JPG  
 0m, Water level, 0% of the vertical dimension

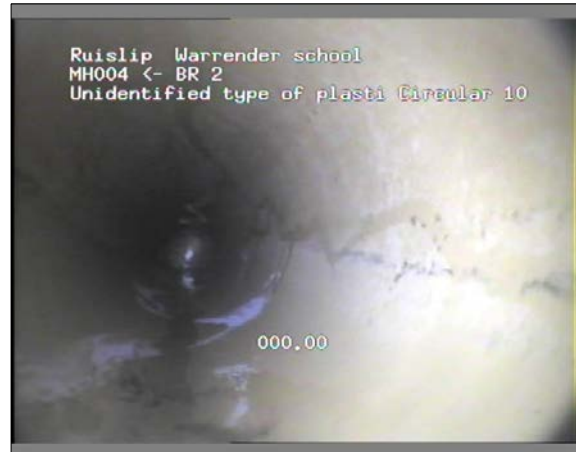
Photo: 11\_11\_43\_A.JPG  
 0m, Water level, 0% of the vertical dimension

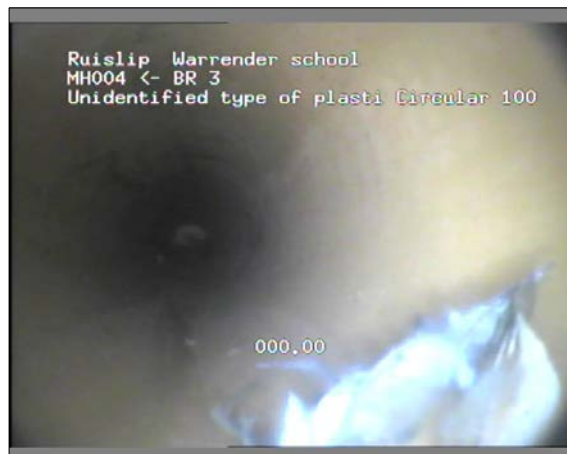
Photo: 12\_12\_46\_A.JPG  
 0m, Water level, 0% of the vertical dimension

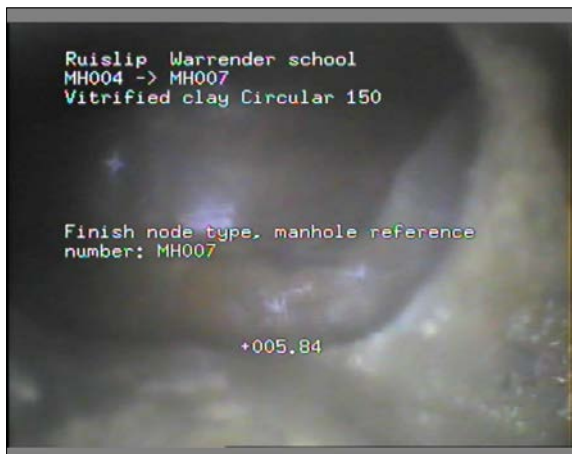
Photo: 13\_13\_52\_A.JPG  
5.84m, Finish node type, manhole reference number: MH007

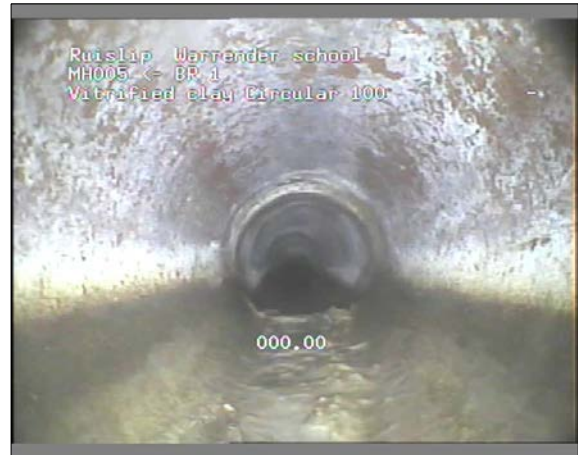
Photo: 14\_14\_54\_A.JPG  
 0m, Water level, 0% of the vertical dimension

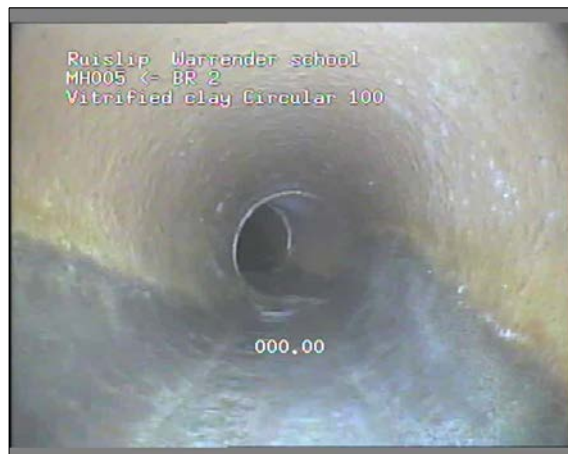
Photo: 15\_15\_59\_A.JPG  
0m, Water level, 0% of the vertical dimension

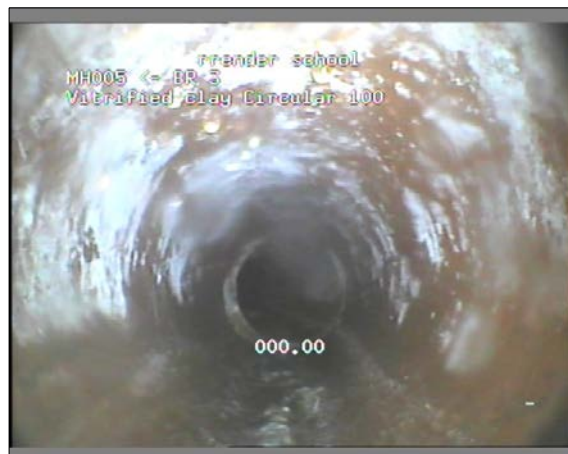
Photo: 16\_16\_63\_A.JPG  
 0.19m, Water level, 0% of the vertical dimension

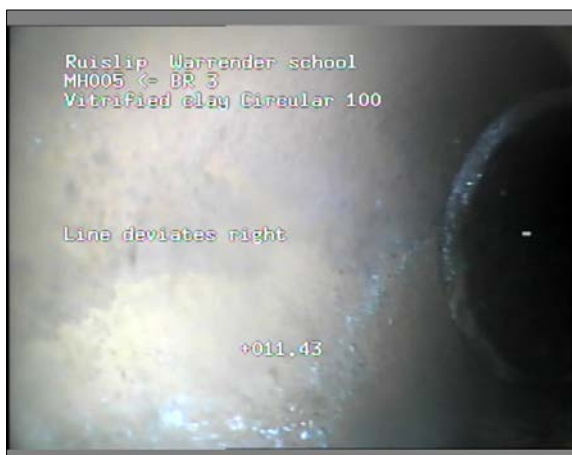
Photo: 16\_16\_64\_A.JPG  
 11.43m, Line deviates right

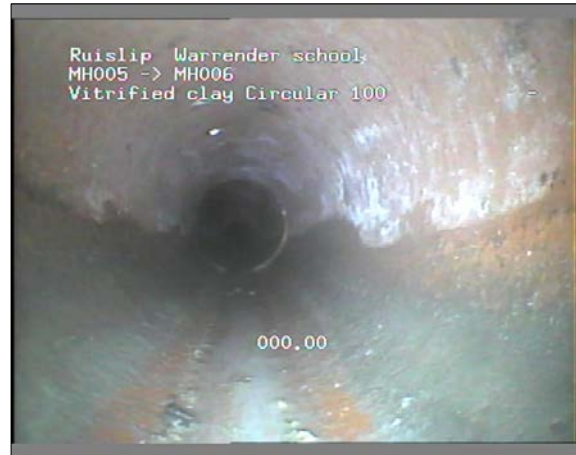
Photo: 17\_17\_67\_A.JPG  
 0m, Water level, 0% of the vertical dimension

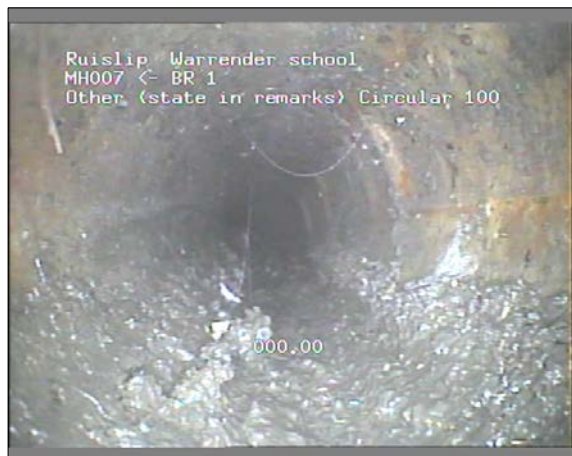
Photo: 18\_18\_70\_A.JPG  
 0m, Water level, 0% of the vertical dimension

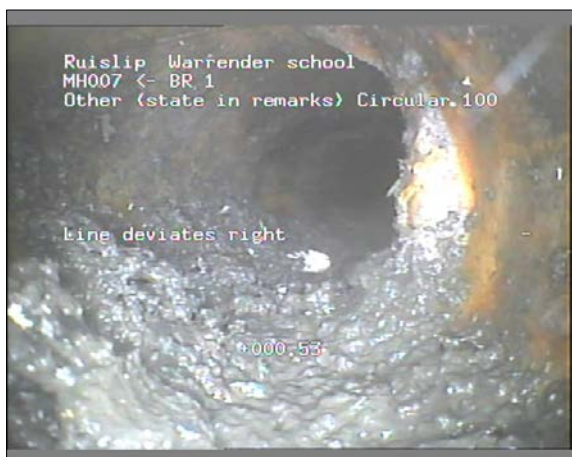
Photo: 18\_18\_71\_A.JPG  
 0.53m, Line deviates right

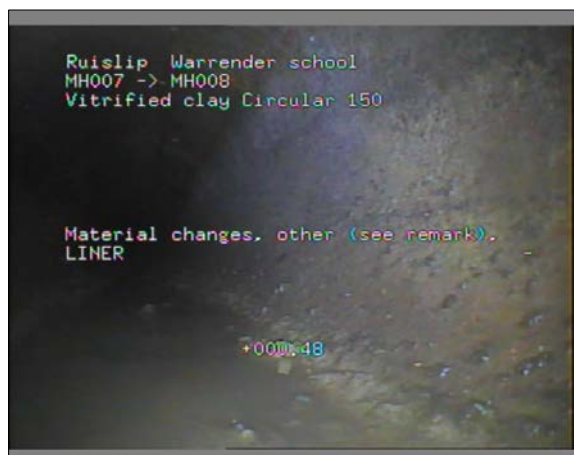
Photo: 21\_21\_86\_A.JPG  
0.48m, Material changes, other (see remark)

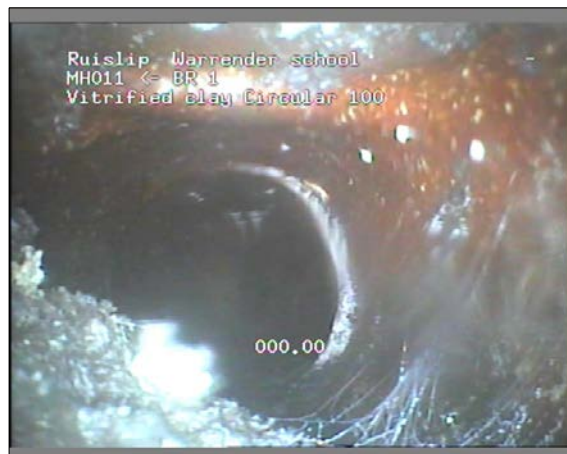
Photo: 27\_27\_109\_A.JPG  
 0m, Water level, 0% of the vertical dimension

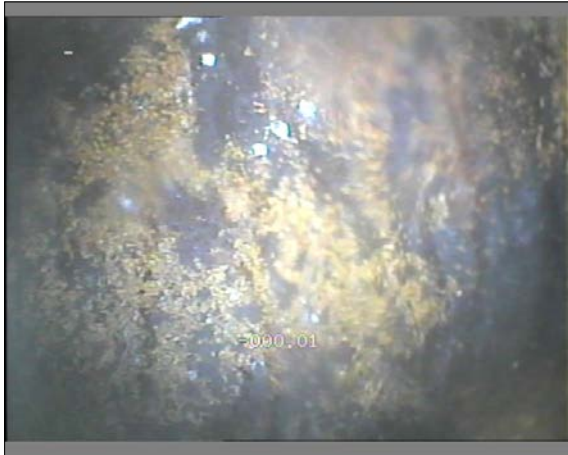
Photo: 28\_28\_113\_A.JPG  
 -0.01m, Water level, 0% of the vertical dimension

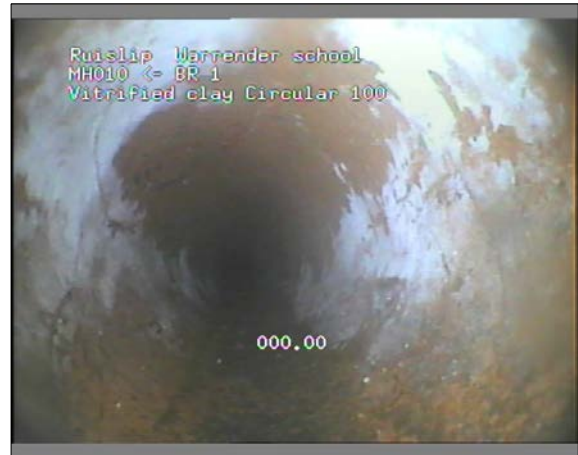
Photo: 29\_29\_116\_A.JPG  
 0m, Water level, 0% of the vertical dimension

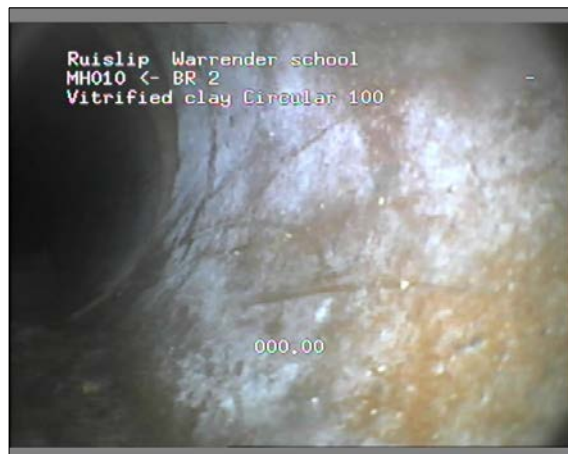
Photo: 30\_30\_119\_A.JPG  
0m, Water level, 0% of the vertical dimension

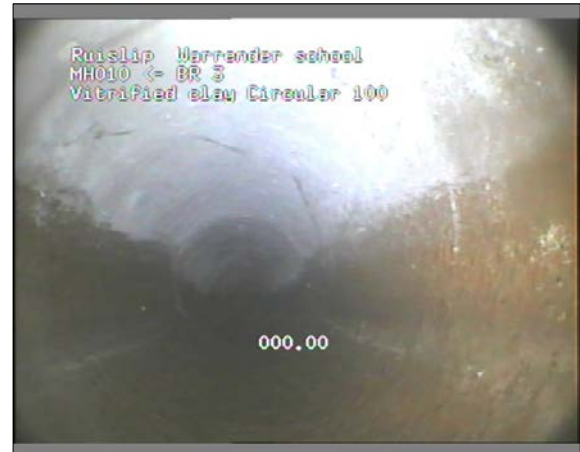
Photo: 31\_31\_122\_A.JPG  
0m, Water level, 0% of the vertical dimension

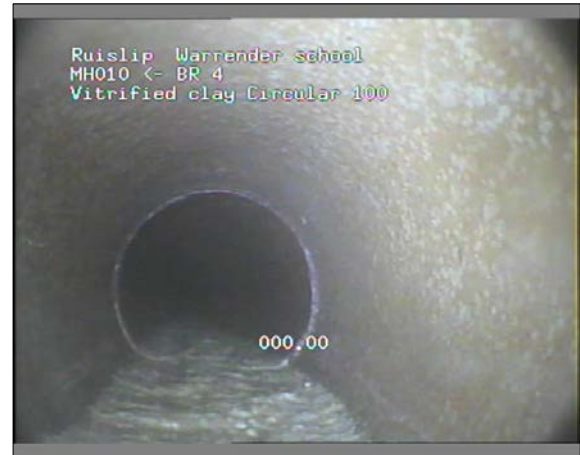
Photo: 32\_32\_126\_A.JPG  
 0m, Water level, 0% of the vertical dimension

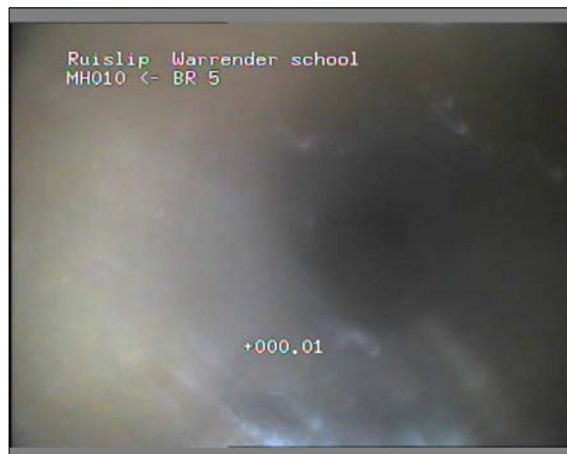
Photo: 33\_33\_129\_A.JPG  
 0m, Water level, 0% of the vertical dimension

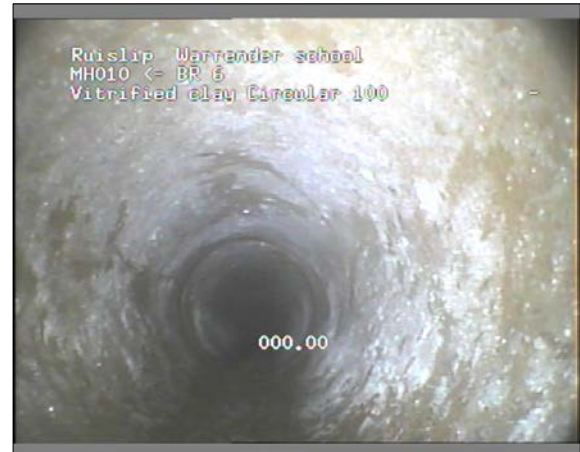
Photo: 34\_34\_132\_A.JPG  
 0m, Water level, 0% of the vertical dimension

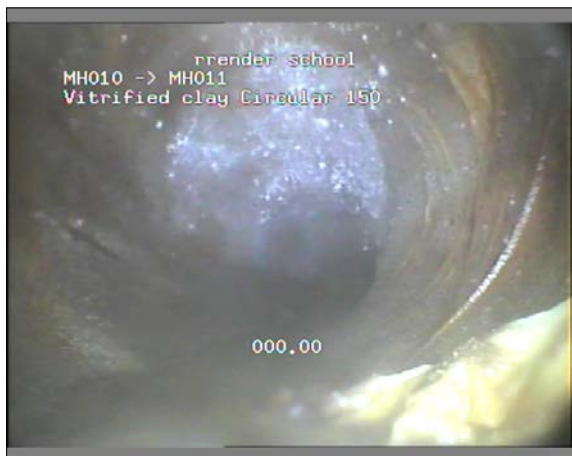
Photo: 35\_35\_136\_A.JPG  
-1.4m, Water level, 0% of the vertical dimension

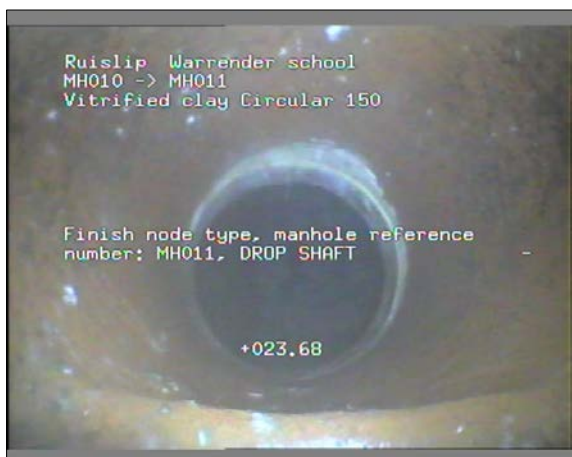
Photo: 35\_35\_137\_A.JPG  
23.68m, Finish node type, manhole reference number: MH011

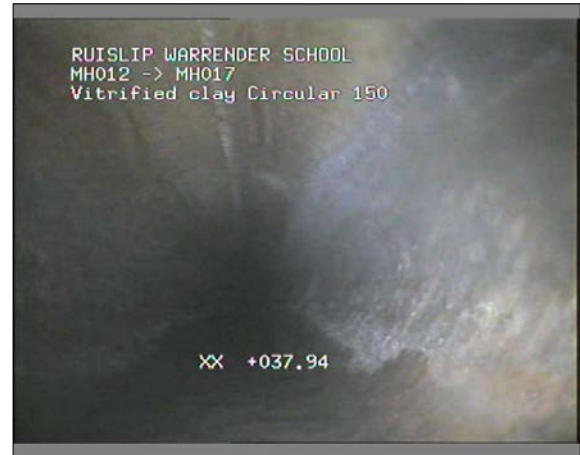
Photo: 39\_39\_154\_A.jpg  
12.23m, Survey abandoned

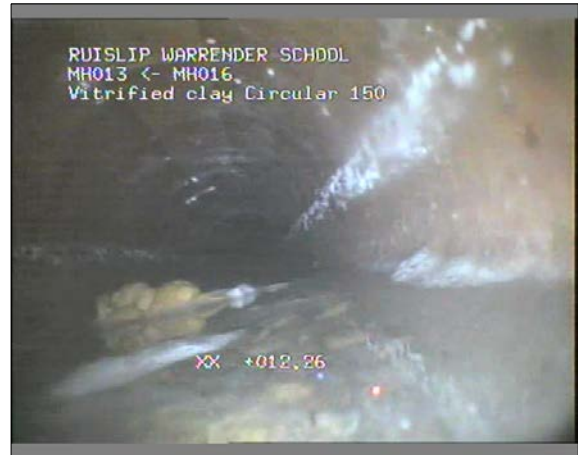
Photo: 45\_45\_173\_A.jpg  
 12.26m, Water level, 15% of the vertical dimension

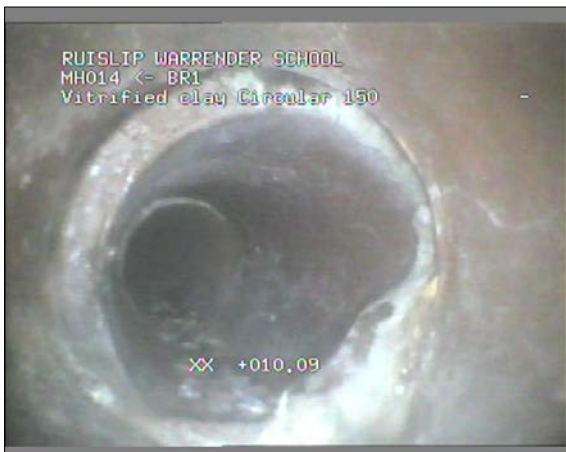
1:90	Position	Observation	Photo
	0.00	Water level, 0% of the vertical dimension	
	0.00	Start node type, manhole, reference number : MH014	48_48_182_A.jpg
	10.09	Joint displaced, medium	48_48_183_A.jpg
	10.09	Survey abandoned	48_48_184_A.jpg

Photo: 48\_48\_184\_A.jpg  
10.09m, Survey abandoned

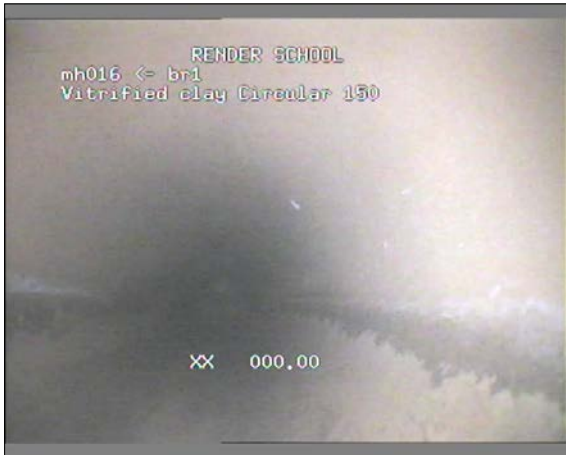
Photo: 58\_58\_217\_A.jpg  
 0m, Water level, 0% of the vertical dimension
