Site Vision Surveys

Warrender School

19 December 2016

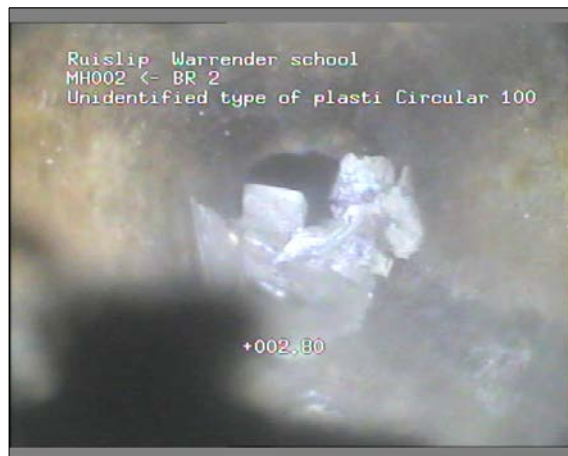
Photo: 4\_4\_15\_A.JPG  
2.8m, Survey abandoned

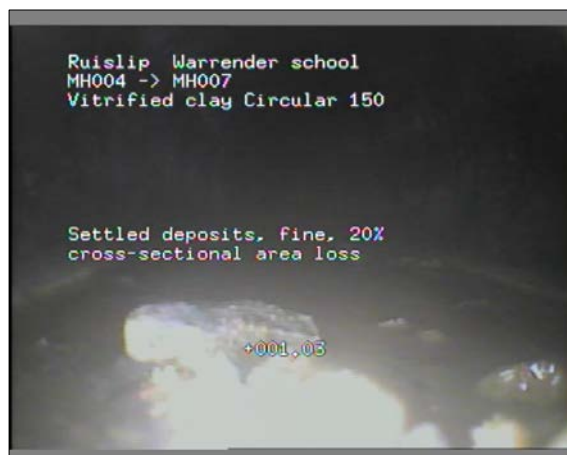
Photo: 13\_13\_51\_A.JPG  
 1.03m, Settled deposits, fine, 20% cross-sectional area loss

Grade 3; Best practice suggests consideration be given to maintenance activities in the medium term

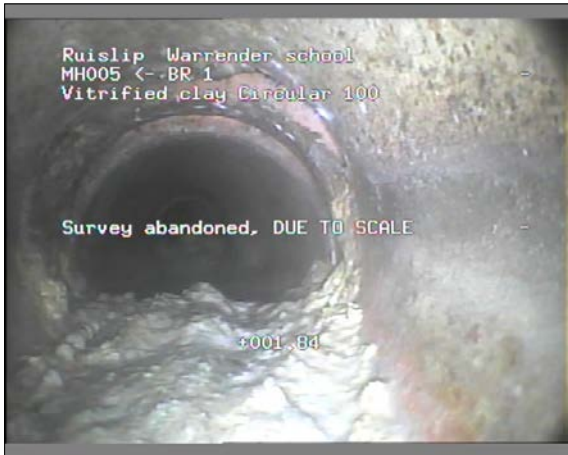
Photo: 14\_14\_57\_A.JPG  
1.84m, Survey abandoned

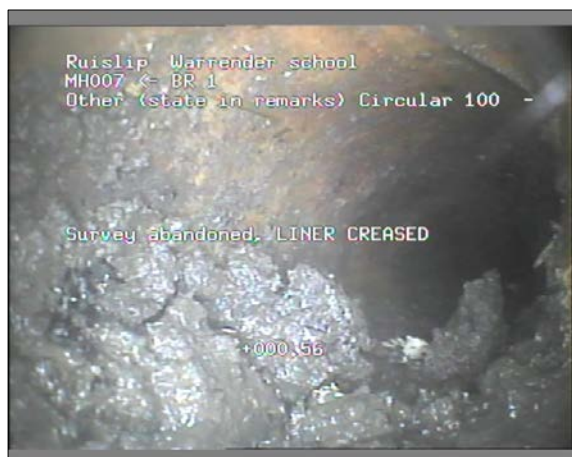
Photo: 18\_18\_71\_A.JPG  
 0.53m, Line deviates right

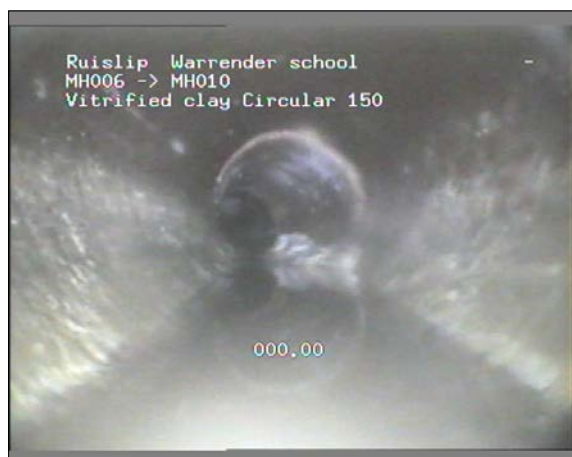
Photo: 26\_26\_103\_A.JPG  
 0m, Start node type, manhole, reference number : MH006

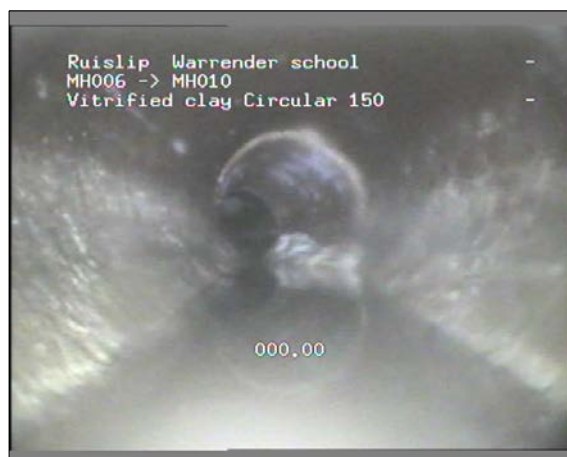
Photo: 26\_26\_104\_A.JPG  
 0m, Water level, 0% of the vertical dimension

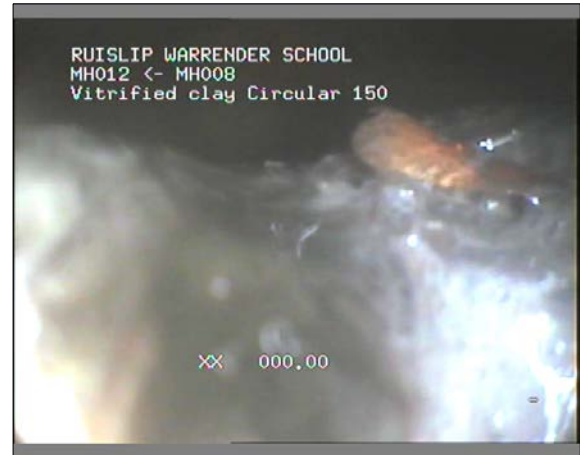
Photo: 38\_38\_151\_A.jpg  
0m, Survey abandoned

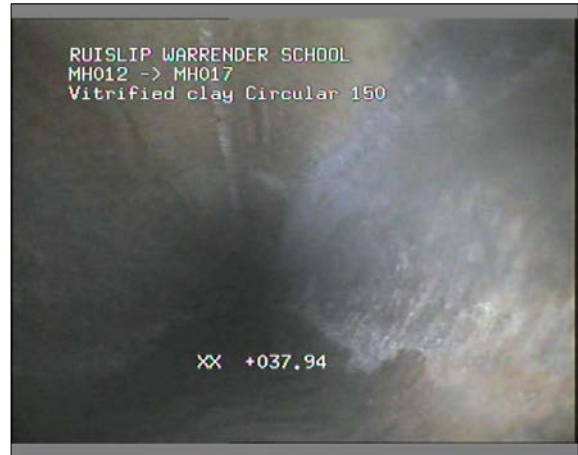
Photo: 39\_39\_154\_A.jpg  
12.23m, Survey abandoned

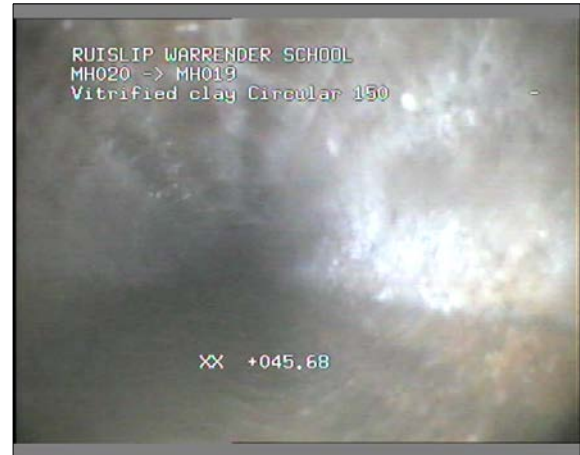
Photo: 40\_40\_157\_A.jpg  
 45.68m, Survey abandoned

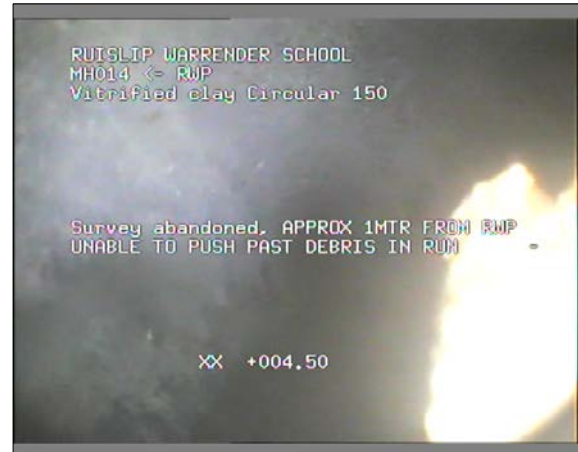
Photo: 42\_42\_164\_A.jpg  
4.5m, Survey abandoned

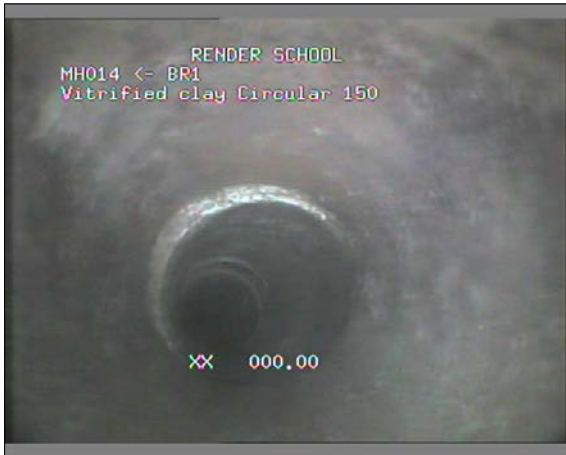
Photo: 48\_48\_182\_A.jpg  
0m, Start node type, manhole, reference number : MH014

1:90	Position	Observation	Photo
	0.00	Water level, 0% of the vertical dimension	
	0.00	Start node type, manhole, reference number : MH014	48_48_182_A.jpg
	10.09	Joint displaced, medium	48_48_183_A.jpg
	10.09	Survey abandoned	48_48_184_A.jpg

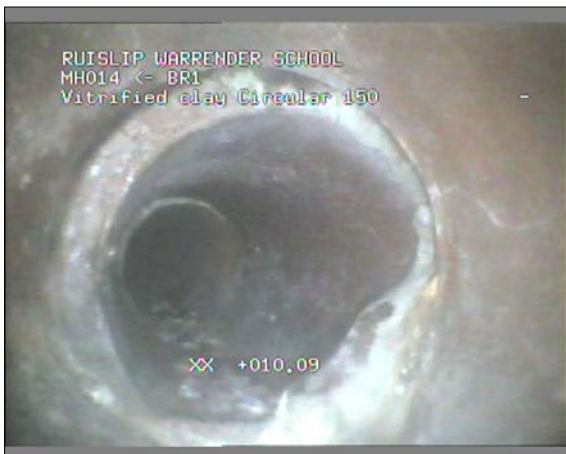
Photo: 48\_48\_184\_A.jpg  
10.09m, Survey abandoned

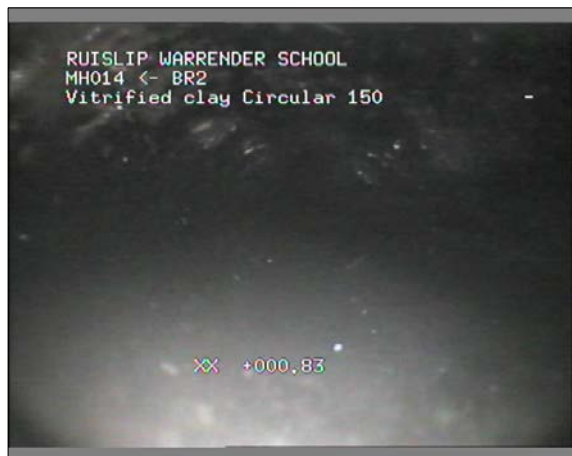
Photo: 49\_49\_188\_A.jpg  
0.83m, Survey abandoned
