## Segro Park Hayes

C14074 - Nestle Avenue Railing Dilapidation Report

Tuesday, 20 October 2020

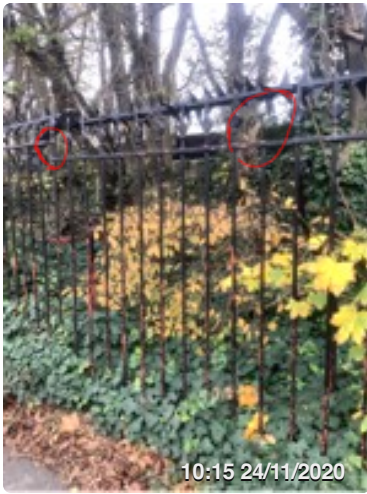
### **Bay 25**

Missing fin

Welding to next panel

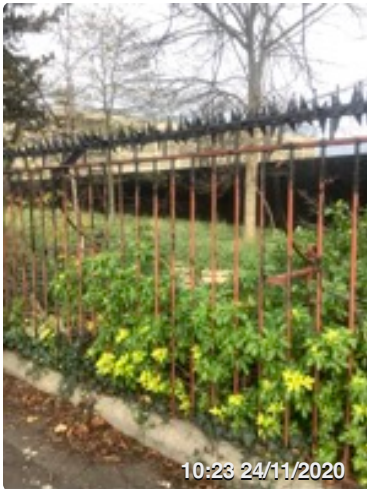
### **Bay 40**

Note, grind down previous fin locations?

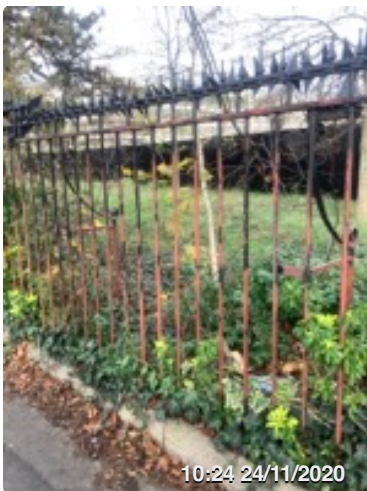
### **Bay 41**

Note, grind down previous fin locations?

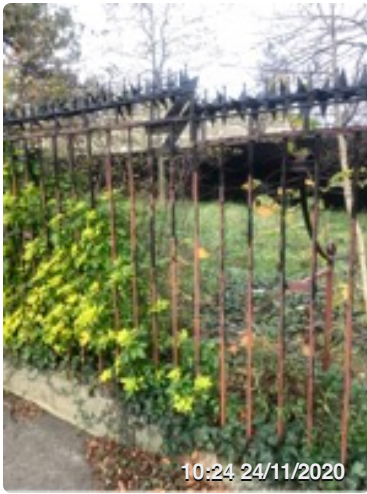
### **Bay 42**

Note, grind down previous fin locations?

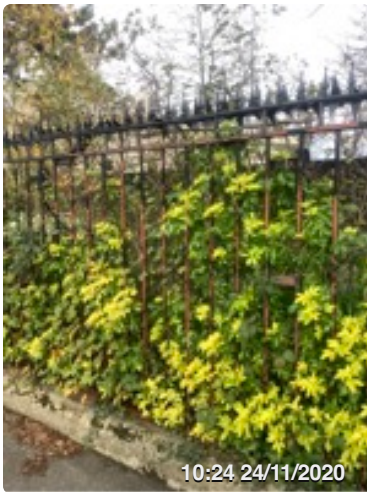
### **Bay 43**

Note, grind down previous fin locations?

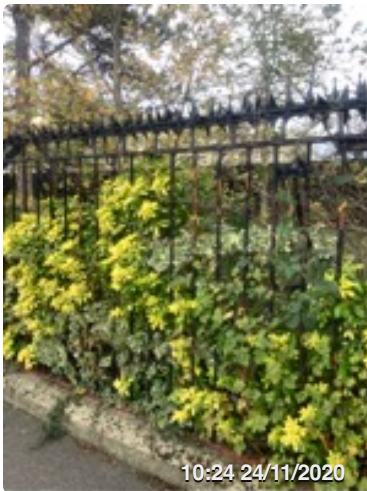
### **Bay 44**

Note, grind down previous fin locations?

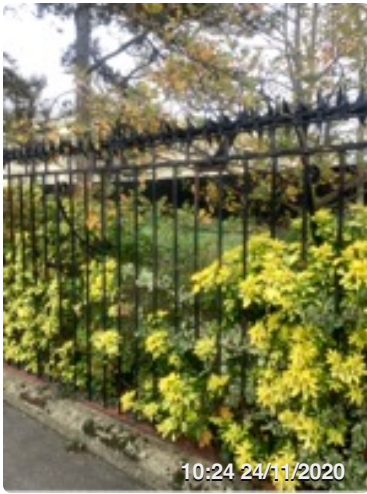
### **Bay 45**

Note, grind down previous fin locations?

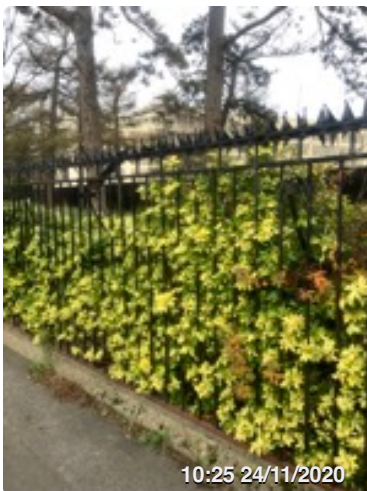
### **Bay 47**

Note, grind down previous fin locations?

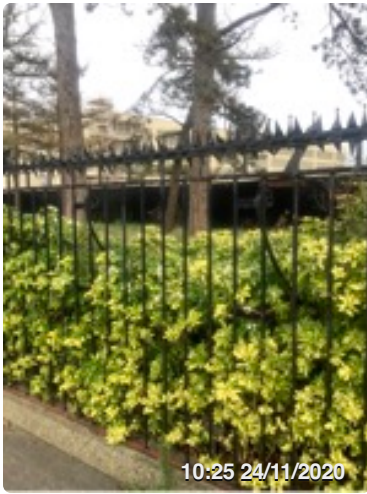
### **Bay 48**

Note, grind down previous fin locations?

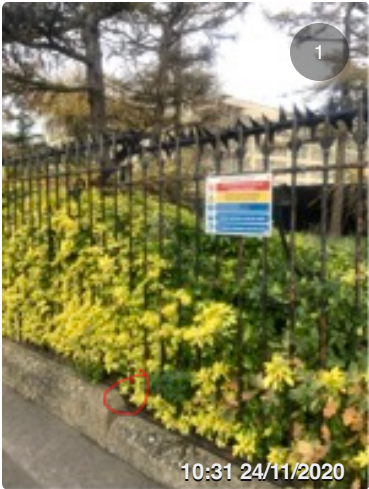
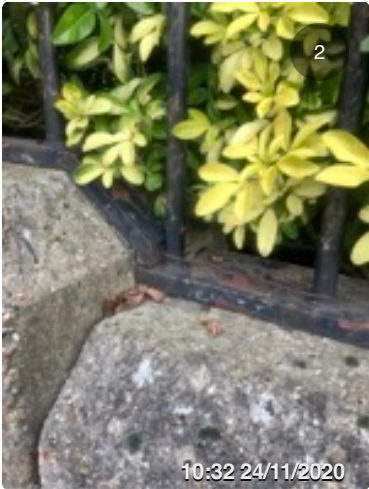
**Bay 63**

Snapped welding bottom rail

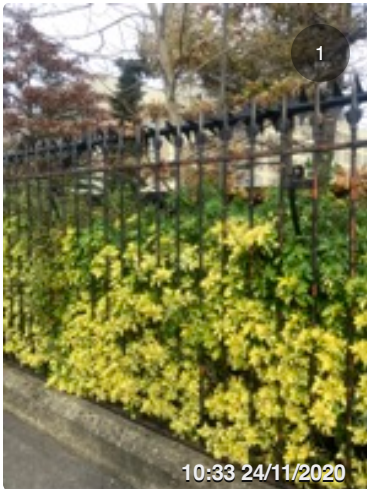
**Bay 67**

Fin out of plumb
