CCTV Inspection Report

Metro Rod (London North West)

Job Number 919711	Surveyed by (Operator) MR MARTIN DOLLING	Base Unit XGFC6NDUIN	Date 25/03/2024
-----------------------------	--	--------------------------------	---------------------------

28 MOOR PARK ROAD
NORTHWOOD
HA6 2DJ

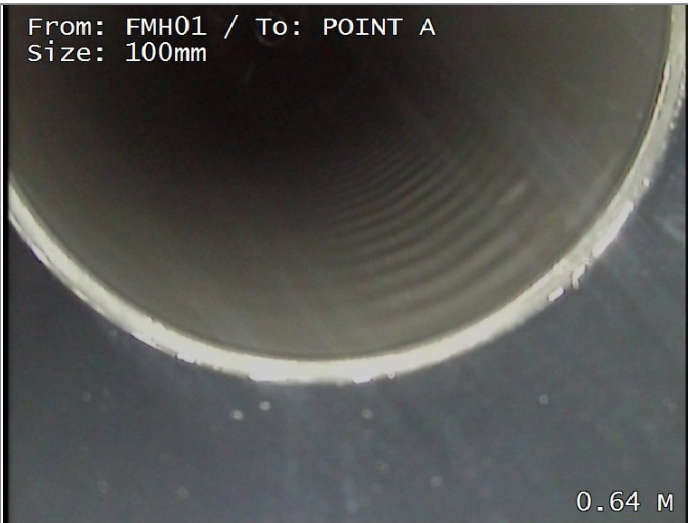
<p>Line of drain/sewer deviates up</p>

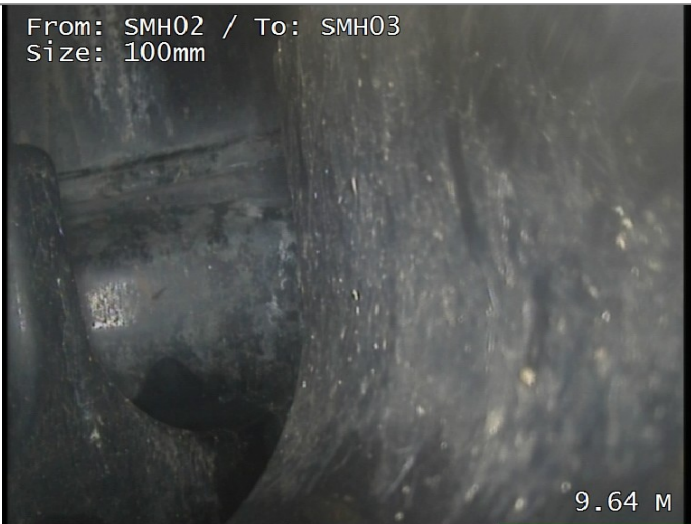
<p>9.26 M</p> <p>Line of drain/sewer deviates right</p>	
<p>From: SMH02 / To: SMH03 Size: 100mm</p>

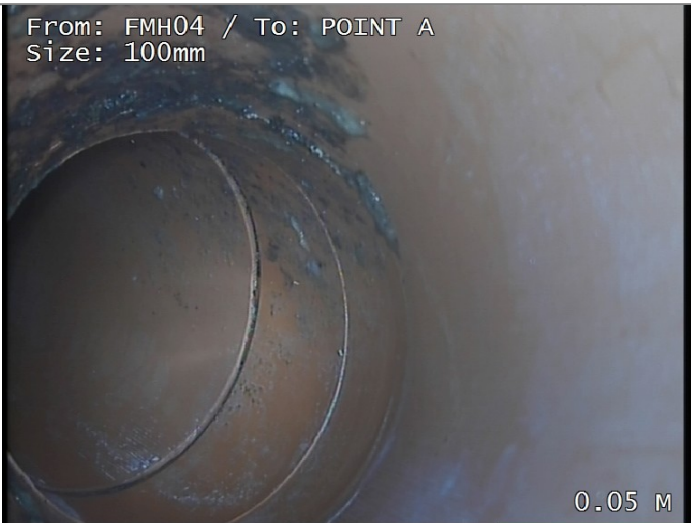
<p>0.05 M</p> <p>Line of drain/sewer deviates left</p>		<p>From: FMH04 / To: POINT A Size: 100mm</p>

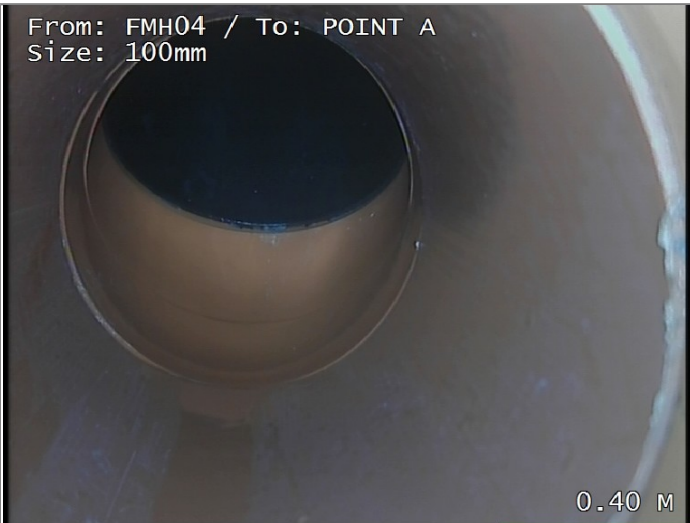
<p>0.40 M</p> <p>Line of drain/sewer deviates up</p>

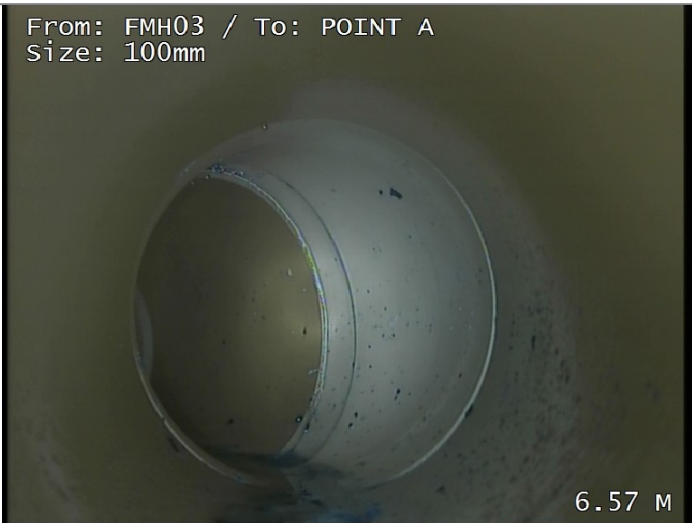
<p>6.57 M</p> <p>Line of drain/sewer deviates left</p>		<p>From: FMH03 / To: POINT A Size: 100mm</p>

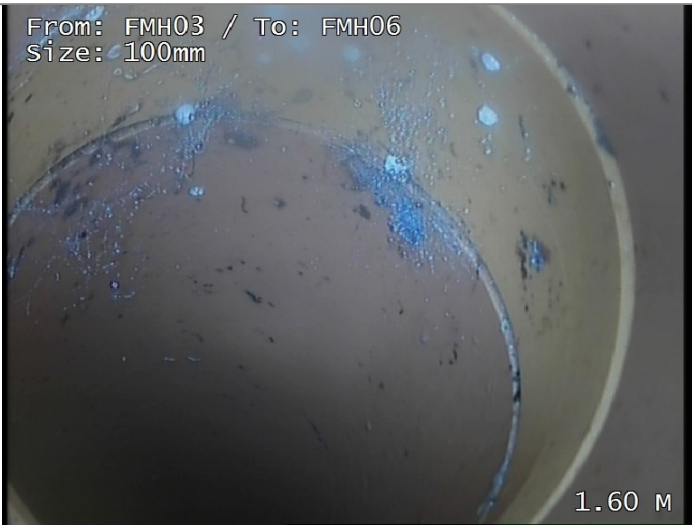
<p>Line of drain/sewer deviates down</p>		<p>From: FMH03 / To: FMH06 Size: 100mm</p>

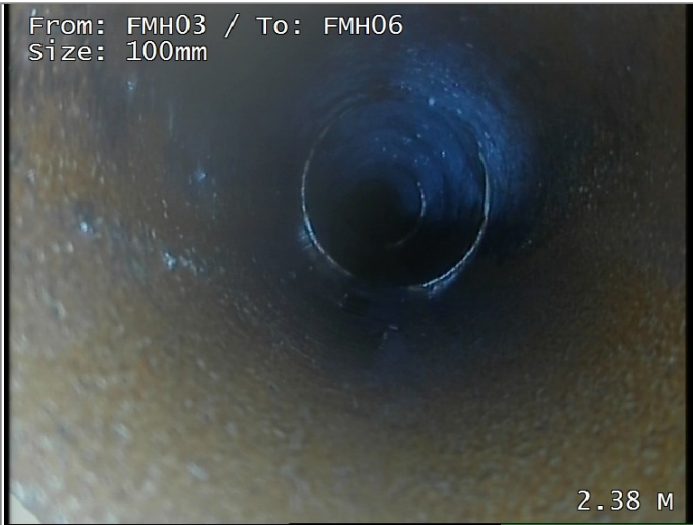
<p>2.38 M</p> <p>Material of drain/sewer changes to vitrified clay at this point</p>		<p>From: FMH03 / To: FMH06 Size: 100mm</p>

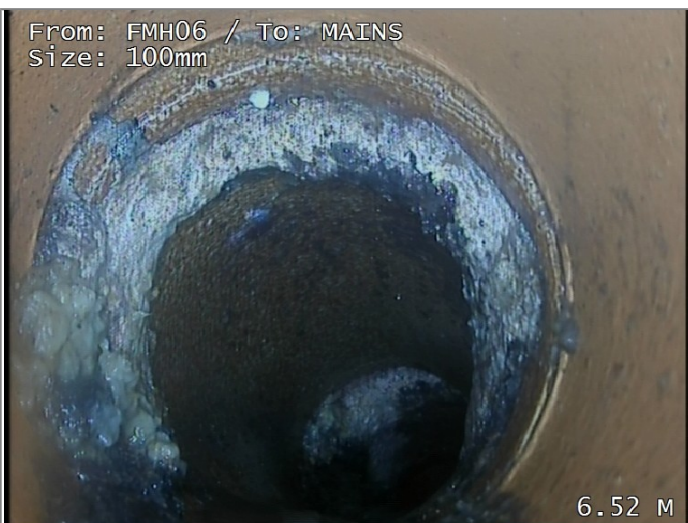
6.52	DEE	Attached deposits, encrustation from 12 to 12 o'clock 30% cross-sectional area loss	9431909	Service / 4
7.24	BRF	Finish node type, major connection without manhole, reference MAINS	9431910	Comment / 0

Attached deposits, encrustation from 12 to 12 o'clock 30% cross-sectional area loss

Service Defects			
Section	PLR	Grade	Fault Description
5	POINT A X	4	Settled deposits fine 50% cross-sectional area loss - Remark: LEAVES
6	SMH02 X	4	Settled deposits coarse 25% cross-sectional area loss, Start
13	FMH06 X	4	Attached deposits, encrustation from 12 to 12 o'clock 30% cross-sectional area loss

Grade 4; Best practice suggests consideration to be given to repair to avoid potential collapse.

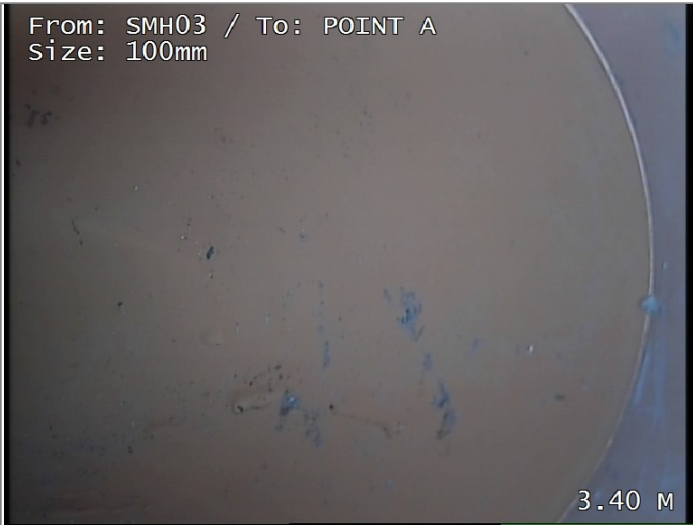
<p>3.40 M</p> <p>Line of drain/sewer deviates left</p>		<p>From: SMH03 / To: POINT A Size: 100mm</p>

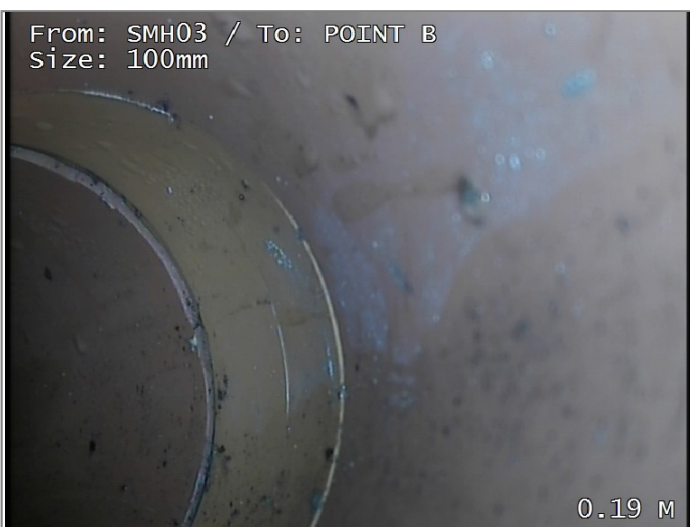
Line of drain/sewer deviates left

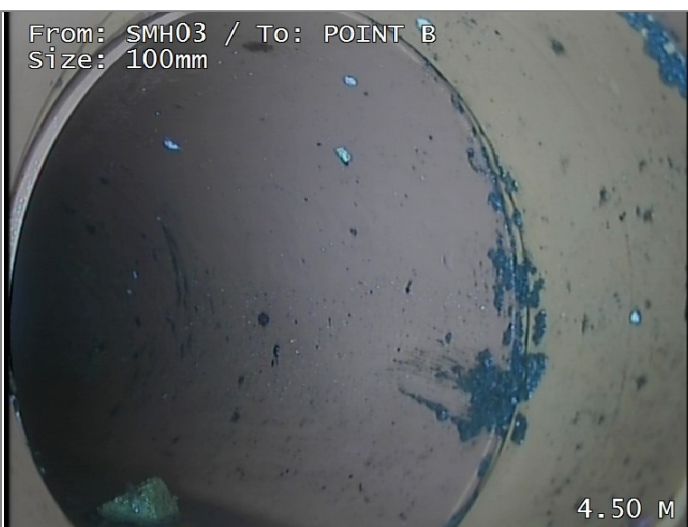
Line of drain/sewer deviates left

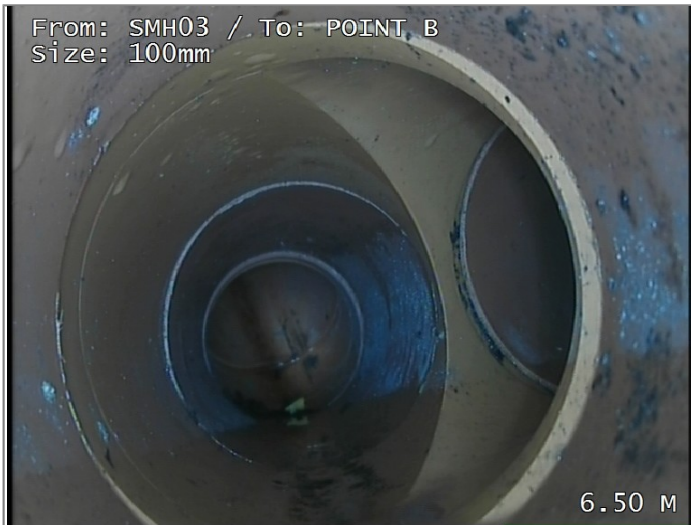
Junction at 3 o'clock, diameter 100mm - Remark: RDP06

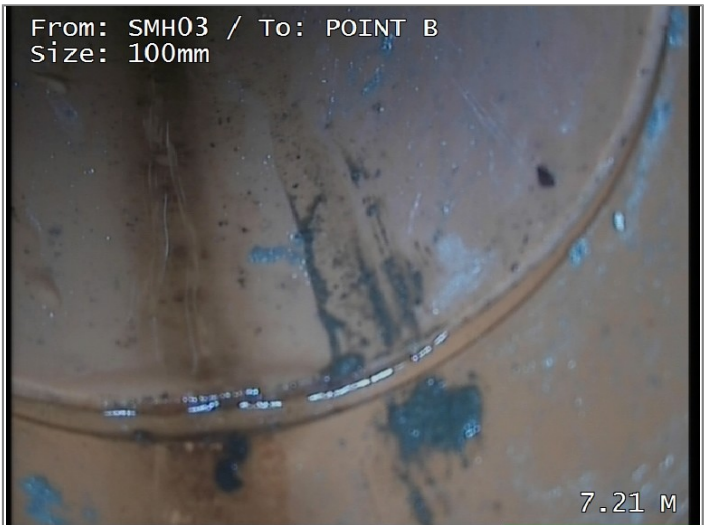
Line of drain/sewer deviates up

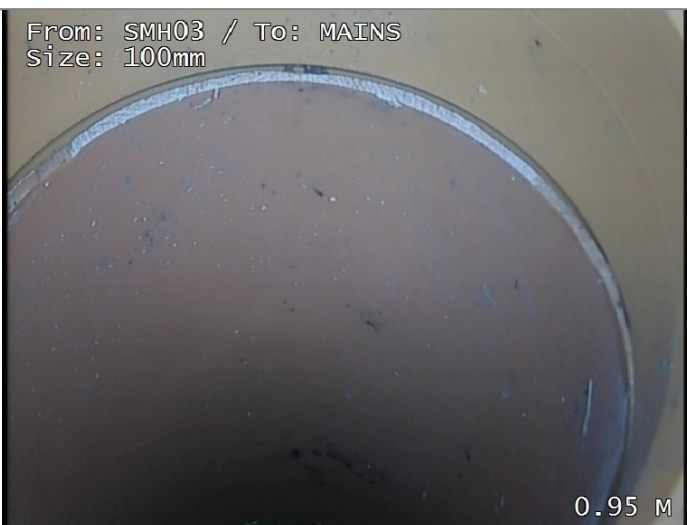
Line of drain/sewer deviates down

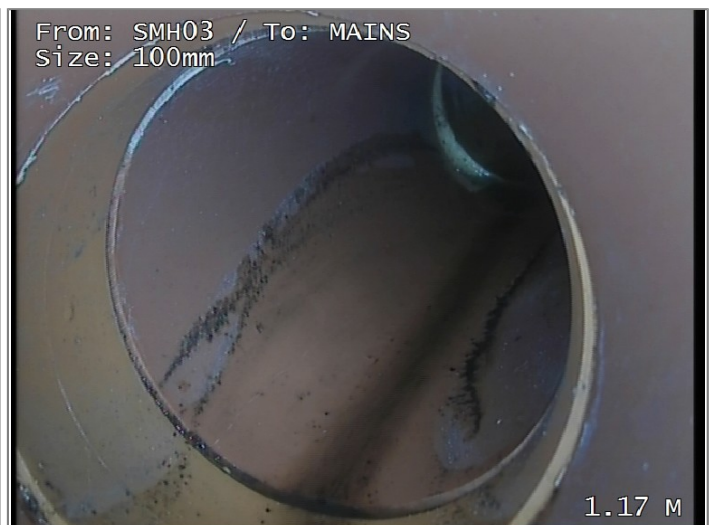
Line of drain/sewer deviates up

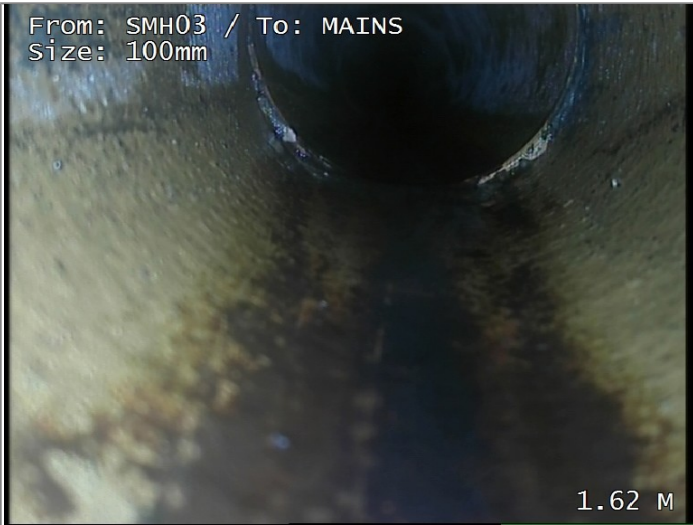
<p>1.62 M</p> <p>Material of drain/sewer changes to vitrified clay at this point</p>		<p>From: SMH03 / To: MAINS Size: 100mm</p>
