## SD - Damage:

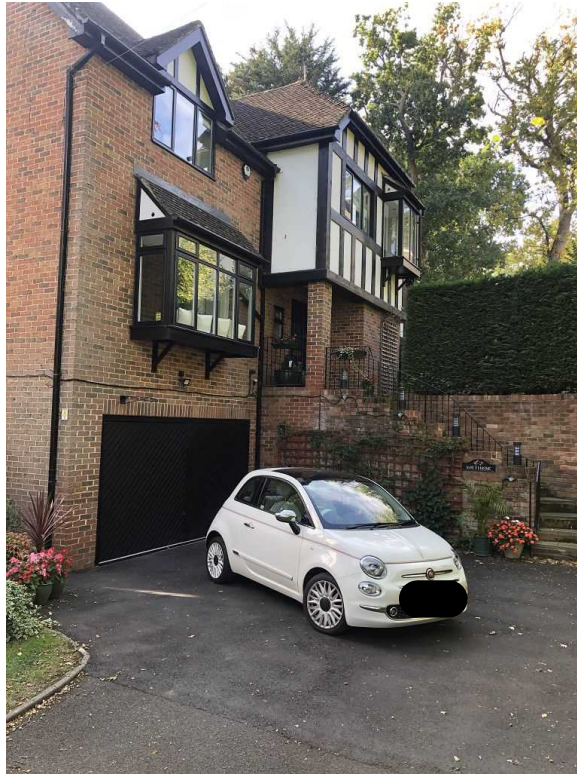
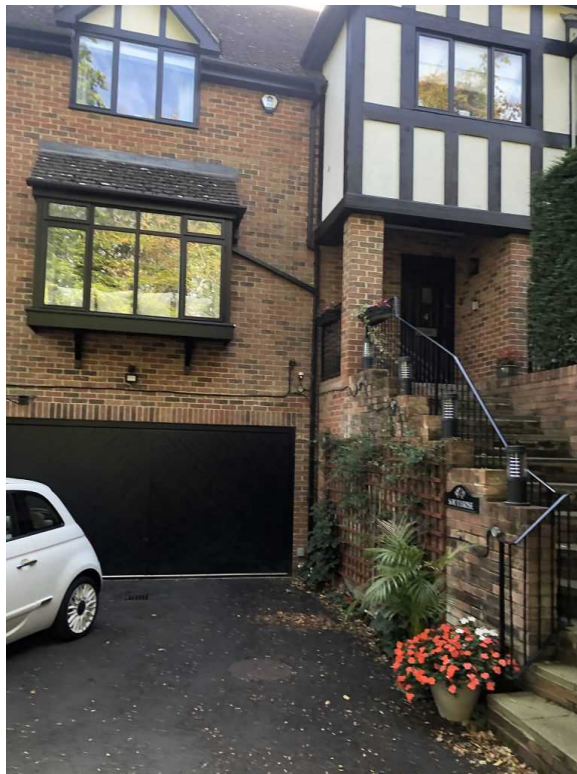
Front elevation

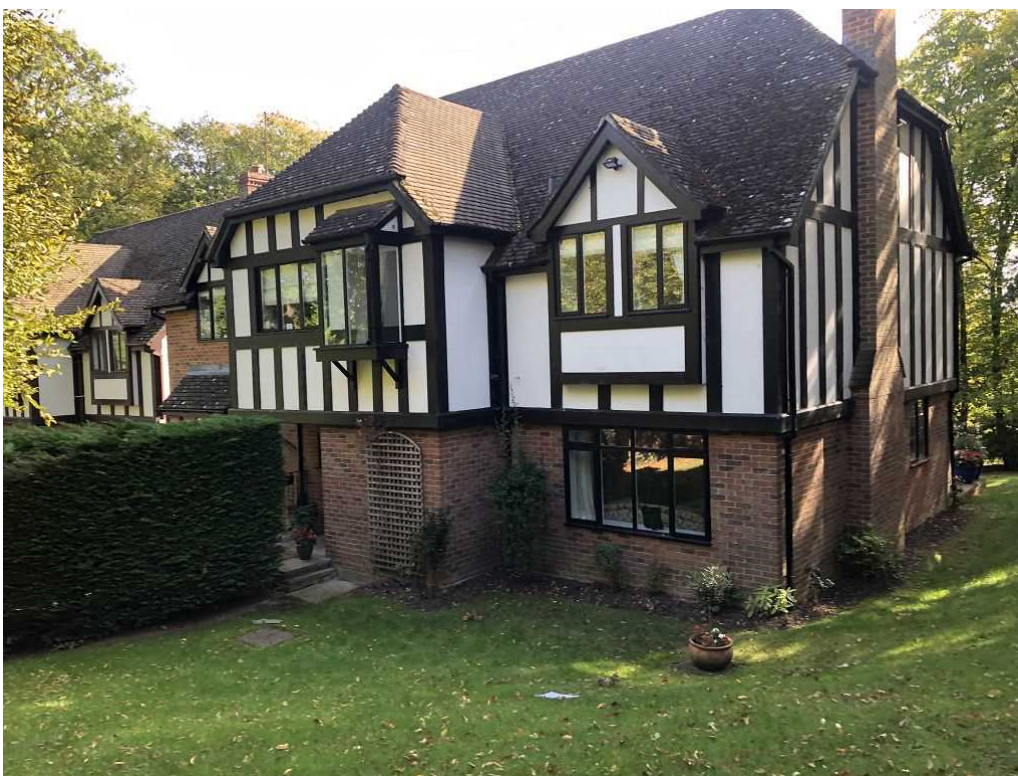
14

Front right corner and right side flank. Note insureds hedging and large trees on right side and rear

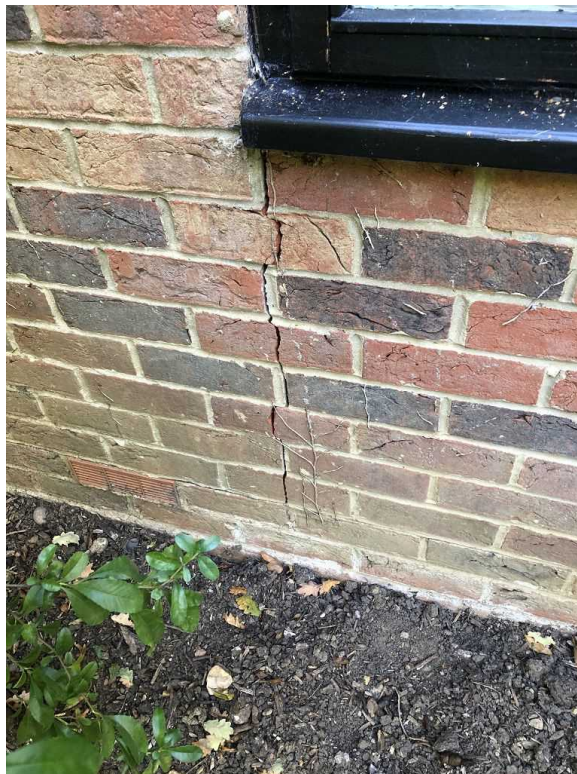
18

Back to the front right corner the insureds engineer report identifies the vertical crack left of lounge window and upper bedroom box window

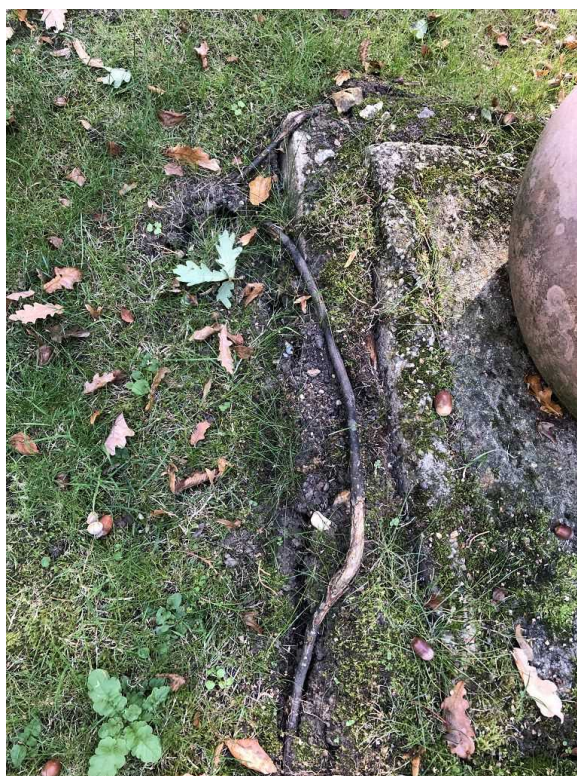
26

A manhole is close to the front right corner. See the tree roots around the manhole and generally coming up through the lawn in multiple places

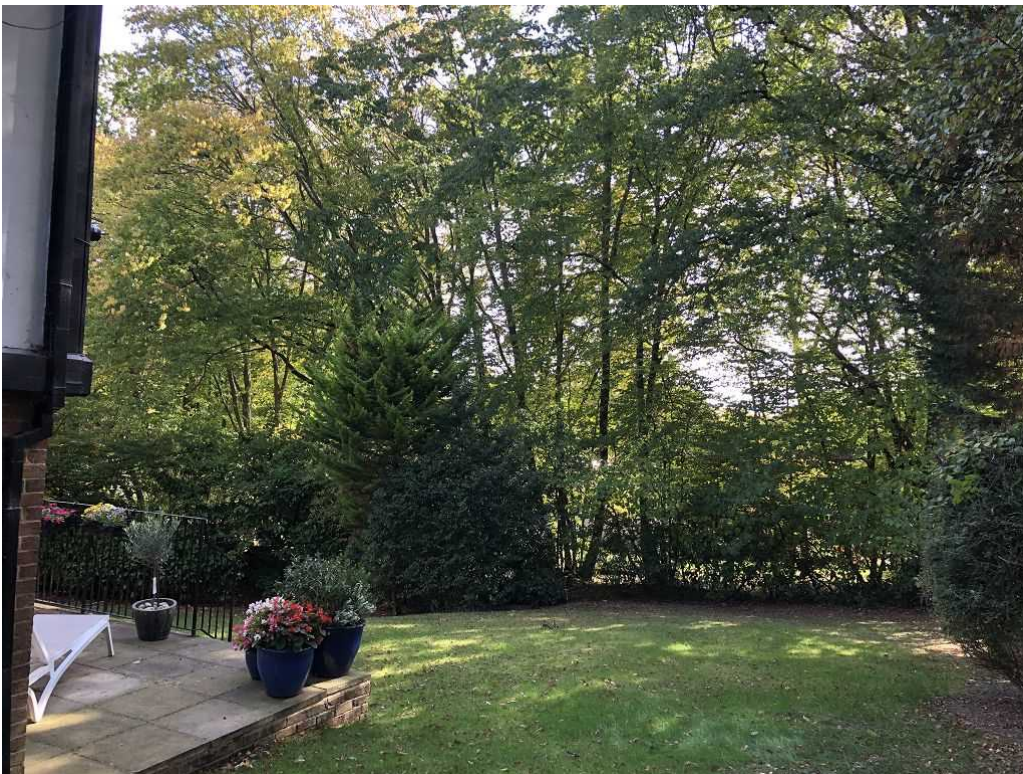
28

Rear right corner and more trees across the back

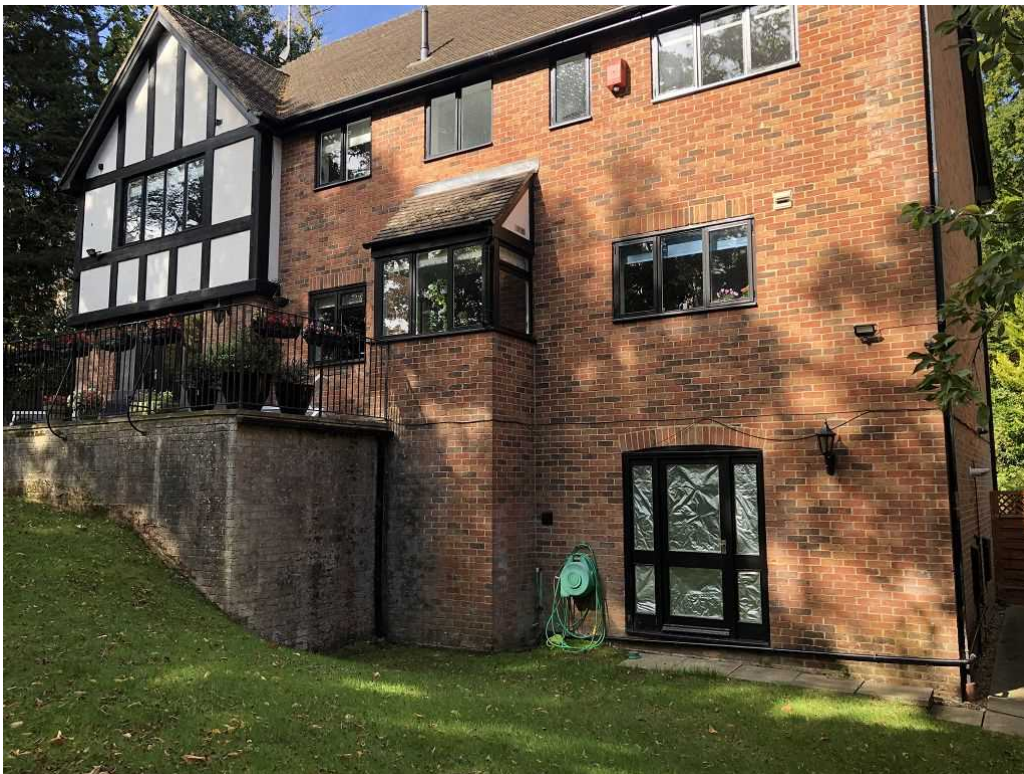
34

Back elevation

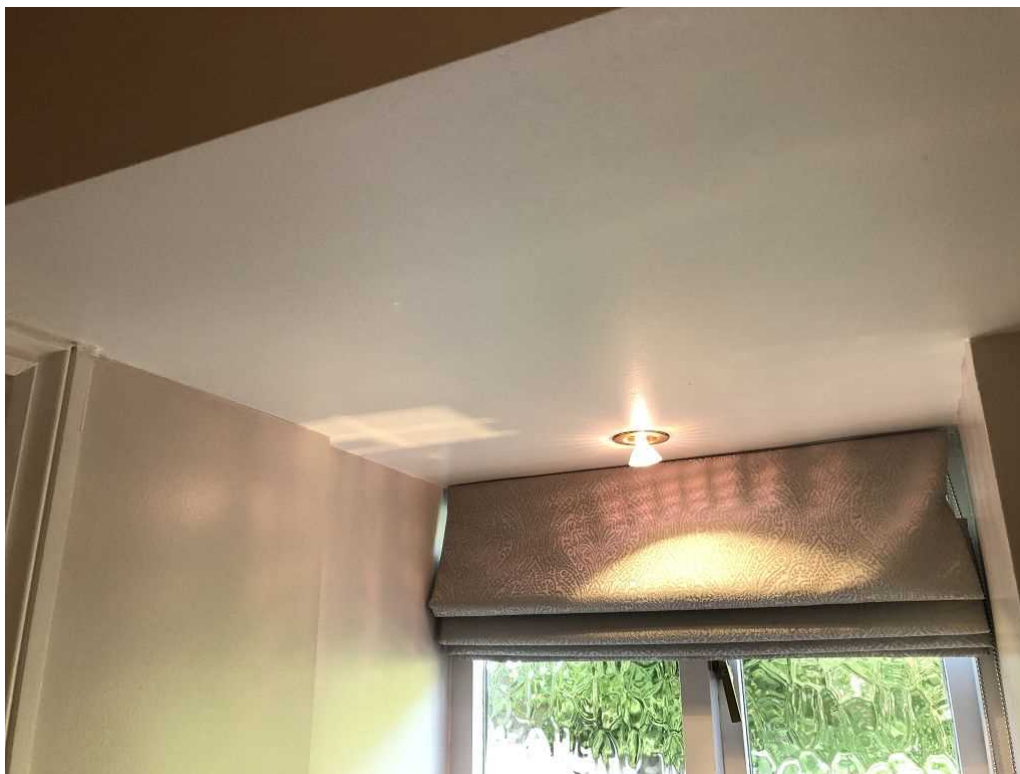
52

Next to the bathroom first floor front corner is the dressing area part of the master bedroom

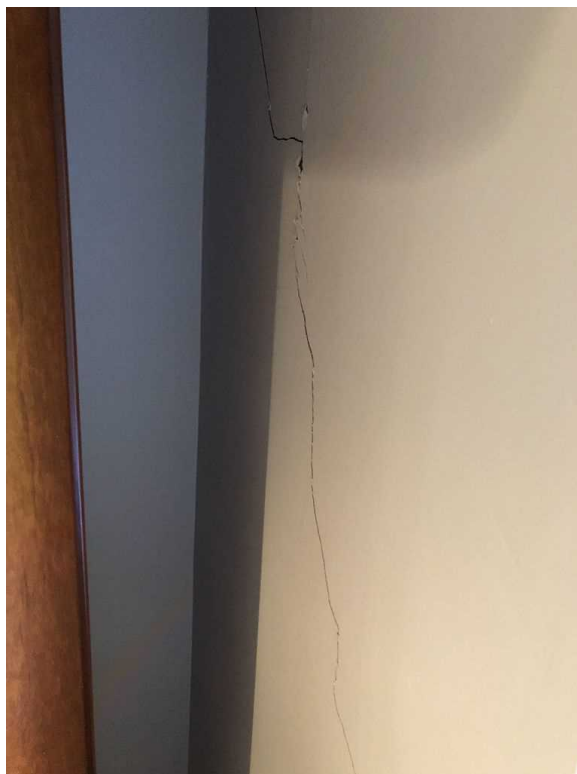
56

Various high level cracks to top of wall and ceiling at the far front right corner of the house ie over the lounge corner

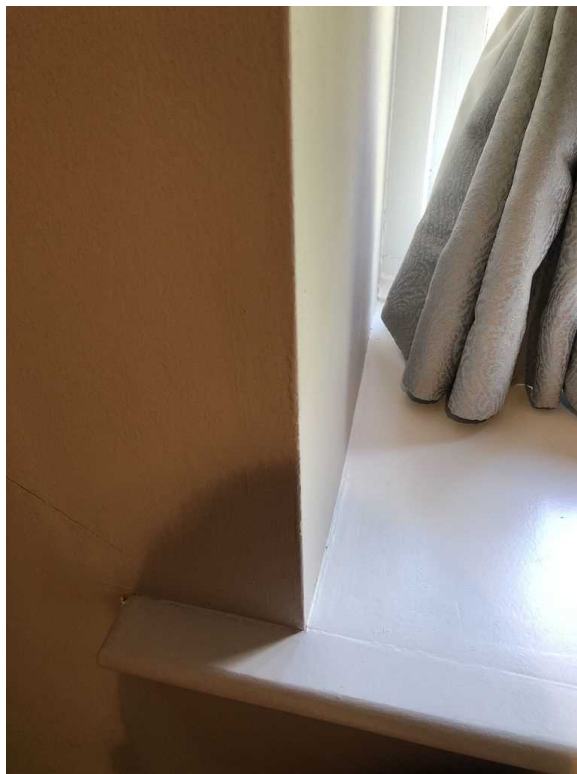
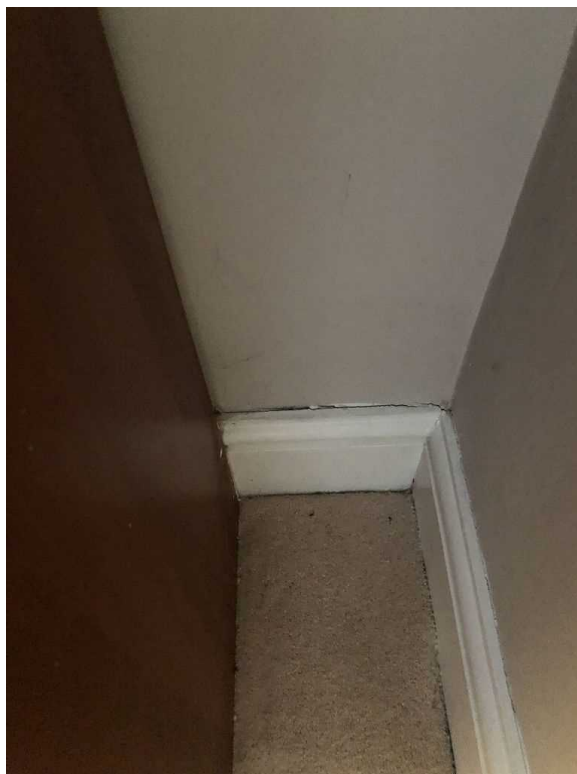
57

Nothing shows at lower levels

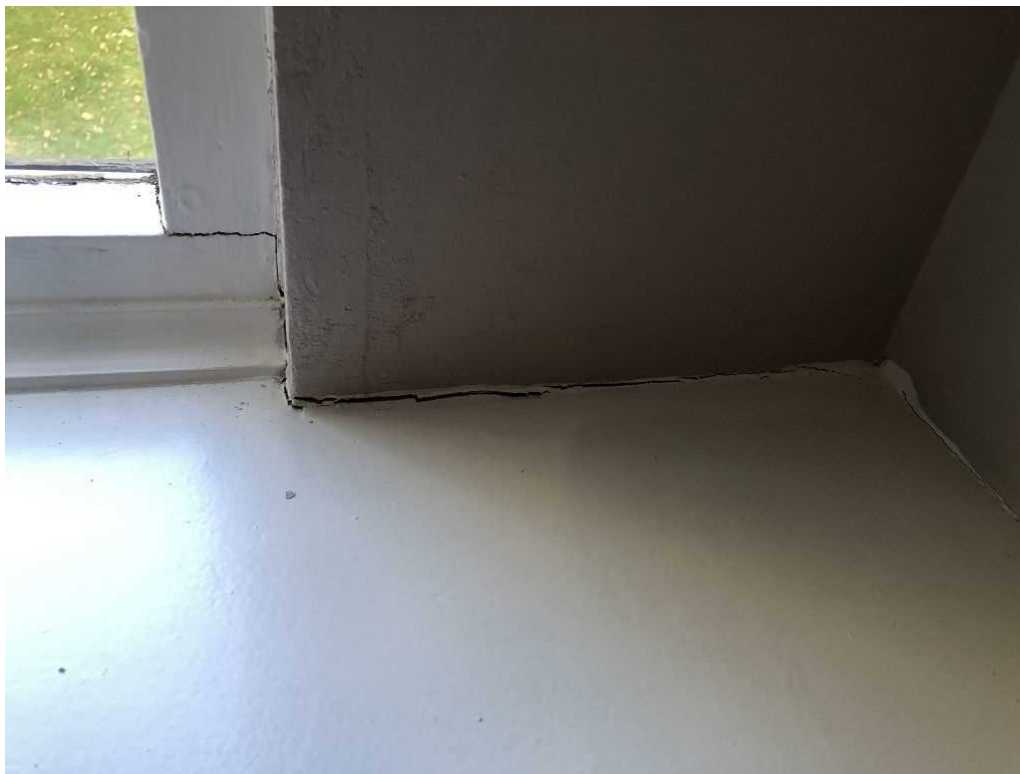
59

Further into the same room ceiling cracks reported as new

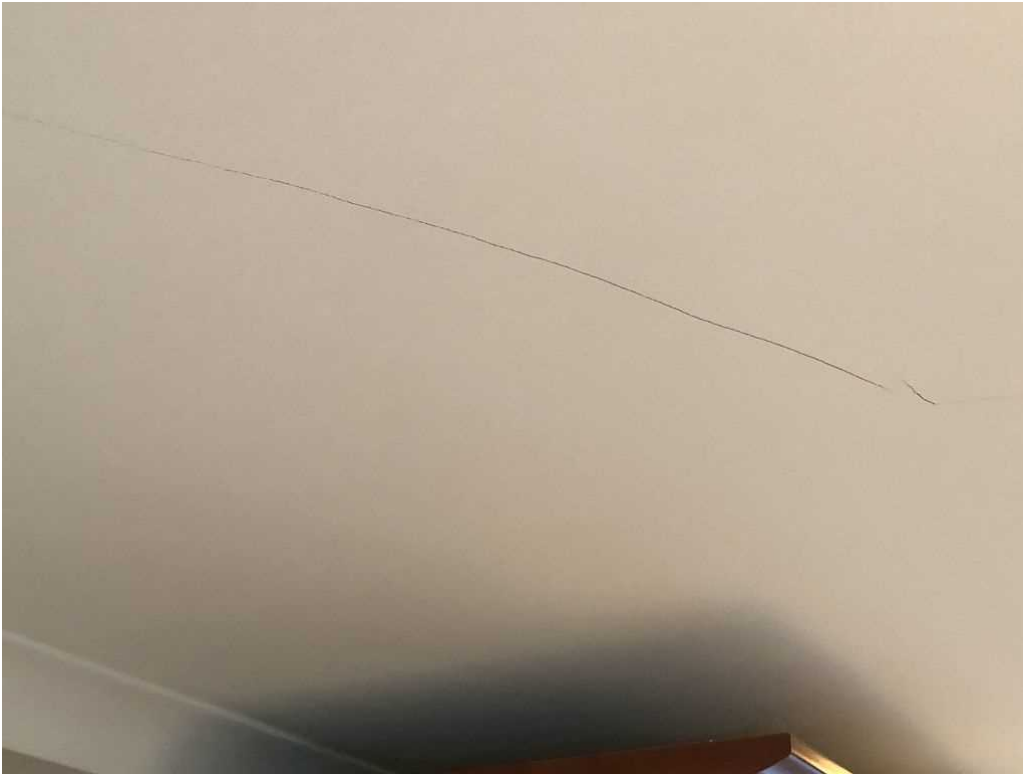
61

The back right corner is over the patio. Top right window corner cracking 1/2mm

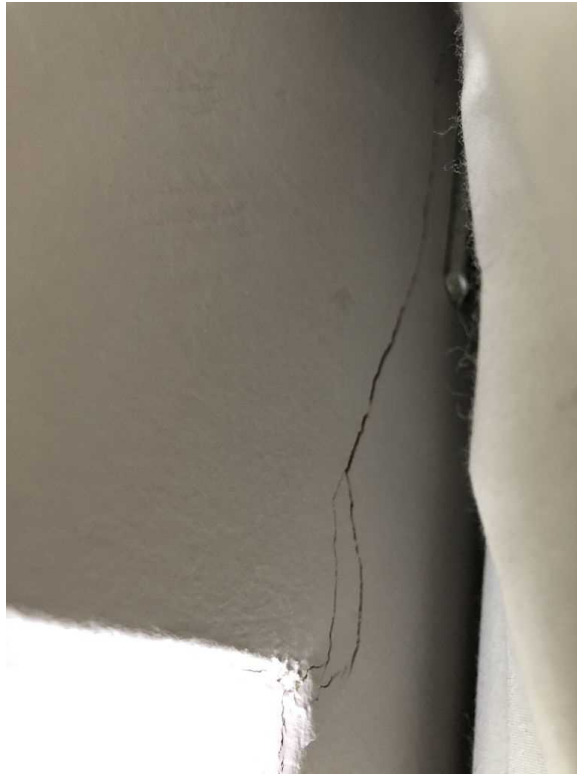
63

And smaller crack bottom left window corner

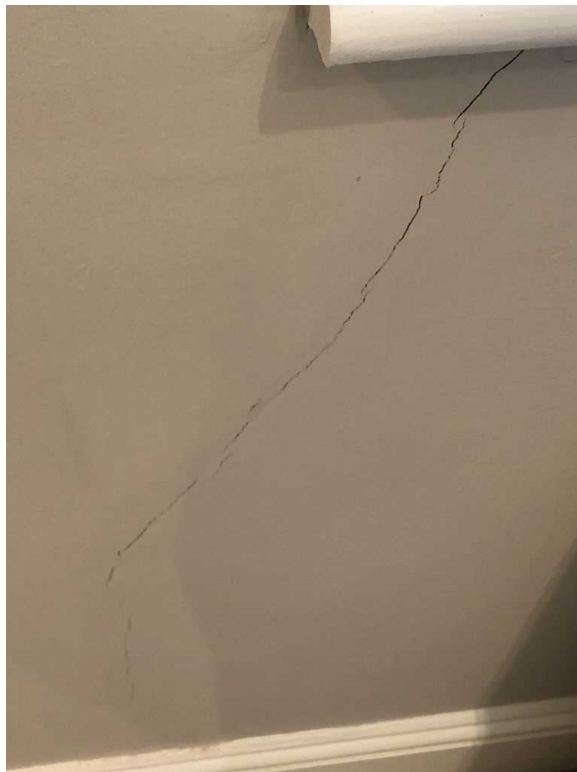
68

Front elevation second floor bedroom above garage. Bottom right corner crack 1mm jagged

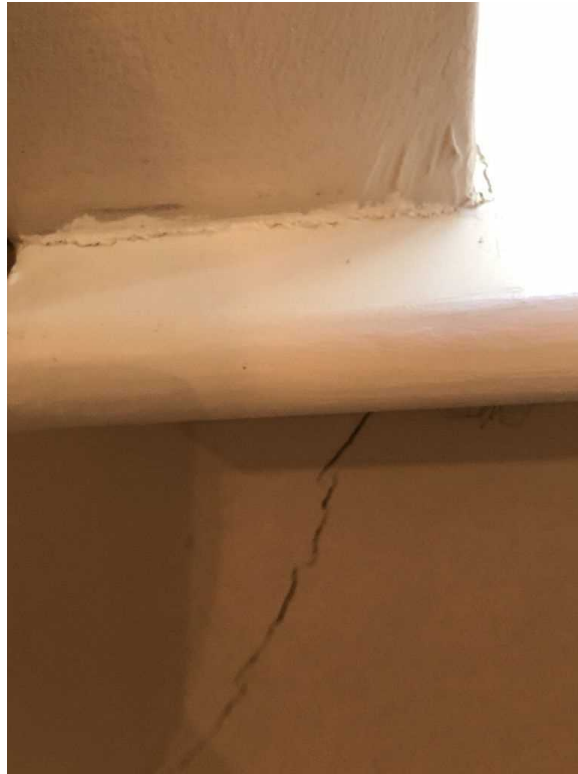
69

Back left corner bedroom - 1mm crack under sill

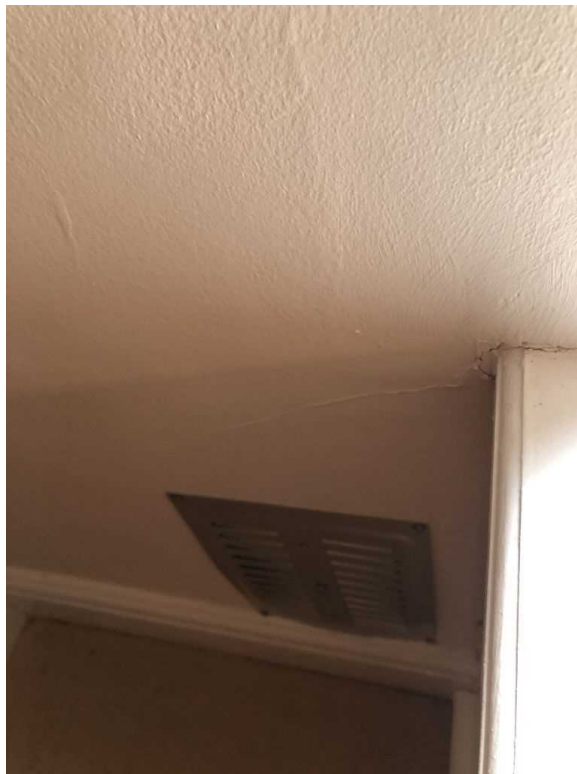
76

Front elevation window was where the engineer identified the vertical crack. Cracking to window corners

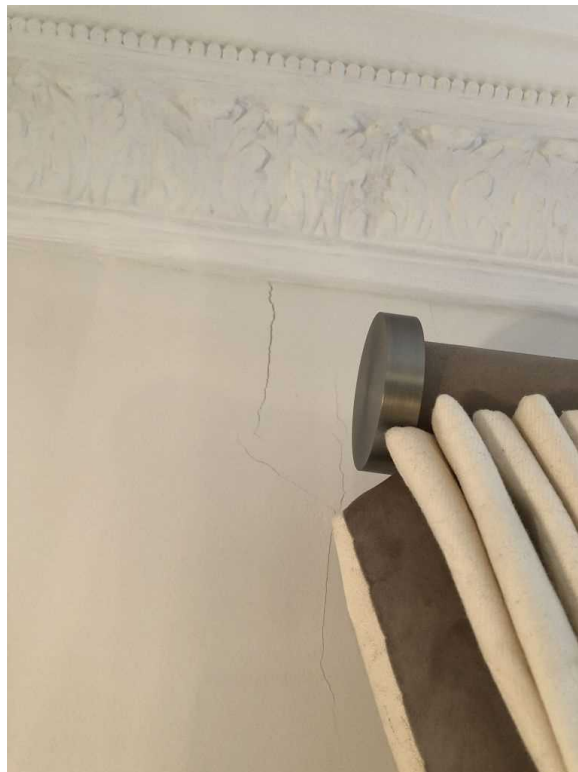
88

Back elevation bi-fold window corner cracks and cornice line gaps
