PROPOSED  
SITE PLAN

| Place :<br><b>HAYES</b> | Road :<br><b>1-3 UXBRIDGE ROAD</b> | Date :<br><b>12/11/2012</b> | Section number :<br><b>6</b> | PLR suffix :<br><b>X</b> |

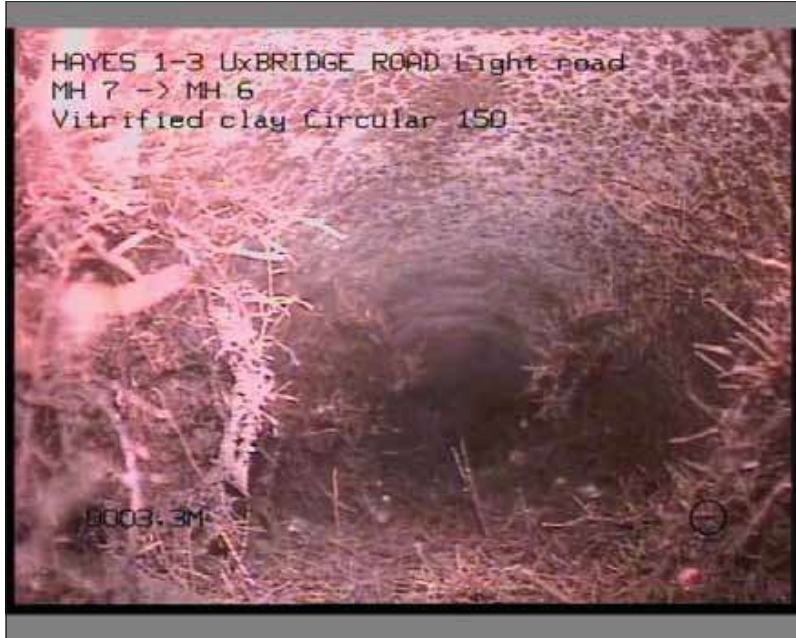
Photo: 20\_21\_174\_A.JPG

3.3m, Survey abandoned Remarks: UNABLE TO PASS ROOTS MASS

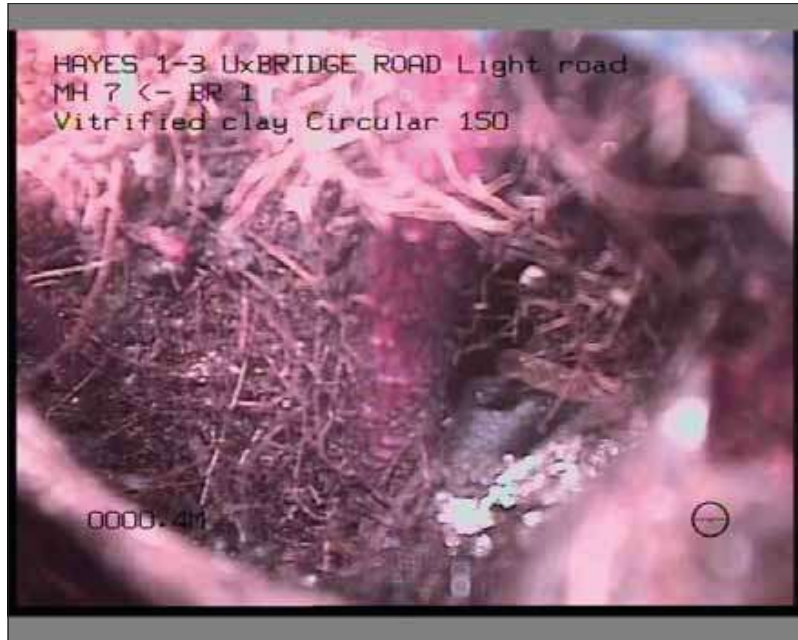
Photo: 22\_23\_181\_A.JPG

0.4m, Survey abandoned Remarks: UNABLE TO PASS ROOTS MASS

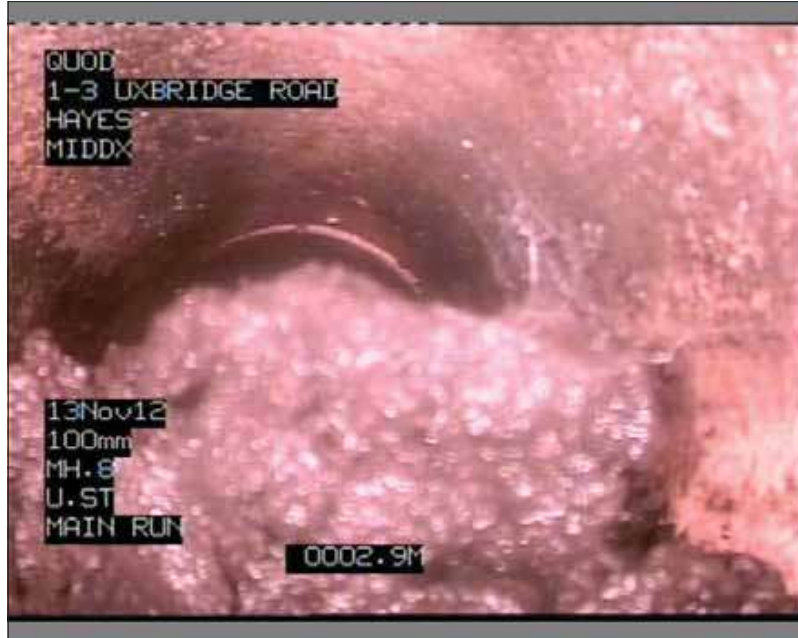
Photo: 24\_25\_190\_A.JPG

2.9m, Debris silt, 60% cross-sectional area loss Remarks: BUILT UP  
IN FRONT OF CAMERA

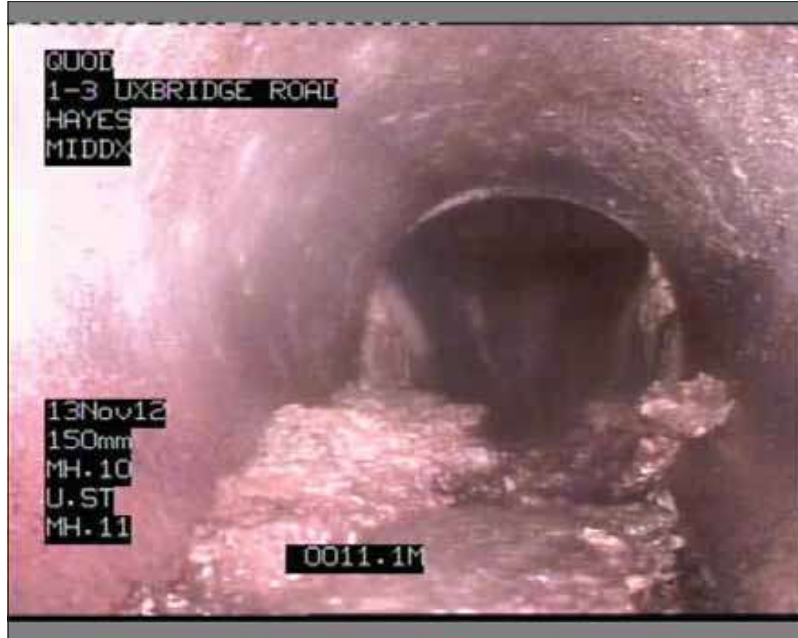
Photo: 30\_31\_255\_A.JPG

11m, Encrustation, medium, from 4 to 8 o'clock, 20% cross-sectional area loss

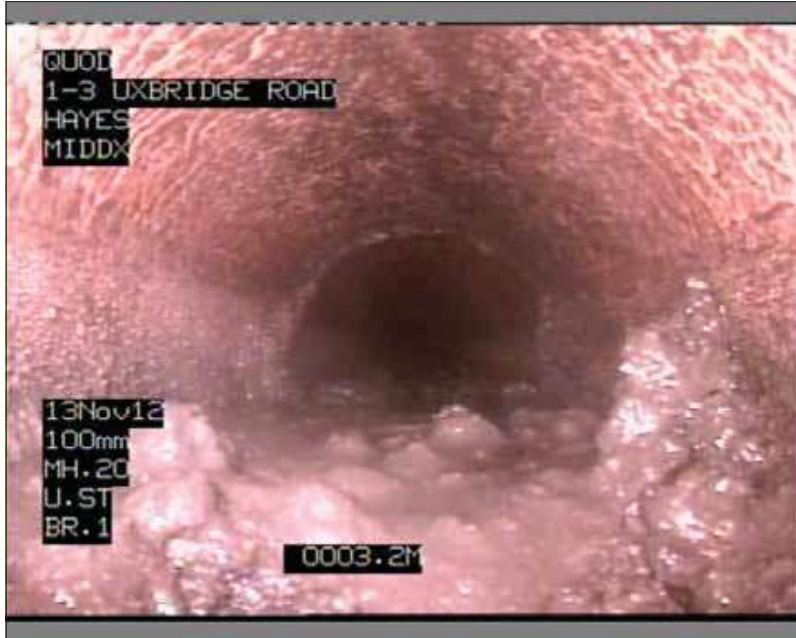
Photo: 42\_43\_391\_A.JPG

3.2m, Survey abandoned Remarks: DUE TO DEBRIS

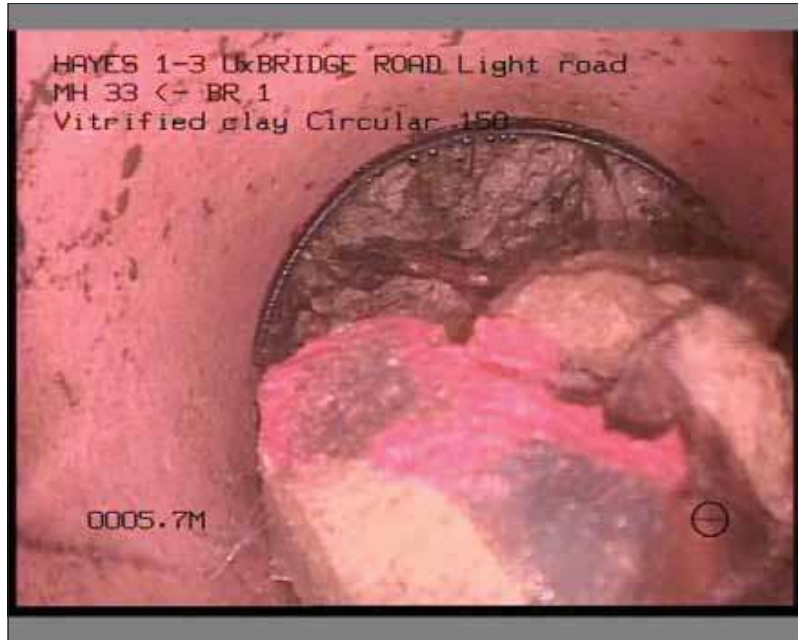
Photo: 63\_64\_563\_A.JPG

5.7m, Survey abandoned Remarks: DUE TO COLLAPSED PIPE

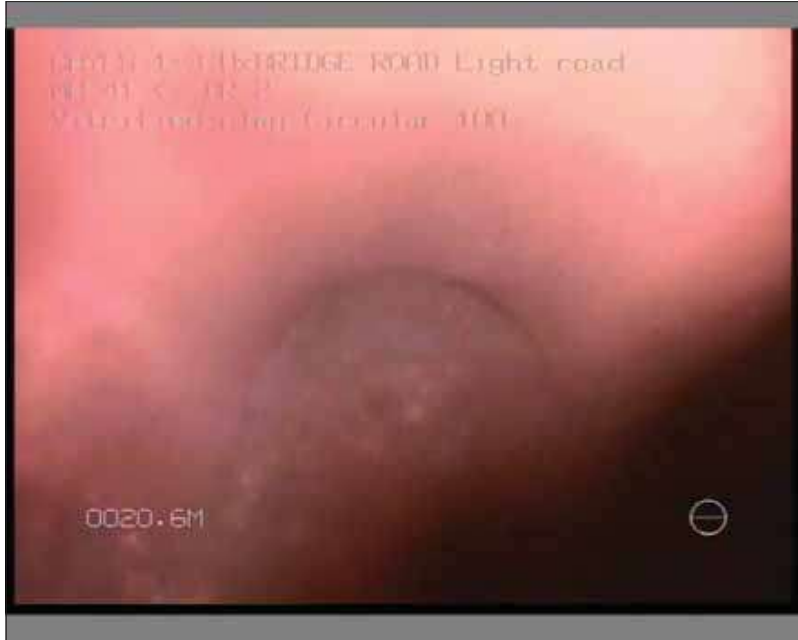
Photo: 69\_70\_632\_A.JPG

20.6m, Survey abandoned Remarks: UNABLE TO PASS DEBRIS SILT

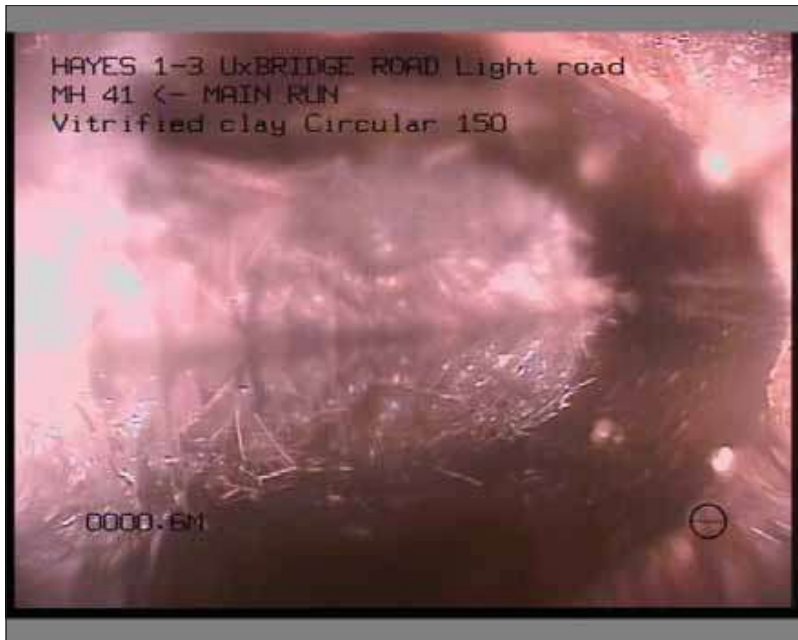
Photo: 71\_72\_638\_A.JPG

0.6m, Survey abandoned Remarks: DUE TO ROOTS MASS
